# FINAL REPORT

Investigation into the ground incident  
of aircraft Boeing A75N1,  
at Mladá Boleslav airport  
on 15 Jun 2006

Prague  
August 2006

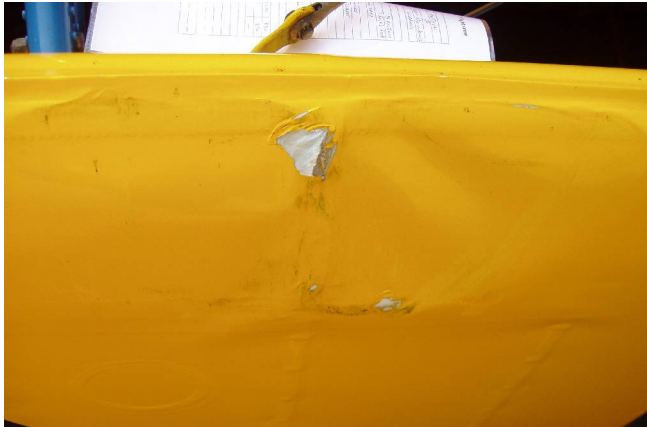
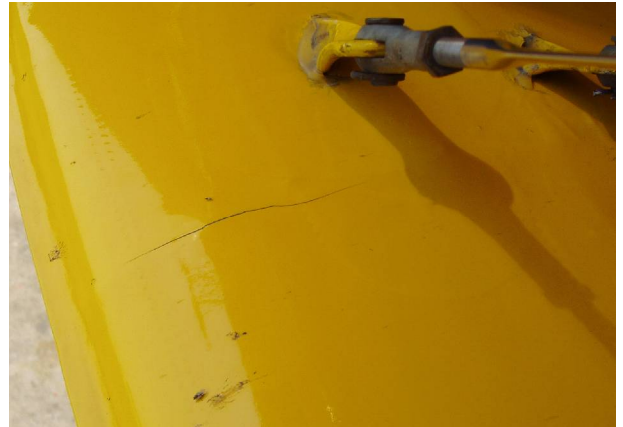
looking left to clear Z43, and caught with its right low wing the right front window pillar of the car Skoda Superb, number plate 5SO 5623, which stood nearest to the plane of all the cars parking there. The pilot stopped the engine following the shock.

The collision of the right low wing with the car windshield frame caused a dent ca 350 mm long in the wing leading edge and a skin crack at the upper side of the wing airfoil.

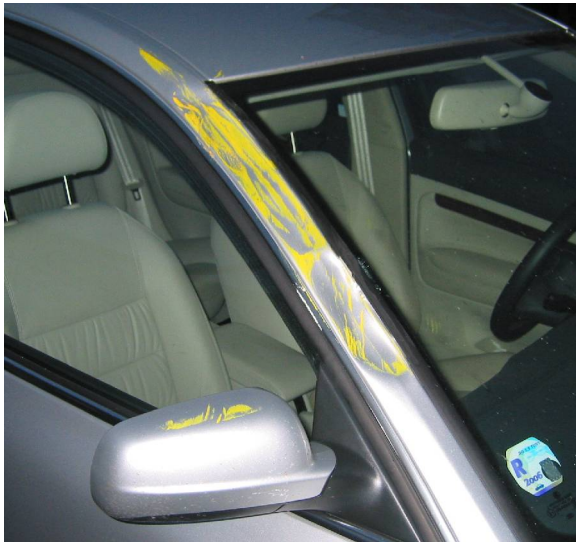
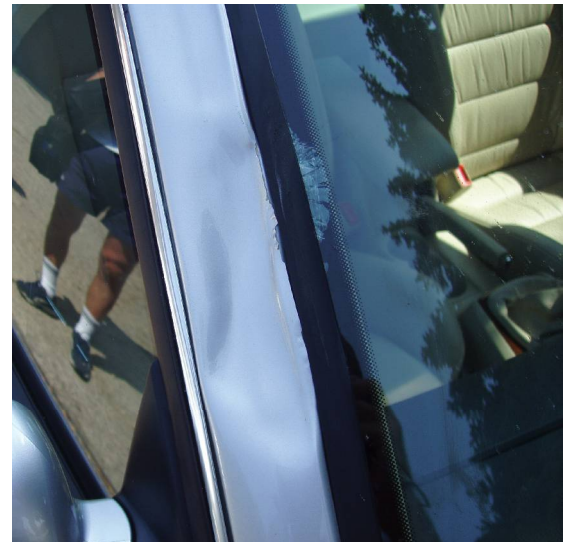
The Skoda Superb, number plate 5SO 5623 had its right front body pillar dented and the windshield broken.

Damage of the Skoda Superb

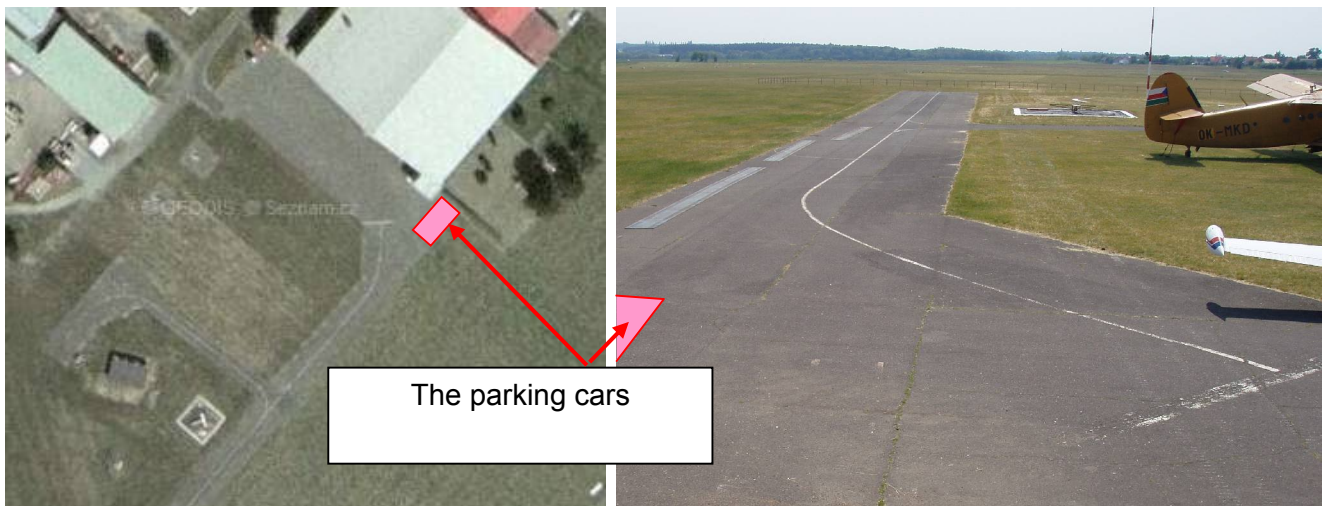
Visual aids and apron markings to enhance traffic safety off the hangar are not used. Remains of a full white line are visible at the place of incident where the asphalt road joins the apron corner.

Apron layout at Mlada Boleslav Airport.

The aerodrome at the town of Mlada Boleslav is a public domestic airport. Its apron in front of the hangar has dimensions 30 m by 60 m. The asphalt road is 8 m broad. Passenger cars parked on both shorter sides of the apron. The airport rules order no-parking on the apron.

Parking the cars at the apron edge in front of AFIS station violated Regulation 3.5 of Mlada Boleslav Aerodrome rules.

The Mlada Boleslav Aerodrome operator should install appropriate traffic signs at the apron entry regulating the movements and parking of vehicles, in accordance with the aerodrome rules.
