AIR ACCIDENTS INVESTIGATION  
INSTITUTE  
Beranových 130  
199 01 PRAHA 99

# **FINAL REPORT**

**The investigation into an incident  
runway incursion at LKPR,  
August 11, 2006.**

Operator: BRITAIR  
Manufacturer and Model: Canadair Aerospace, CRJ 100  
Call Sign: BZH5904  
Place of event: LKPR RWY 24  
Date: August 11, 2006  
Time: 15:49 ( all times in UTC )

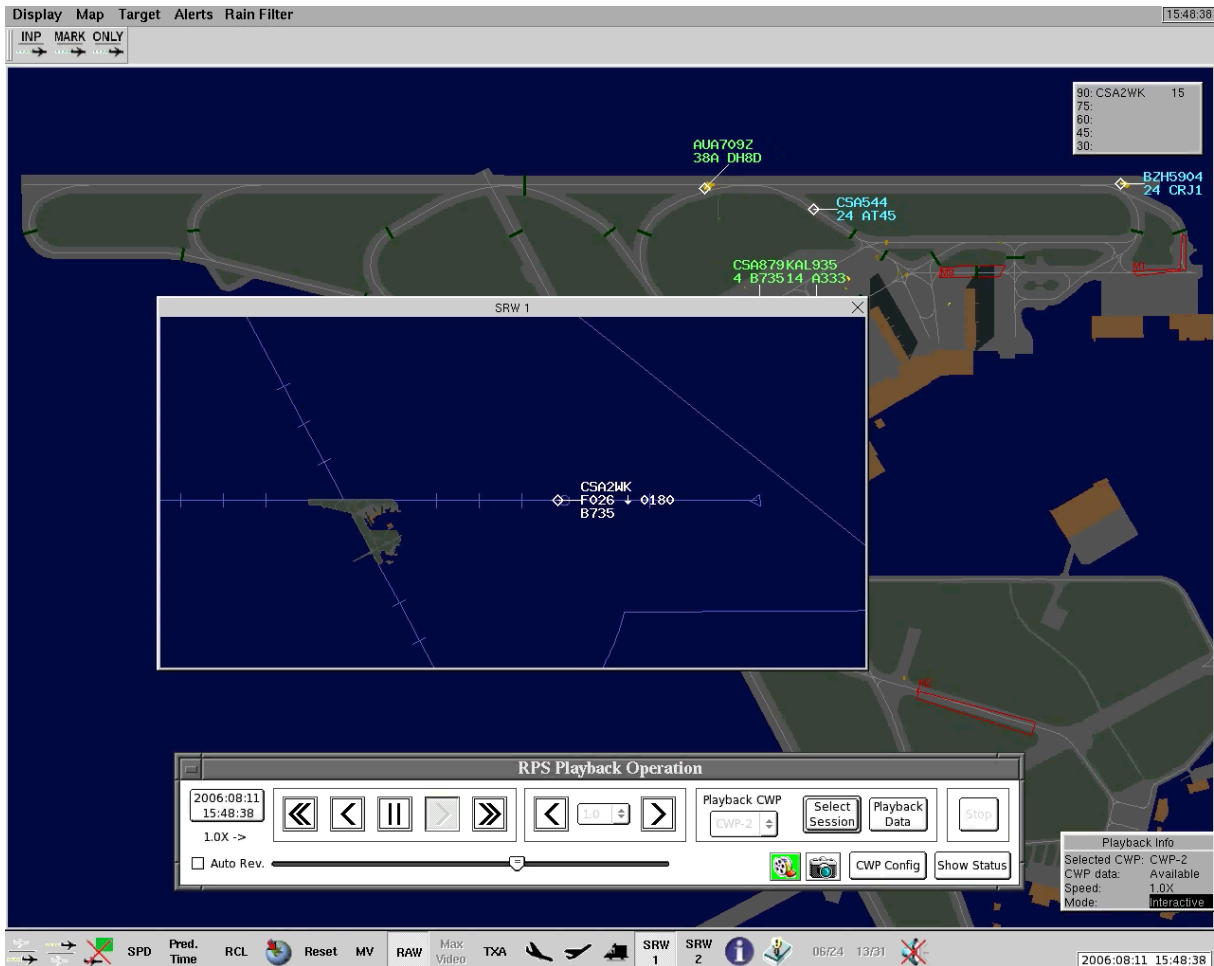
Radar screen

- RWY 24 and 31 were serviceable at LKPR Airport.
- EC TWR cleared CSA544 to enter RWY 24.
- EC TWR did not clear BZH5904 to enter RWY 24.
- According to the radar record, BZH5904 commenced to taxi on RWY 24 from TWY A without permission at the time when the landing AUA709Z was in TDZ RWY 24.
- At the time when instructions were being issued to CSA544, this was taxiing on TWY B to RWY 24.
- At this time BZH5904 was on RWY 24.
- At the same time AUA709Z was on TWY C after having left RWY 24.
- CSA took-off after AUA709Z had left RWY 24.
- With regard to the BZH5904 position on THR RWY 24, EC TWR issued a go-around instruction to CSA2WK which was on the final, ca 4 NM.
