FINAL REPORT

Investigation of glider accident, Registration Mark D-2802 on 1st August 2008

Operator: Segelfliegerclub Greifswald, Germany
Aircraft manufacturer and model: PDPS Bielsko-Biala, Poland, type SZD-51-1 Junior
Registration Mark: D-2802
Place of incident: West village Strážné, Czech Republic
Date and time: 1st August 2008, 11:04 (all times are UTC)

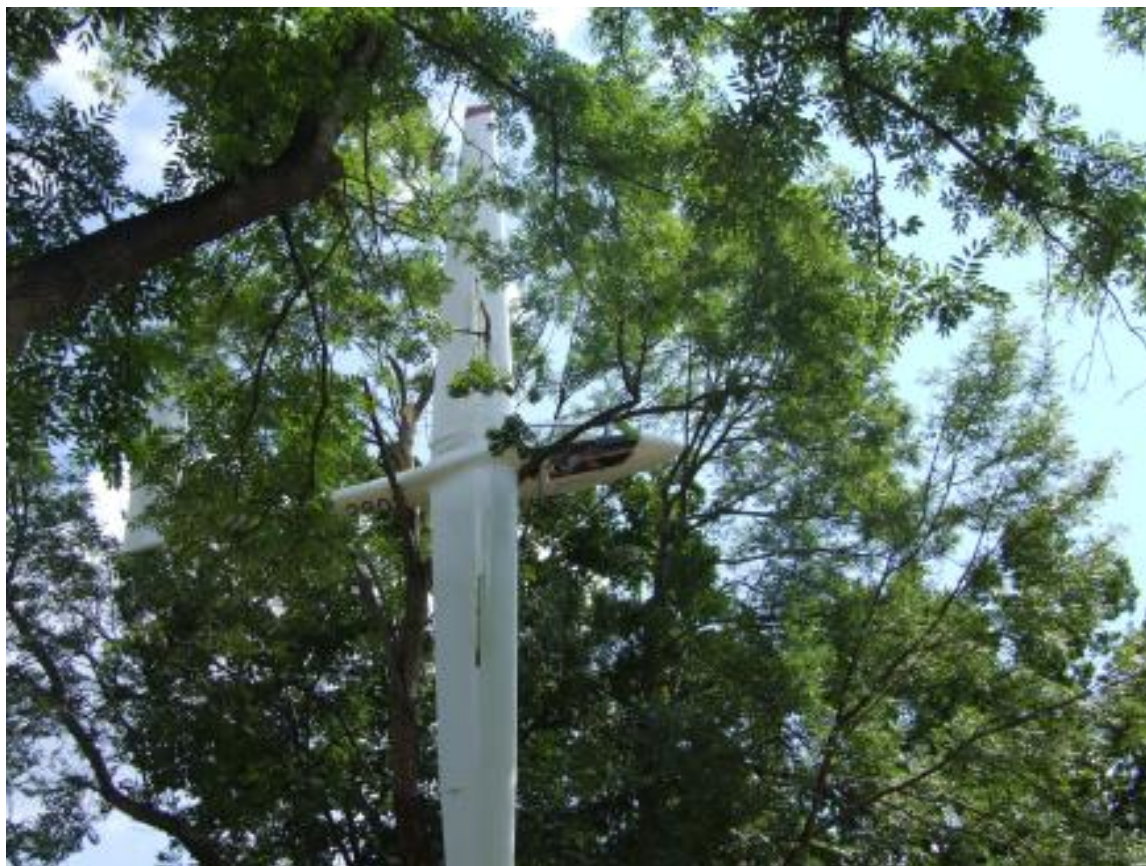
The flight lasted 1:51 h from take-off to the accident. According to the witnesses, the glider hit one of the trees 15 m high and got stuck in it. After about 30 minutes the glider set free by itself and fell down on the hard soil under the tree and was destroyed, causing injuries to the pilot.

Glider on the tree

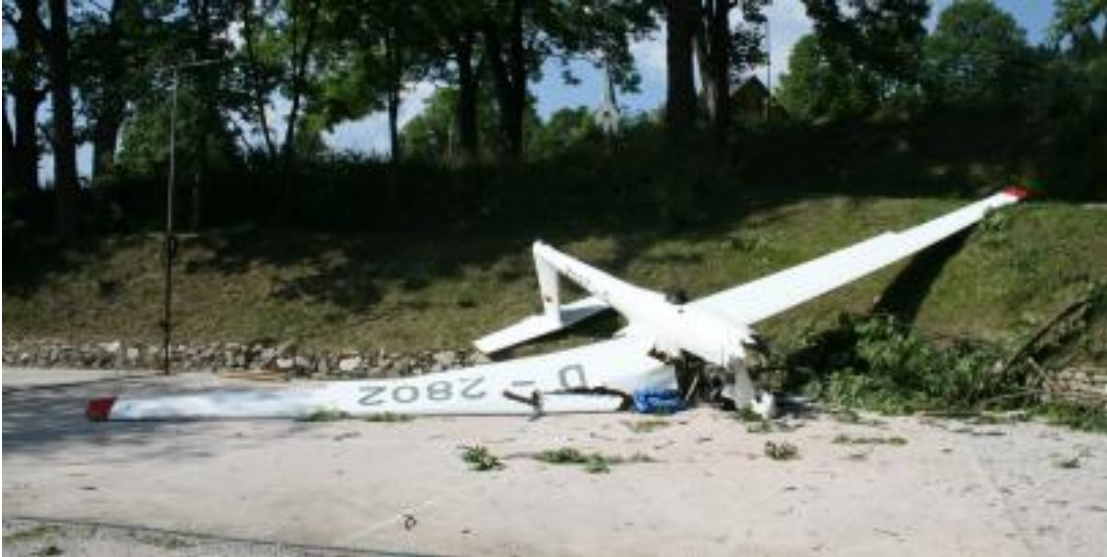
Glider on the ground

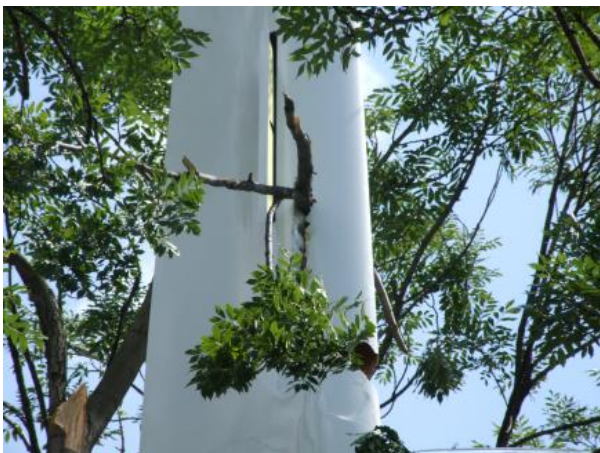
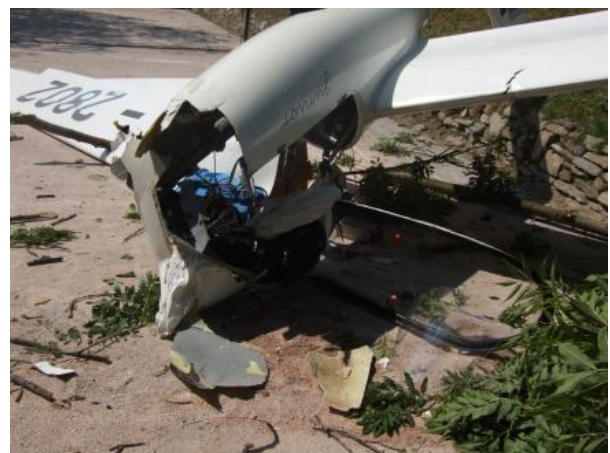
Owing to the collision of the glider with the tree, the following glider's parts were damaged: surface of both of the half-wings, the primary structure of the left half-wing, and the fuselage structure past the wing was partly broken. The canopy was ripped out, the fore fuselage was destroyed, and the left half-wing's hinge was torn off in the crash. The tail plane primary structure was not damaged, the skin was scratched slightly.

Glider damage

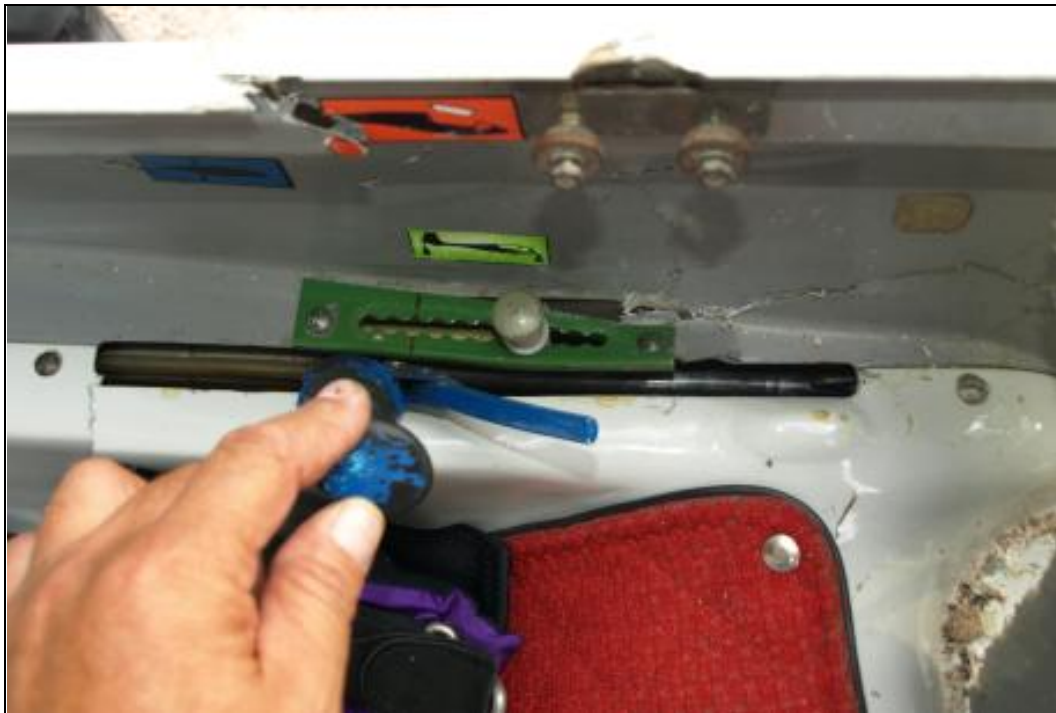
Position of stick to command air brakes and lengthwise balance

- judging from the extended air brakes, the pilot probably wanted to terminate the flight by landing onto the ground.

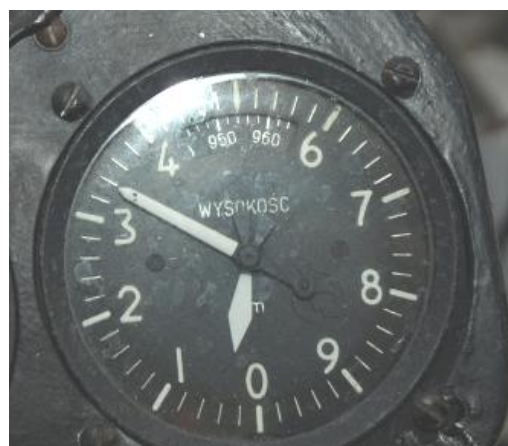
Altimeter

The value indicated on the barometric pressure scale was 954 mb and the altimeter pointer indicated 340 m.

- the altimeter was probably set to QFE at LKVR valid for 09:00 h, i.e. at the time of TKOF;
- the record of the last flight phase showed that due to the way the flight was executed the altitude decreased by around 150 – 200 m, so the height over the village of Strážné was not sufficient to fly as far as the LKVR aerodrome. Between the village of Strážné and the LKVR Aerodrome there are mountains Strážná Hůra (824 m AMSL) and Jankův Kopec (694 m AMSL), which are higher than the glider's real height was;
