AIR ACCIDENTS INVESTIGATION
INSTITUTE
Beranových 130
199 01 PRAHA 99

Ref. No. CZ - 12 - 131

FINAL REPORT

**Investigation of the air accident
involving the Safari helicopter, registration N 557XS,
at the village of Litvínovice - Šindlovy Dvory,
14 May 2012**

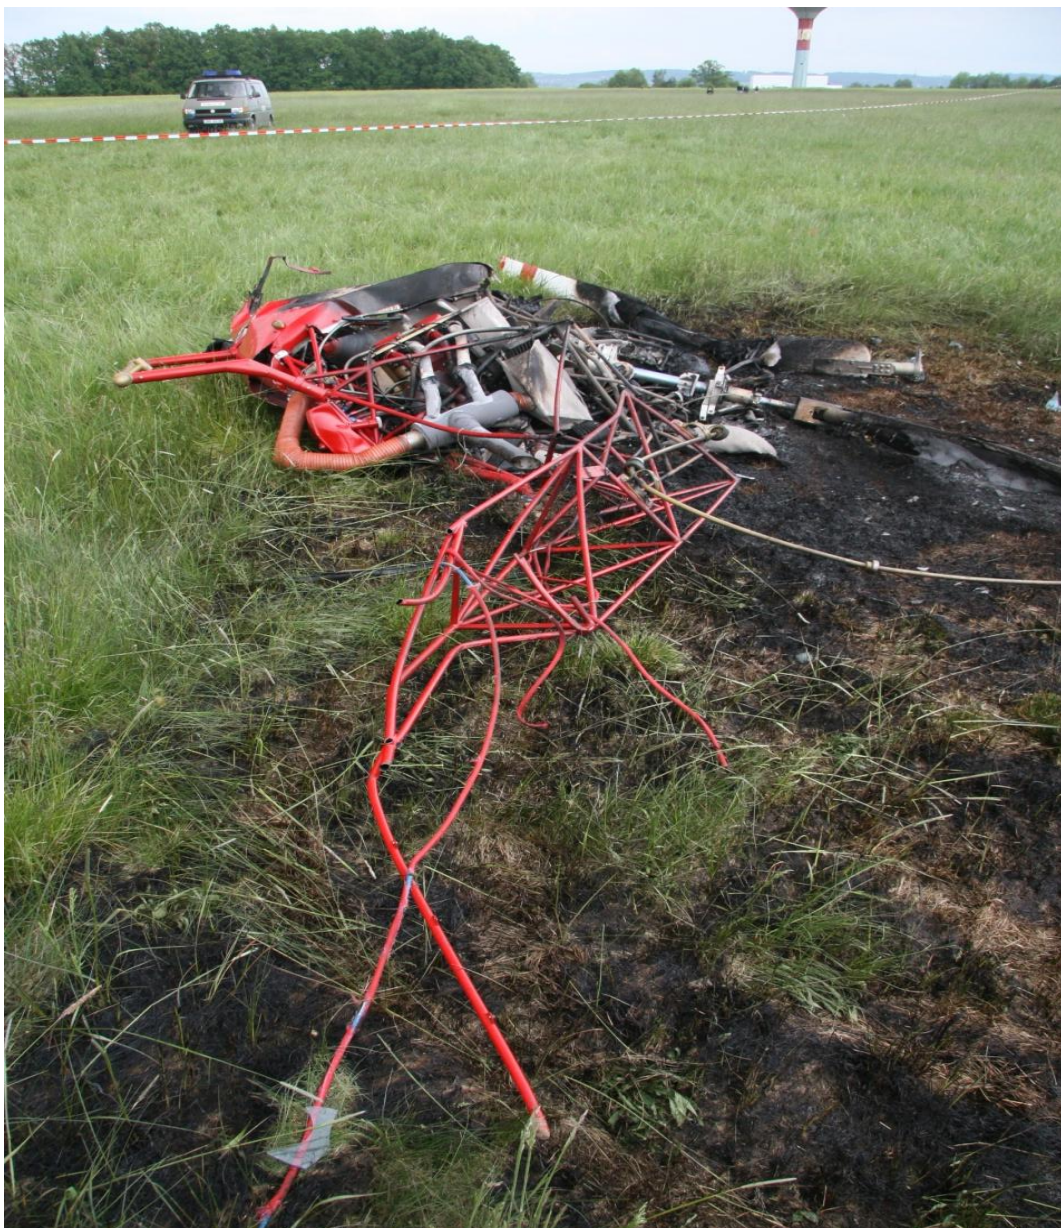
The helicopter was completely destroyed by its fall to the ground and subsequent fire.

Fig. 2: The destroyed Safari helicopter

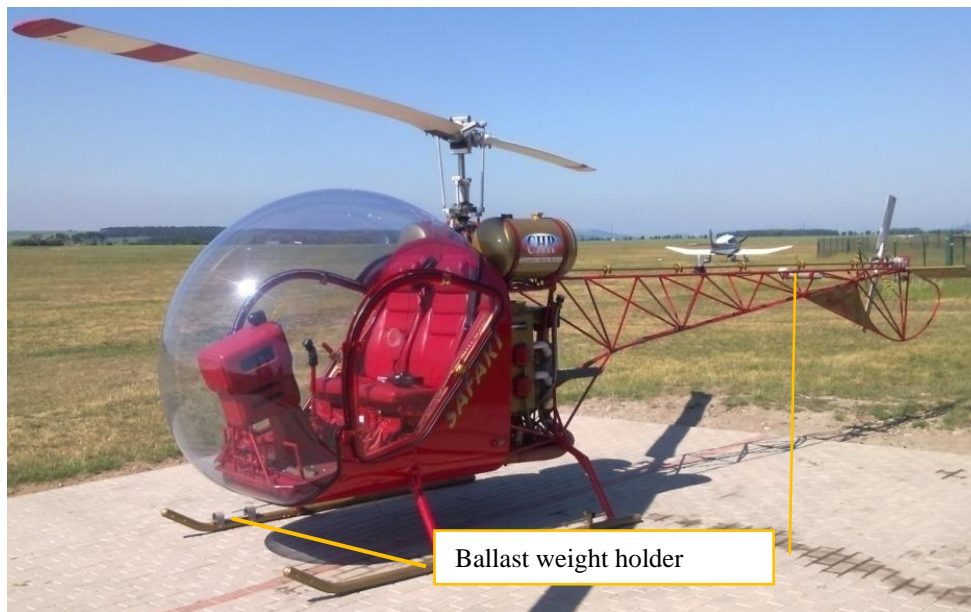
The manufacturer supplies the helicopter as a kit that can be assembled by amateurs. The helicopter, registration N 557XS, was assembled in the USA in 2001. According to the manufacturer's description, the helicopter is piloted from the left seat in the cockpit. For proper longitudinal trim, the helicopter is supplemented with a portable ballast weight (hereinafter weight) weighing 13.8 – 14.0 lbs. If only one seat is occupied, before a flight, the weight is secured in the holder on the front part of the right landing skid. If both seats are occupied, the weight is placed in the holder in the rear part of the truss near cross member No. STA 187.

Fig. 3: Overall view of the Safari helicopter and ballast weight holder

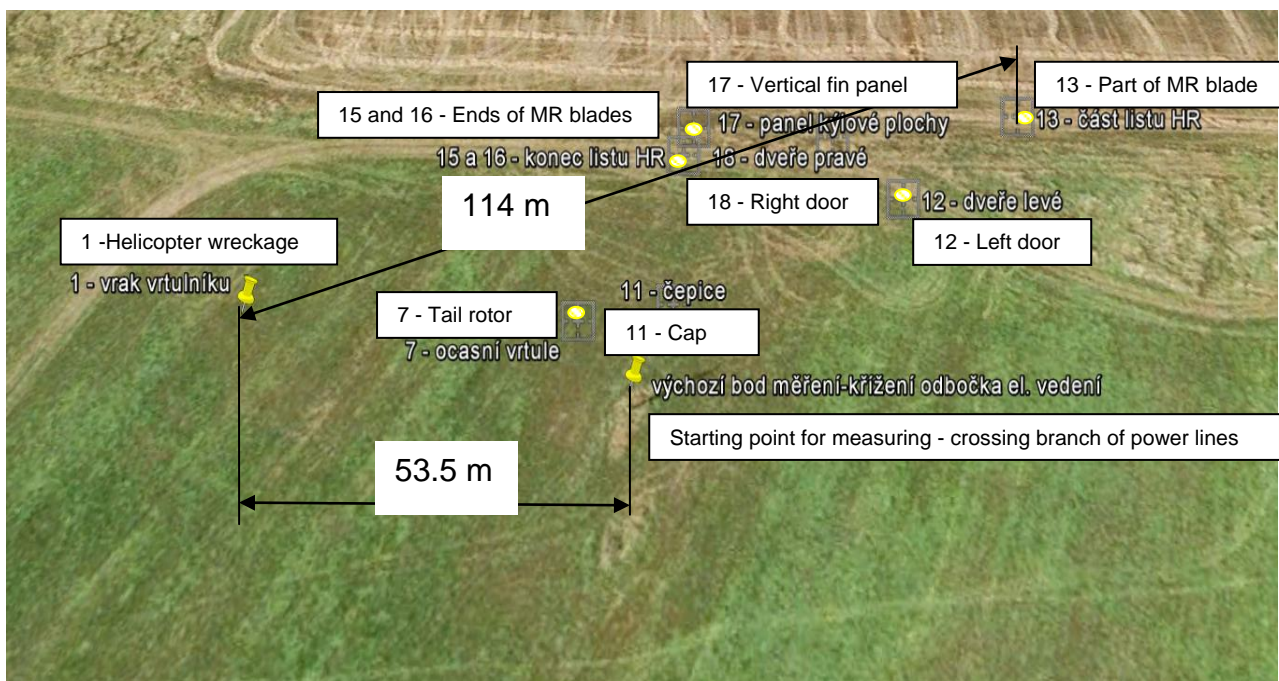
When assembling the main parts, it was found that the ballast weight with the locking pin and the left part of the rear holder of the weight were missing.

Fig. 4: Diagram of scattered wreckage – legend corresponds to the description of the Police of the Czech Republic

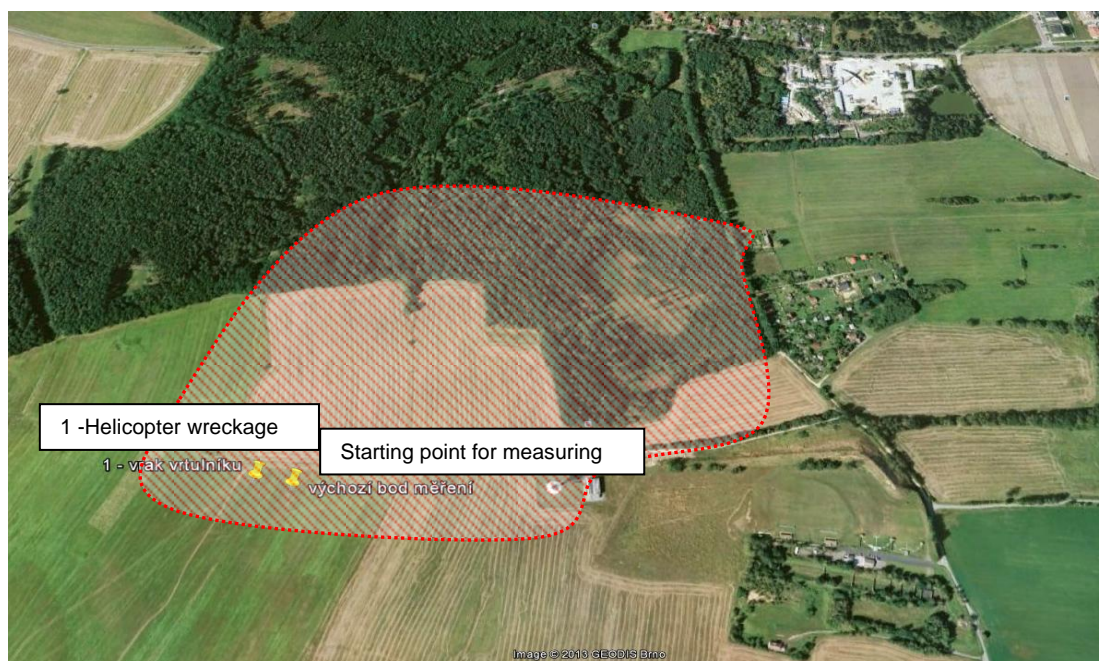
The AAI ,in cooperation with the Police of the Czech Republic and volunteers, organized two searches for the missing weight. The search teams searched in the area of the projected flight path as described by witness testimonies. The search ended with negative results and the weight was not found.

Fig. 5: Search area for ballast weights

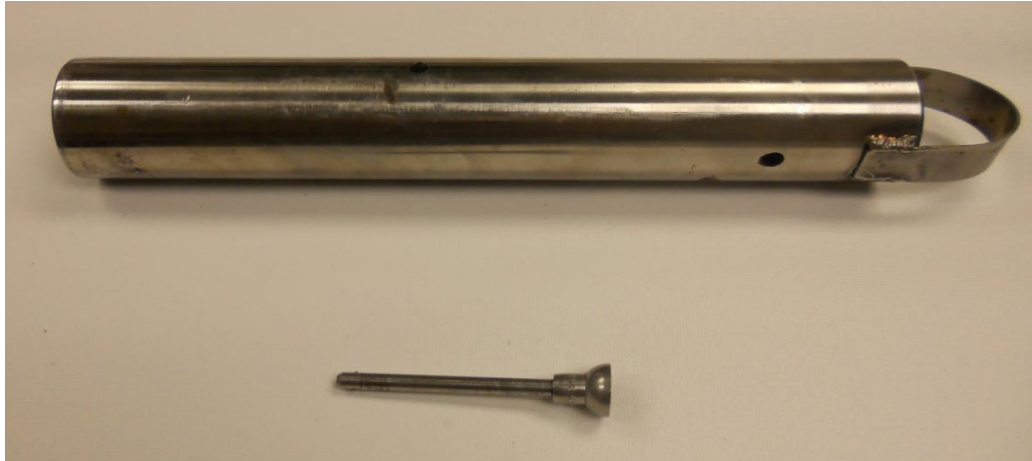
He said that the weight weighs 13.8 – 14.0 lbs. He also described the structural design and securing of the weight on the helicopter. The commission was not able to find evidence of how the weight was secured on the crashed helicopter. Presuming that it was the same as described by the manufacturer, the weight was secured by one locking pin into an opening on the left side of the holder. It can be presumed that the connection of the locking pin/hole could have been worn from operation of the helicopter, e.g. the ovality of the hole as a result of vibration of the tail beam during operation, or the ball mechanism of the locking pin could have been damaged thus losing its securing function.

Fig. 7: Usual design of weight with locking pin (illustrative photo)

With regard to the likely cause of the air accident and the very plausible hypothesis that during the flight the ballast weight was lost, a weight secured by a securing element of the so-called first level, and when after the loss of the securing function the weight can fall off, we recommend that the manufacturer of the helicopter carry out a change in the manner of securing the weight or a change in the design of the locking pin.

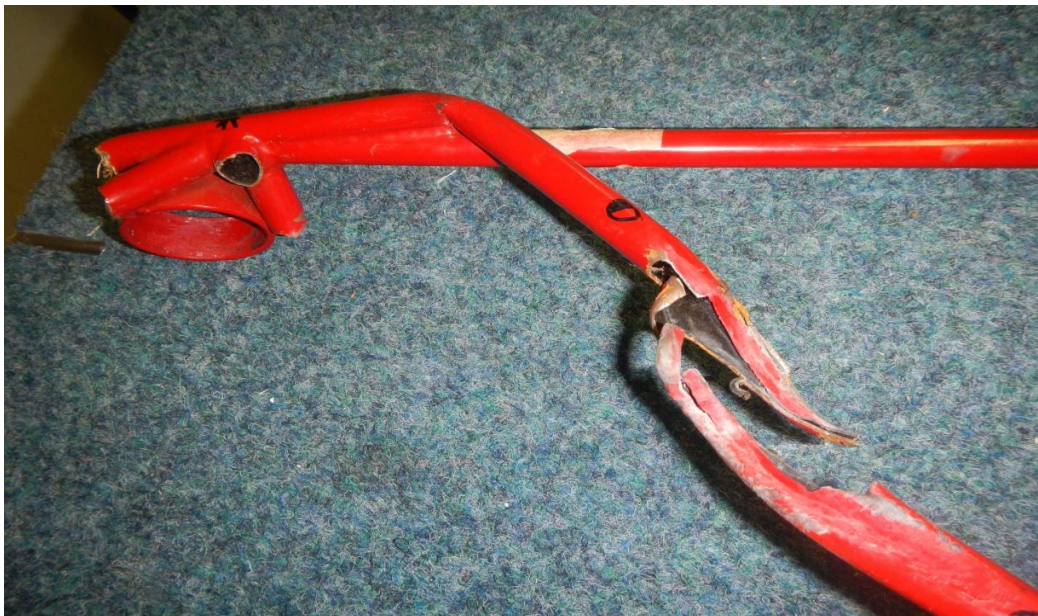
Fig. 8: Holder of the ballast weight on the right side of the tail beam
