Ref. No 411/06/ZZ

FINAL REPORT

**Investigation of Accident A/C Cessna 150H, Registration Mark OK-CTD,
after landing on 15th August 2006**

Prague
November 2006

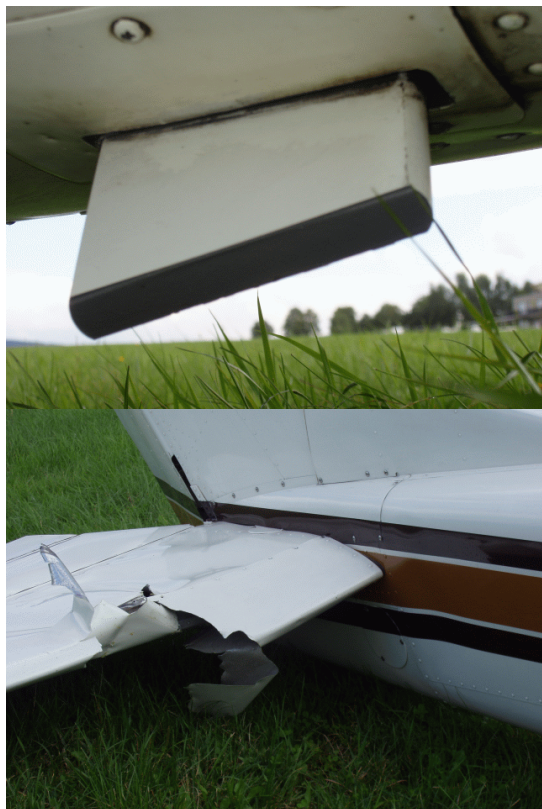
The strut of right-hand undercarriage leg broke off, 95 mm away from its fixation into the fuselage. After the accident, the separated leg along with the landing gear's wheel and brake lay around 27 m behind the airplane. The separated landing gear strut had hit the right-hand side of the horizontal tail unit and damaged it.

Pic.No 1- leg broke off, 95 mm away from its fixation

Pic.No 2- horizontal tail unit and

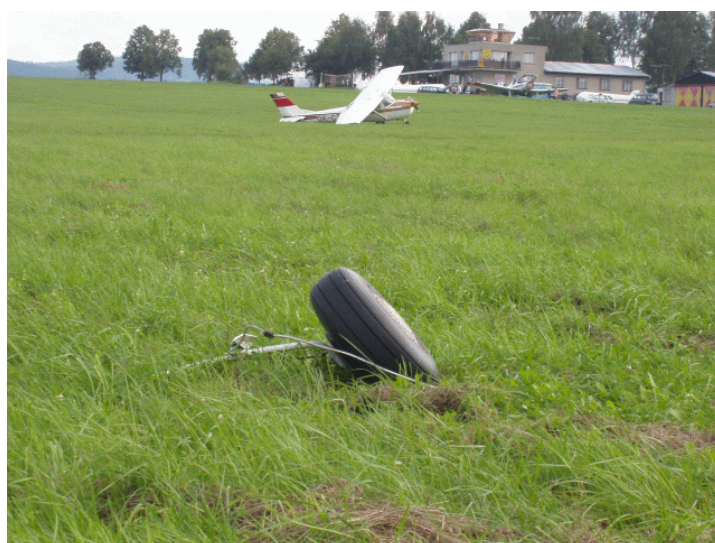
The final position of the plane following the accident was around 200 m from TRH RWY 13 LKST.

Pic. No 3- final position

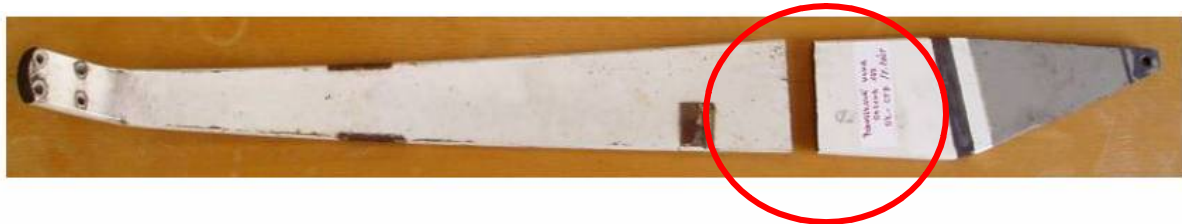
The expert group had commissioned VZLU, a.s. Praha (Aeronautical Research and Test Institute in Prague) to conduct an expert analysis of the strut and undercarriage fractured surfaces. The analysis confirmed material fatigue of the parts concerned.

Obr. 1-1 Rozlomená noha letounu

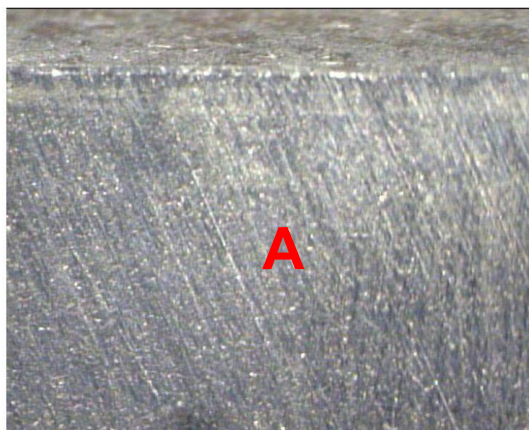
The undercarriage strut is stressed by bending and has a rectangular cross section. The semi-finished product of the strut was surface-ground on the pressure-stressed side (A surface) to remove surface unevenness and corrosion defects.

Obr. 1- 12 Povrch A po odstranění laku

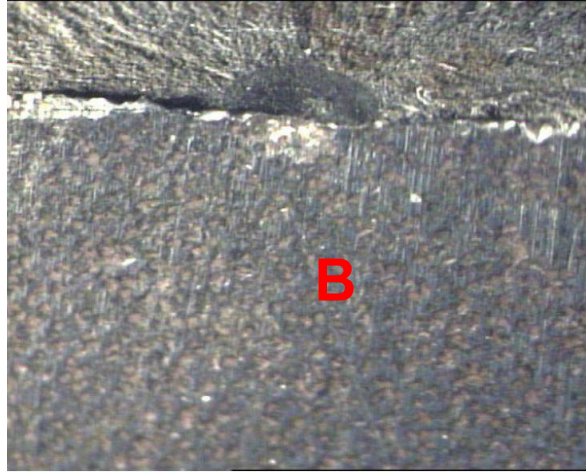
The tension lower side of the semi-finished strut (B surface) had no surface treatment before colour paint was applied to it. After removing the paint, the surface showed unevenness with traces of corrosion products.

Obr. 1- 11 Povrch B po odstranění laku

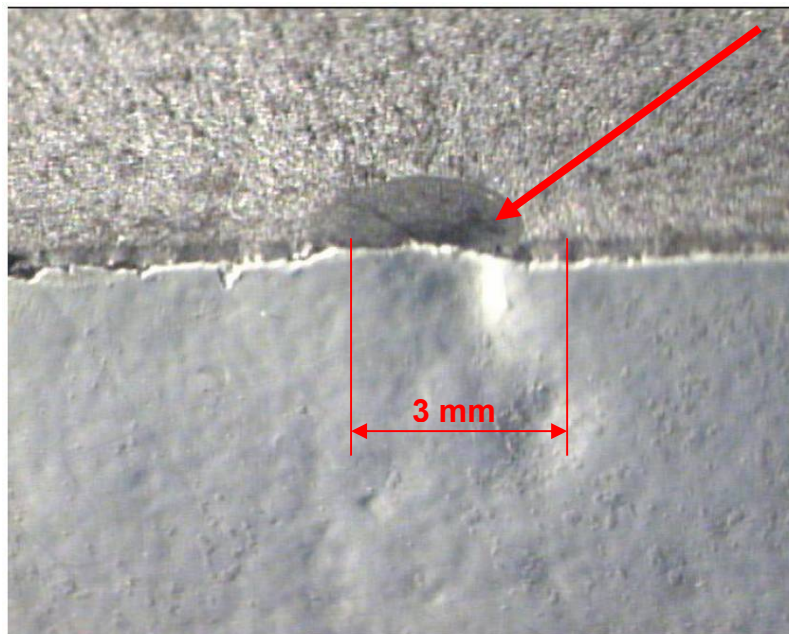
The fracture was caused and initiated by surface unevenness of the strut hidden under the undercarriage paint.

Obr. 1-10 Detail - počáteční trhlinka - pohled z boku na povrch B

There was material fatigue caused by gradual increase of service time. The crucial cross-section created by propagating fatigue fracture could not resist the load and broke off completely when it was subjected to the landing forces.

The decision on whether the Cessna 150/152 maintenance procedures should be extended to include checks on the undercarriage type concerned falls in the competency of the Czech Republic Civil Aviation Authority.
