**Ref. No CZ-07-384**

# **FINAL REPORT**

**Investigation into the incident  
- separation minima infringement between FAH6984 and WZZ135K  
on the FIR Praha and FIR Warsaw boundaries  
on 5 September 2007**

Prague  
November 2007

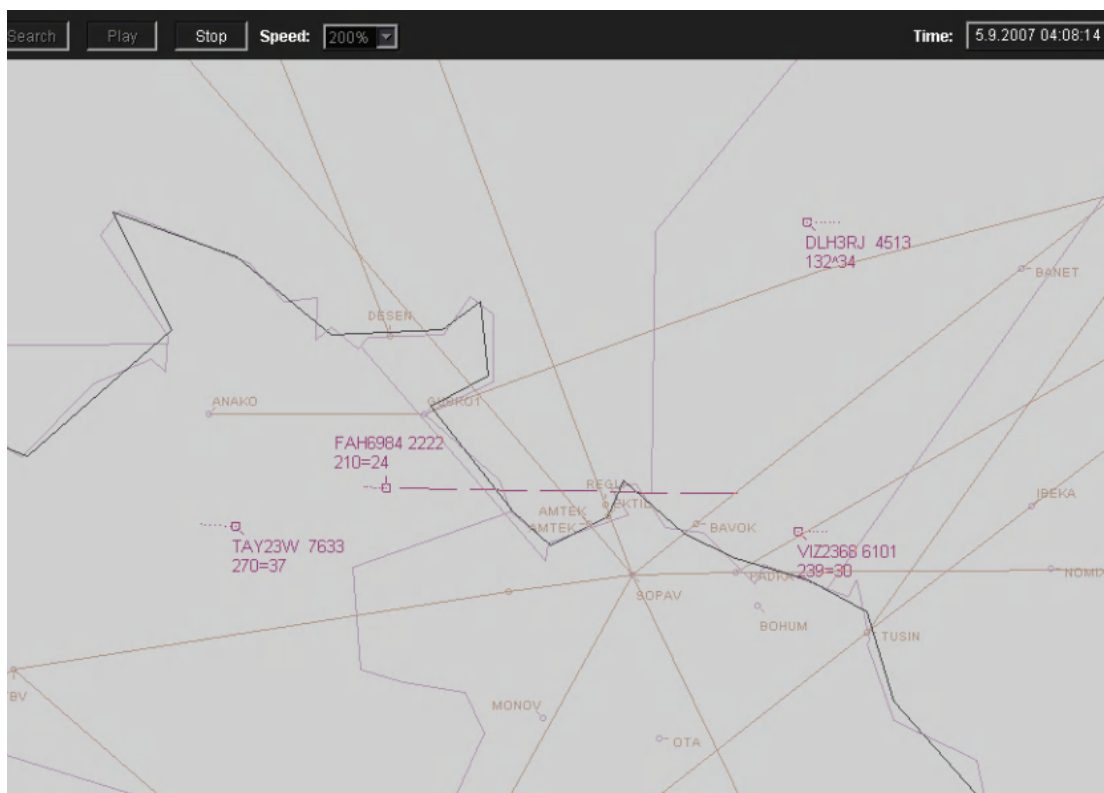
Fig. 1 – 04:08:11

At 04:08:14 LM EC had no information about the counter-traffic of WZZ 135 when he instructed FAH6984 to descend to FL 150. The information had been transferred to sector L and WZZ135K was not yet displayed on the radar, see Fig. 1.

ACC EPWW did not coordinate the change in input conditions to “In climbing to FL 200” and did not correct the coordinating time that differed by more than 6 minutes.

According to information from ELS (WZZ135K FL 220), FAH6984 did not represent any conflict traffic to L PC. Taking into account the sequence and data of the coordination reports, ensuring the separation lay in the EPWW authority.

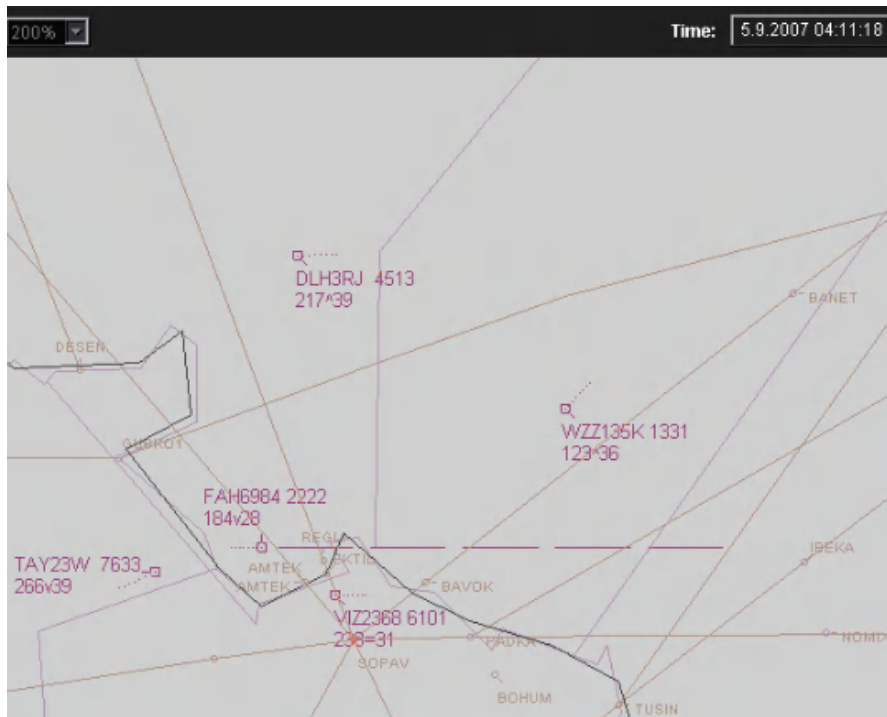
Fig. 2 – 04:11:18

At 04:11:18 WZZ 135K reported on LM EC frequency as it was climbing toward the point BAVOK to FL 200 at a speed of 2,000 ft/min and less (in spite of the ACT report from EPWW saying that it would fly at FL 220). For the traffic situation see Fig. 2.

In establishing contact with WZZ135K, LM EC did not take into account the actual conflict with the descending FAH6984. He was convinced that it is ACC EPWW that was in charge of separation control and did not realize that FAH6984 was still on his frequency.

EPWW failed to make good judgment on the situation because FAH6984 was not radar-identified due to the responder malfunction and EPWW had only ACT information about the planned passage. The EPWW assumption was probably based on the radar information only.

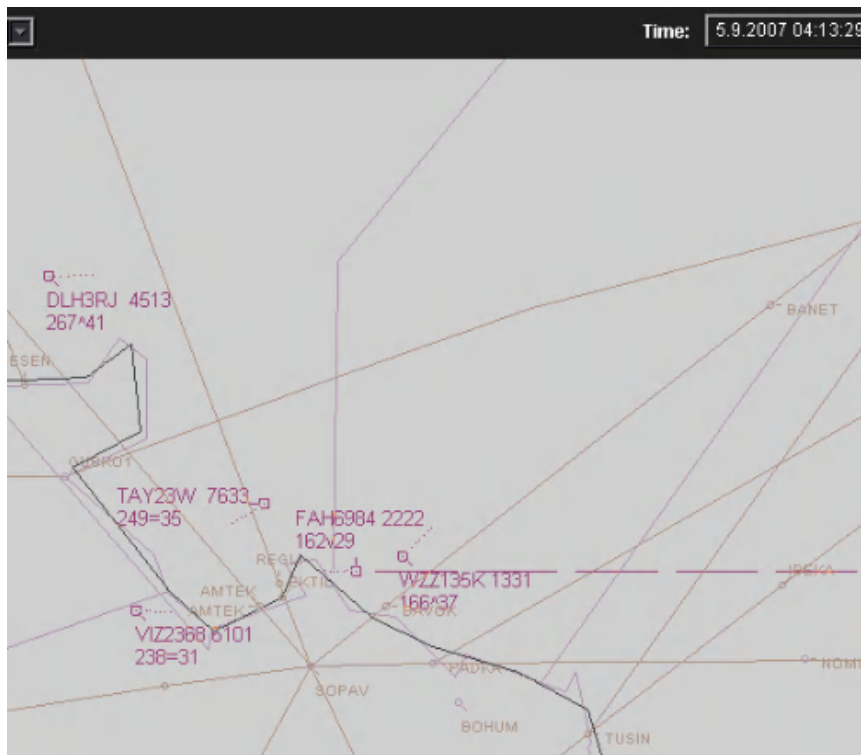
Fig. 3 – 04:13:19

The minimum separation was violated at 04:13:18 when both of the planes approached each other within less than 5 NM at a vertical distance of 100 ft. Sector LM, which had

STCA indication at that crucial time, had already its working frequency 127.125 MHz off. Sector L was already connected to this frequency, but at the beginning both L EC and L PC had not enough information to provide effective ATS. Based on a radar record, the situation is shown in Fig. 3.
