# FINAL REPORT

Investigation into the incident  
runway incursion of aircraft B737-3Q8,  
at LKPR on 26 May 2006

Prague  
November 2006

Aircraft type: Boeing, B737-3Q8  
Registration: G-THOF  
Place of Incident: Prague / Ruzyně Airport (LKPR)  
Date and Time: 26 May 2006, at 13:41 (All times in this report are UTC)

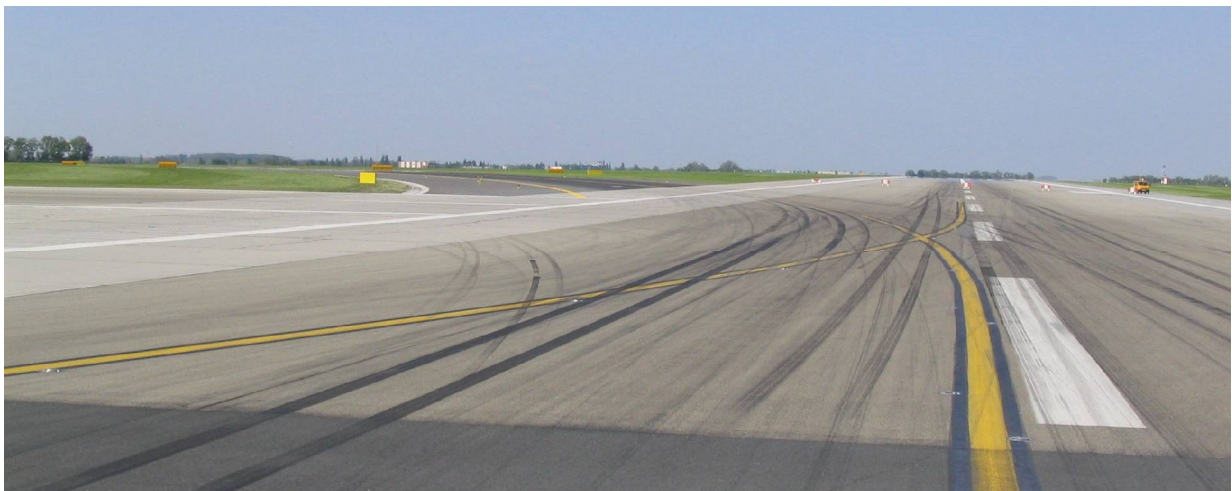
RWY 24 was in use at LKPR. The exit to TWY D marking signs and the exit from TWY 24 to TWY D marking are made in accordance with Annex 14.

Marking at the TWY D exit from RWY 24 (intersection RWY 13/31 with RWY 06/ 24)

2.1 The TOM 1747 crew wanted to vacate RWY 24 taking exit from RWY 24 to TWY D. In turning at the intersection of RWY 06/24 and RWY 13/31, the crew did not follow the marking leading to TWY D and made a half turn to the direction of RWY 13 axis. There, having realized the mistake, the crew stopped. The LKPR taxi rules do not permit to go to RWY 13 after landing on 24 unless ATC rules otherwise.

2.2 The exit marking from RWY 24 to TWY D and the axis marking on TWY D are made in such a way as to give guidance from the axis marking to RWY 24. The axis marking at the intersection TWY D with RWY 06/24 and RWY 13/31 is arch-shaped to join the RWY 24 axis marking to make the turn and exit from RWY 24 fast and easy.

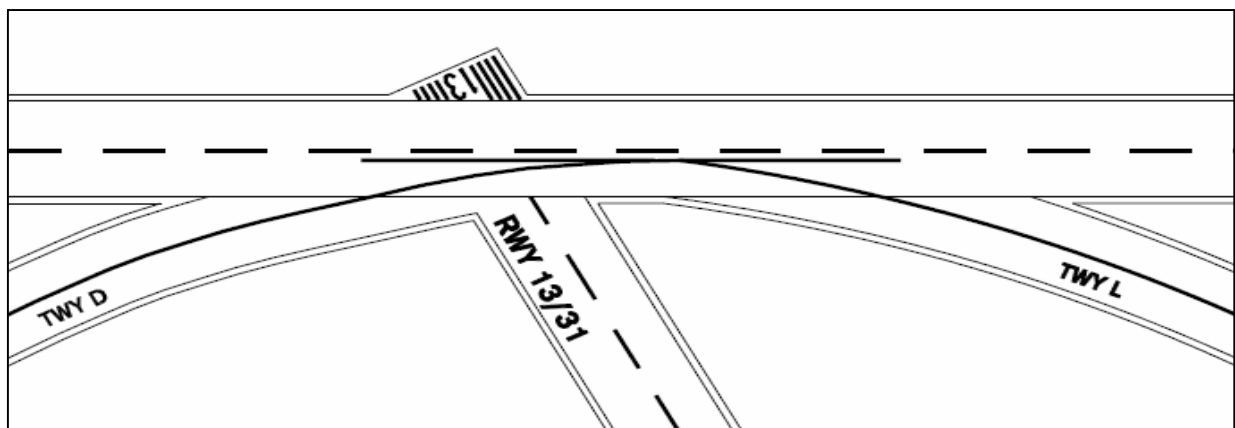
Chart of the TWY D exit from RWY 24 and intersection RWY 13/31 with RWY 06/ 24
