CZ-09-294

FINAL REPORT

**Investigation into an Air Accident
of a GA-8 Airvan Airplane,
Registration mark G-VANA,
at Jihlava Aerodrome,
on 28 July 2009.**

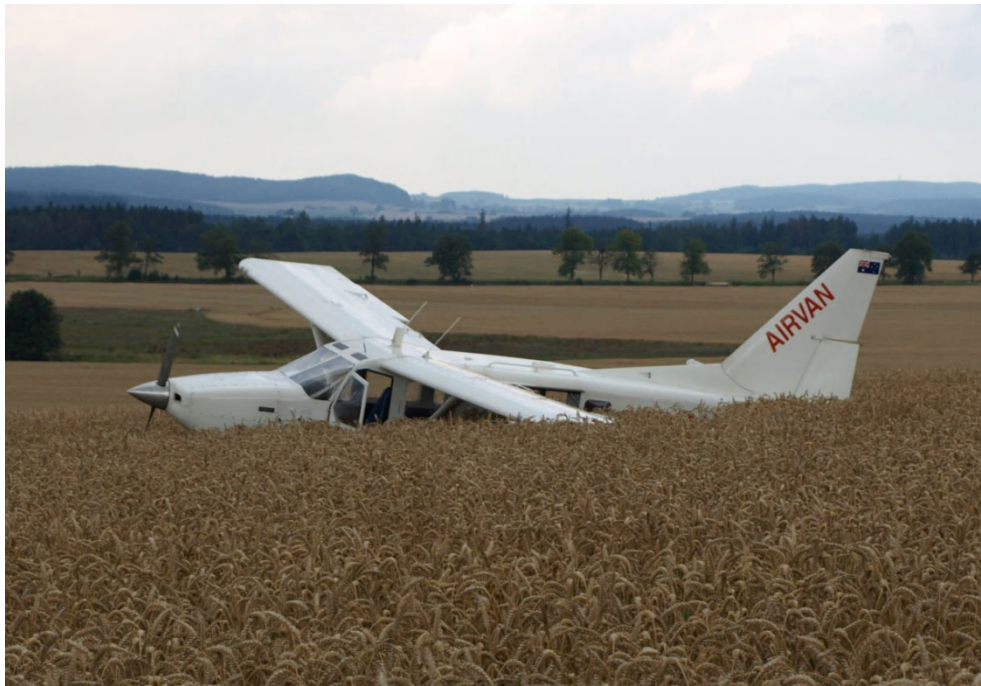
The inspection at the scene of accident showed significant damage to landing gear, bulkheads in place of lower rear part of large sliding door in the left aft fuselage, and pierced lower skin of the left horizontal stabilizer.

The engine ran till the plane came to a standstill in the field. Then it was turned off by the pilot. Its external inspection showed no visible damage. No damage to the propeller was found either, except normal operational wear.

Fig. 1 Damaged airplane GA-8 Airvan

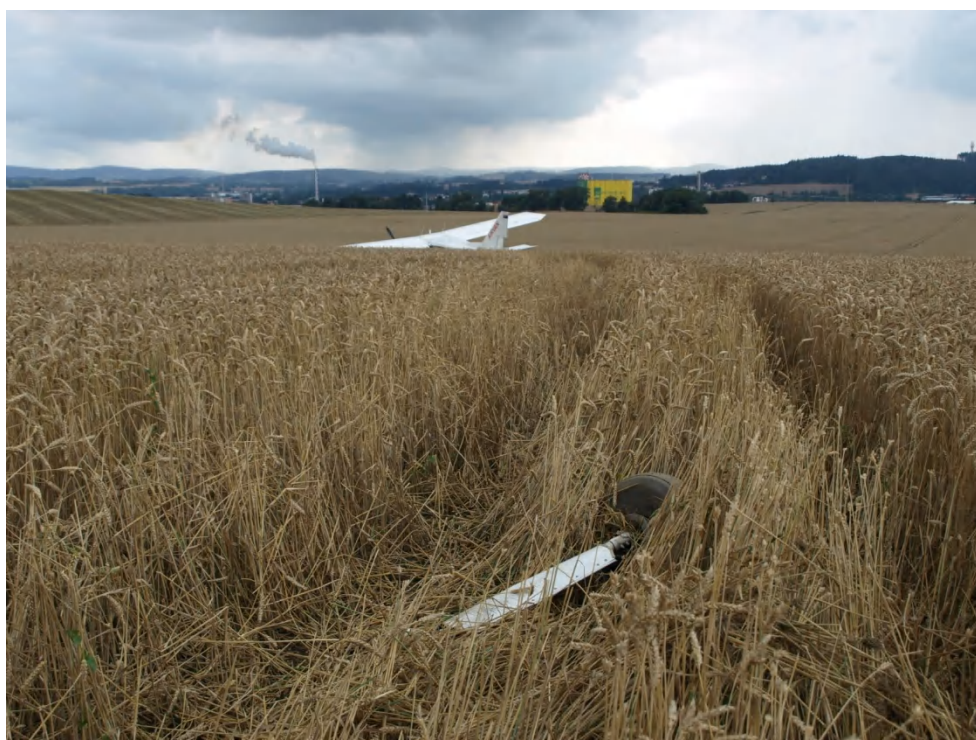
The accident took place in the field behind the road no. 352 between villages of Hruškové Dvory and Heroltice. The first trace of the wheel impact was on the raised side of a road crossing the RWY centre line 690 m west of the LKJI reference point. Behind the road past 56 m there were other traces left by the plane having landed on grown corn. Past another 12 m, the main undercarriage left leg and wheel were found. From that place on, the traces turned left, and past 50 m the plane, inclined on the left wing, stopped moving. The tyre of the right main undercarriage was burst; the fork of the nose undercarriage was bent to the right. The skin was distorted in the left lower aft fuselage at large sliding door. The left stabilizer lower skin was pierced. The two propeller blades were not damaged at the accident.

Fig. 2 Situation at scene of the air accident
