AIR ACCIDENTS INVESTIGATION
INSTITUTE OF CZECH REPUBLIC
Beranových 130
199 01 PRAHA 99

CZ-12-425

FINAL REPORT

**Serious incident involving
A319 AFR1482 and B735 CSA77E
on 7th September 2012 at LKPR**

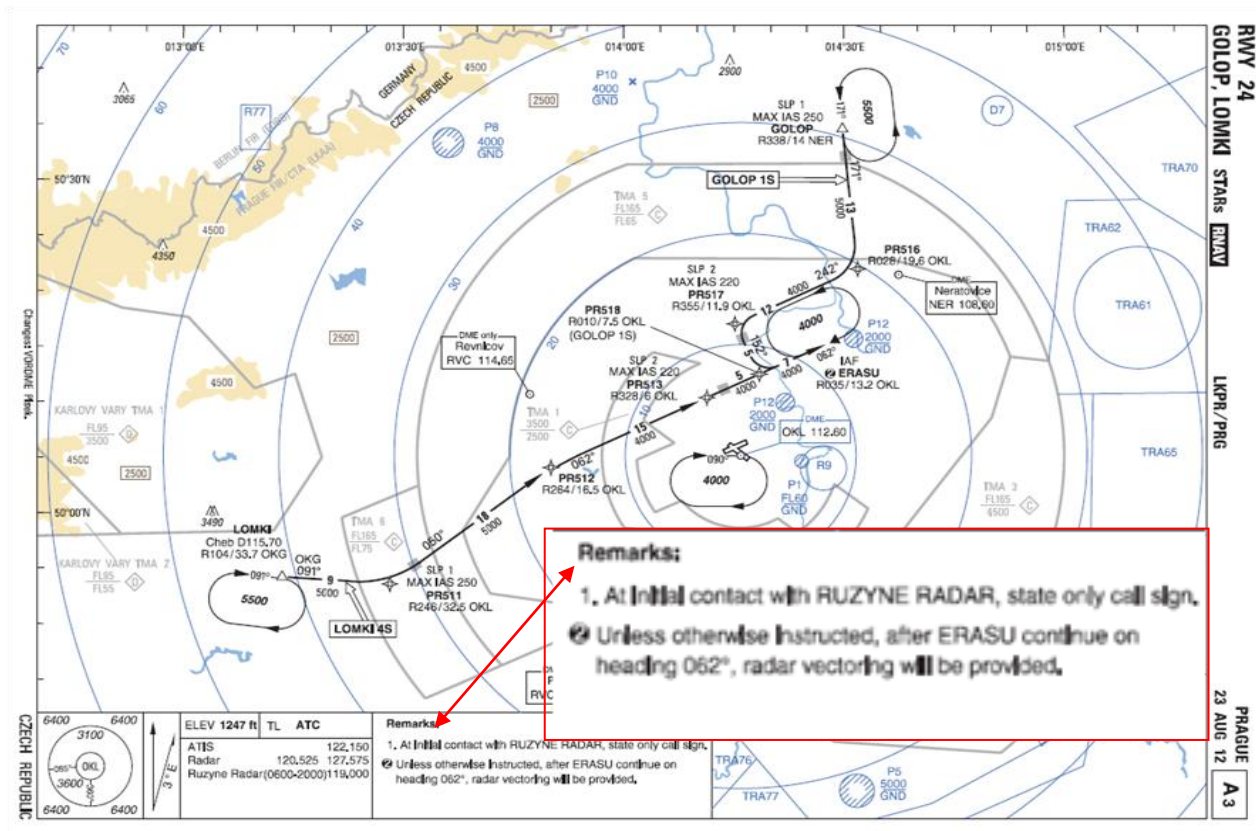
For navigation preparation, the crew had a map for approaching the LKPR on RWY 24 GOLOP, LOMKI STARs RNAV, publisher not stated, which was in accordance with the AIP of the Czech Republic. A note on the map states the procedure for approach along STAR LOMKI 4S after passing IAF ERASU.

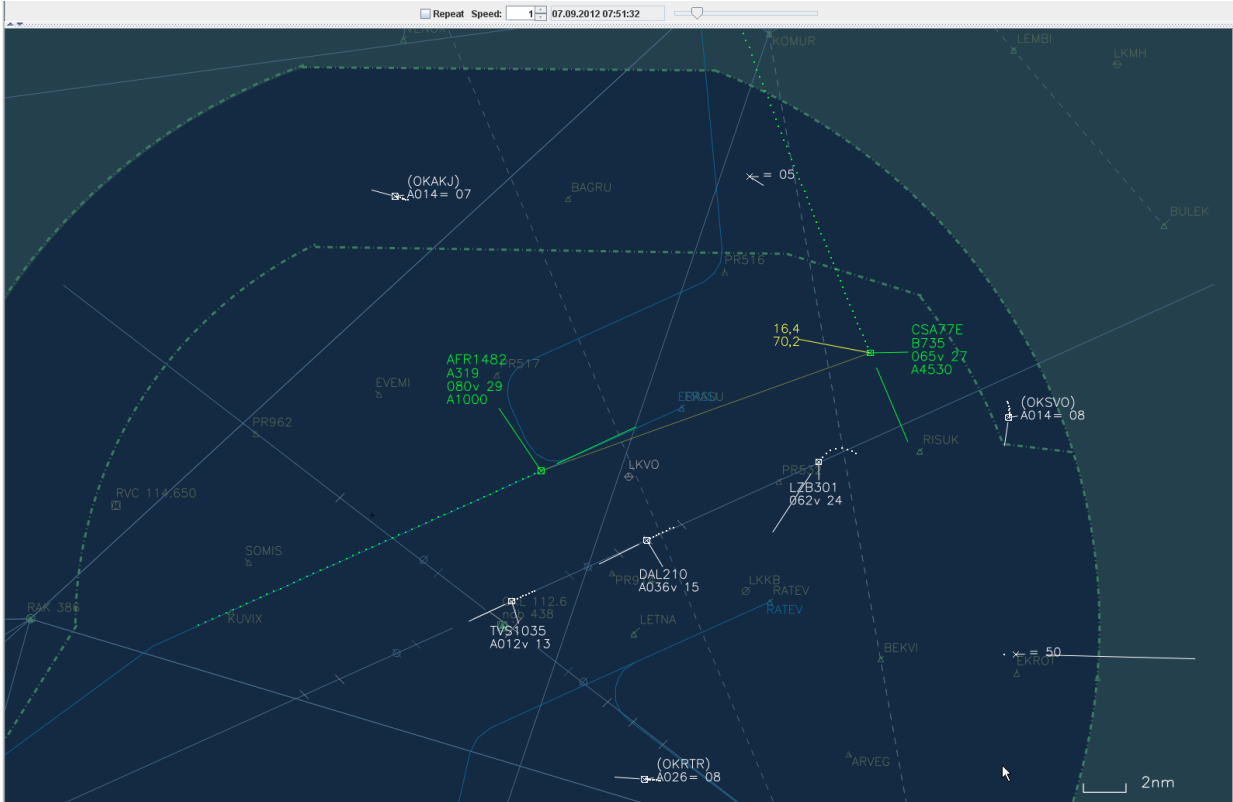
07/09/2012 07:51:32

After passage over IAF ERASU without further instructions, the crew commenced to turn into ILS RWY 24 in descent to ALT 4,000 ft.

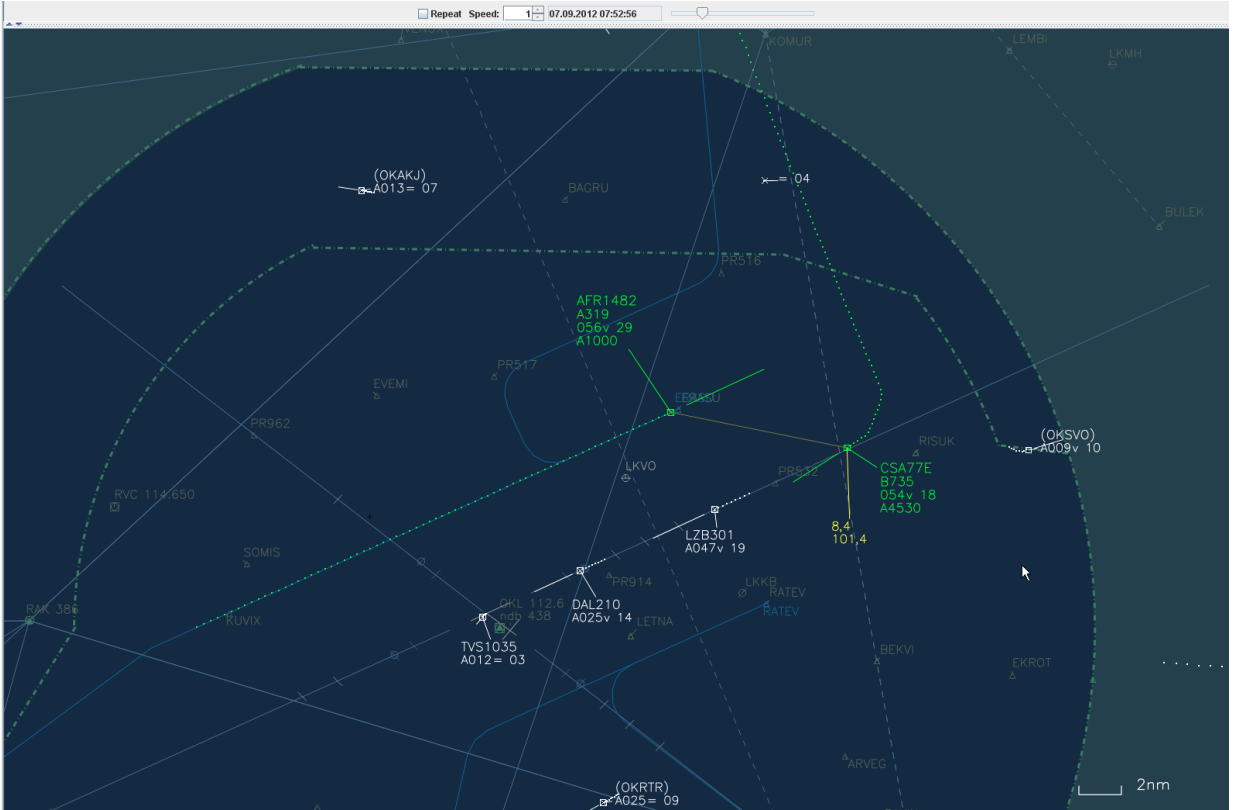
07/09/2012 07:52:56

At that time there was the B735 aircraft on the LLZ RWY 24 before FAF in ALT 4,000 ft with which the A319 came onto a collision course at the same ALT.

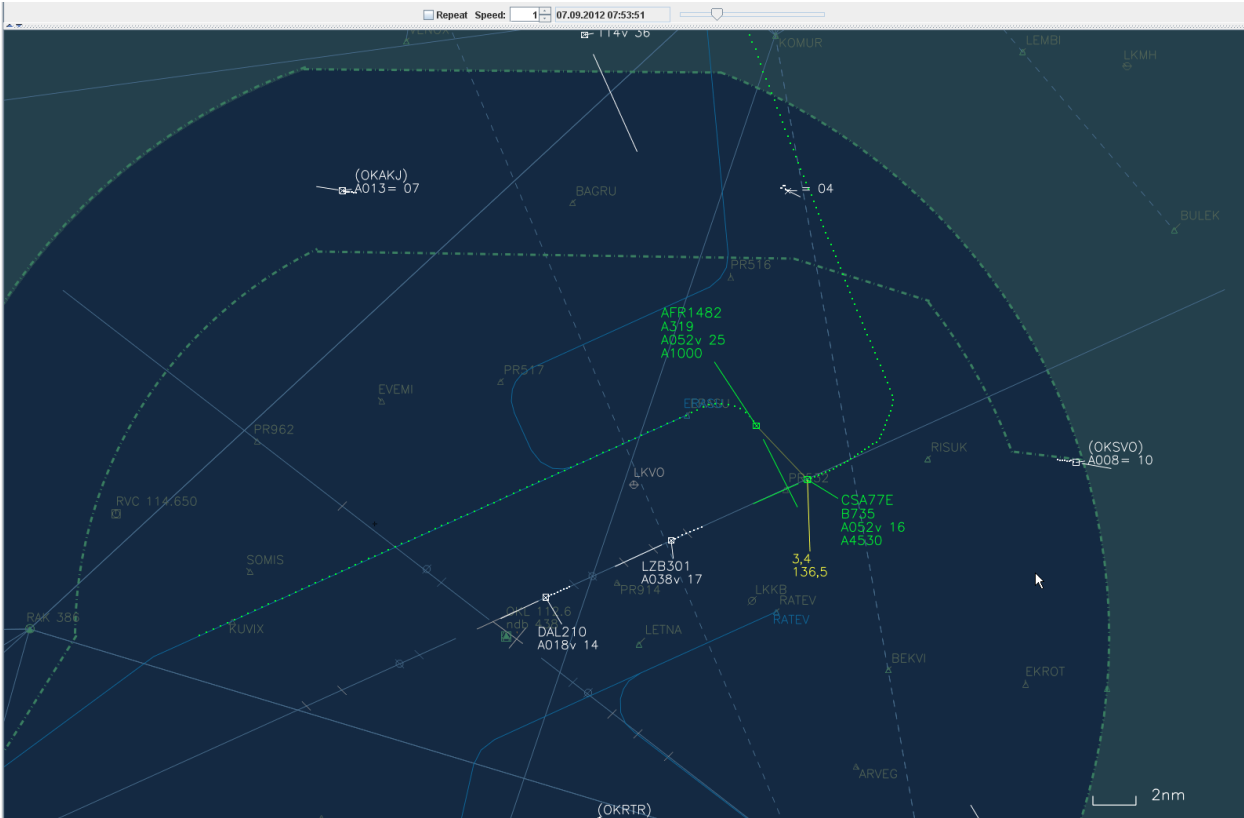
07/09/2012 07:53:51

- The first instruction to solve the collision situation, to left-hand turn in 060 degrees heading, was issued by the ATCo at 07:53:39 when the aircraft separation was 4.1 NM.

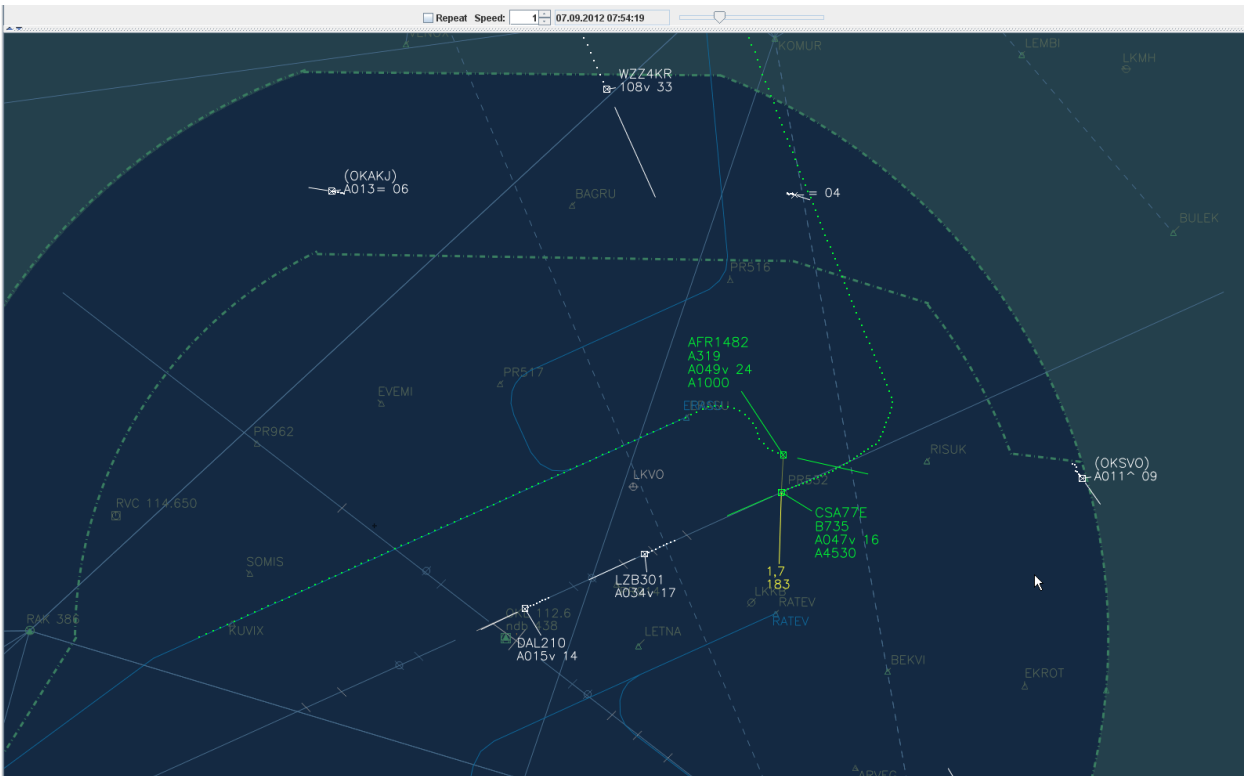
07/09/2012 07:54:19

- The A319 crew acknowledged "*Left heading 060. We are following standard arrival.*"
- Regarding the slow response of the crew, the ATCo repeated the instruction to left-hand turn at v 07:53:54 when the aircraft separation was 3 NM. After acknowledging the said instruction by the crew, the ATCo issued the instruction to ascend to FL 60. The A319 crew acknowledged the said instruction.

- ATS were vectoring the A319 for landing on RWY 24 in the course of approach.
- The crew stated the horizontal distance between the two aircrafts greater than 3 NM. According to the radar record reading the given distance was 1.7 NM.
