FINAL REPORT

Investigation on the accident
to PITTS S-2B
at Olomouc airfield
on 8 September 2007

Prague
November 2007

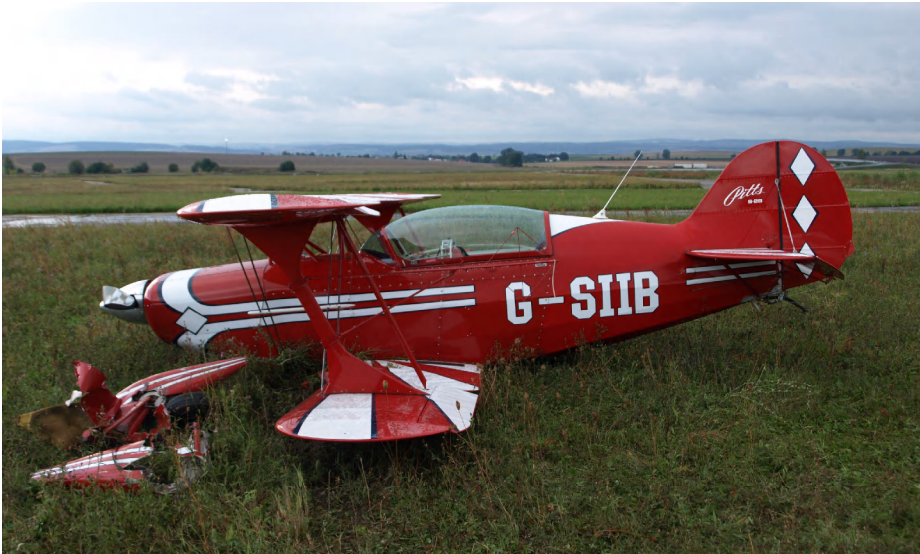
The airplane was damaged as it hit the ground and moved on the belly. The main undercarriage legs were broken as well as the lower half-wing main beam, the propeller was distorted, the engine was stopped by force, the tail wheel got broken off, the fuselage structure was dented in. The airplane condition is in Fig. 1.

Figure 1 The accident site – airplane G-SIIB

In hitting the ground, the tail wheel was bent and separated, main undercarriage was destroyed, and the main beam of the lower left wing was broken. Through the shock and subsequent movement the engine was stopped by force and the propeller blade tips were bent backwards.

The fuselage in front of the cockpit got distorted slightly, its aft part remained integral including the tail plane. The rudder skin was torn on its right-hand side as it was hit by the tail wheel.

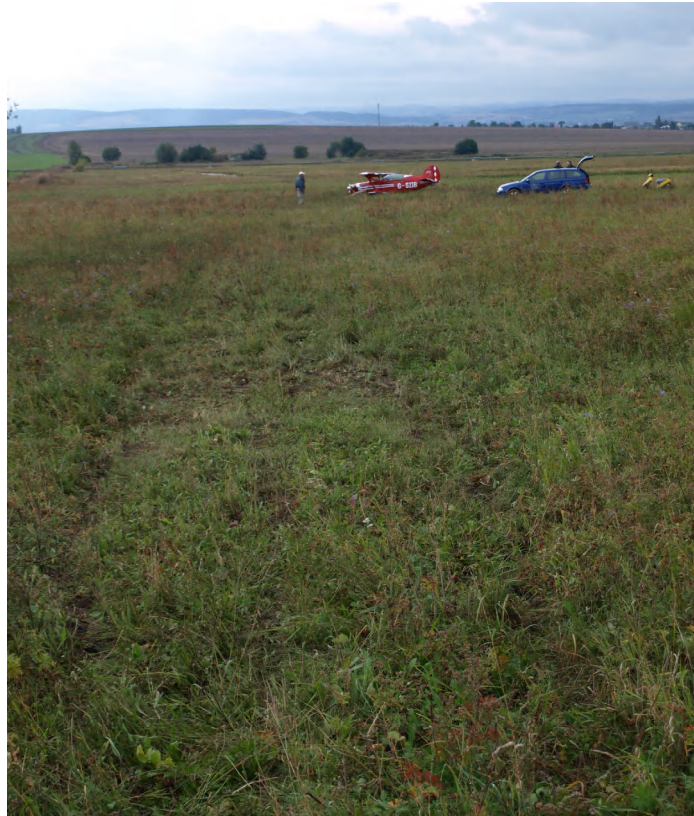
Figure 2 The accident site – marks from airplane's impact south-east part of LKOL airfield

The airplane hit grassy land at the aerfield's south-east boundary at a small angle. The impact coordinates are 49°35'9.67'' N and 17°12'47.16'' E.
