Ref. No 37/05/ZZ

FINAL REPORT

**Investigation into the incident
of aircraft PA 23,
registration OE-FFY,
at LKPR on 9 February 2005**

Prague
March 2005

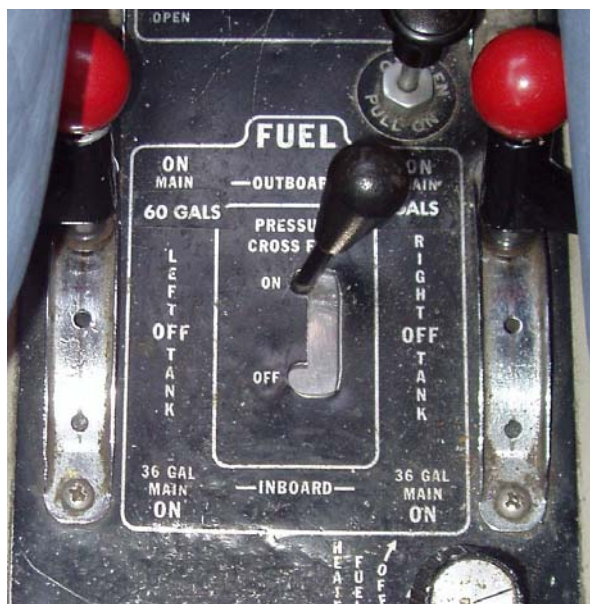
Photo Fig. 1

The fuel system of the aircraft of the given production number is made up of two INBD tanks, two OUTBD tanks and two wing TIP tanks stored in the right and left wings. The pilot said that at taking off from the EKOD Aerodrome the tanks were full of fuel and at landing at LKPR there was only little fuel left in the right wing. On 26 February 2005 a technician of the Diamond Maintenance GmbH&CoKG service organization checked the aircraft and found no leak in the fuel system. Fig. 1 shows setting of fuel valve actuators and "Crossfeed" actuators in position ON on landing.

2.3.2 Inspection of the fuel system revealed no defects that could have caused fuel leakage in the right wing tanks in flight. The smell in the cockpit may have been due to the cabin heating system. The fuel consumption assessed by the operation manual was in good agreement with the actual fuel drop in the tanks. Given the little fuel left in the right wing, one may suppose that either engine took fuel from the right wing tanks. Looking into the problem it was not possible to verify the position of fuel valve actuators and the "Crossfeed" cock prior to emergency situation or if they were manipulated to take corrective steps.

- Investigation into why the amount of fuel dropped in the right wing tanks failed to find a reason. Probable that could have been provoked by a wrong setting of the fuel cock actuators and "Crossfeed" cock during the flight.
