Ref. No 329/06/ZZ

FINAL REPORT

**Investigation of Serious Incident A/C Airbus A 321, Registration Mark OK-CEC,
during the take off on 18th July 2006**

Prague
July 2007

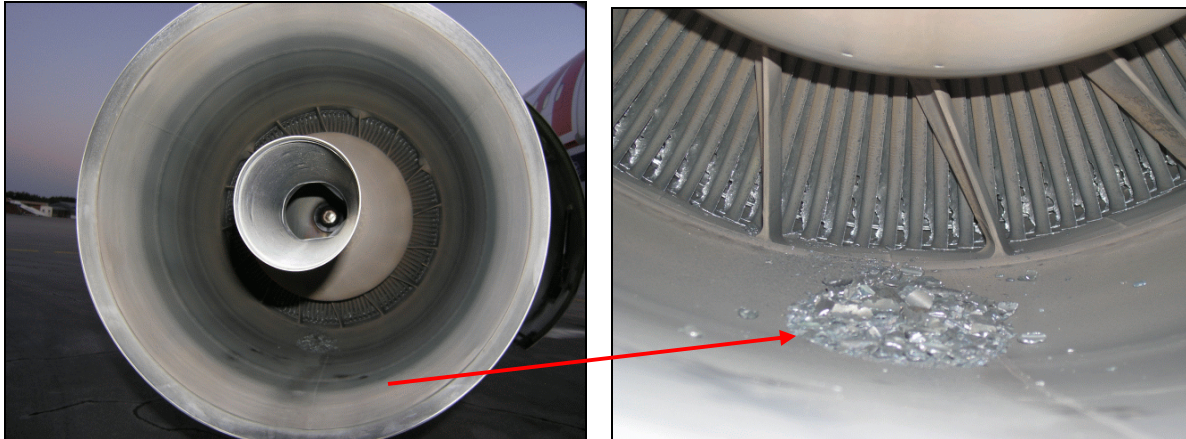
The internal parts of the left engine suffered damage causing the engine shut down. The engine cowling and other aircraft parts were not damaged.

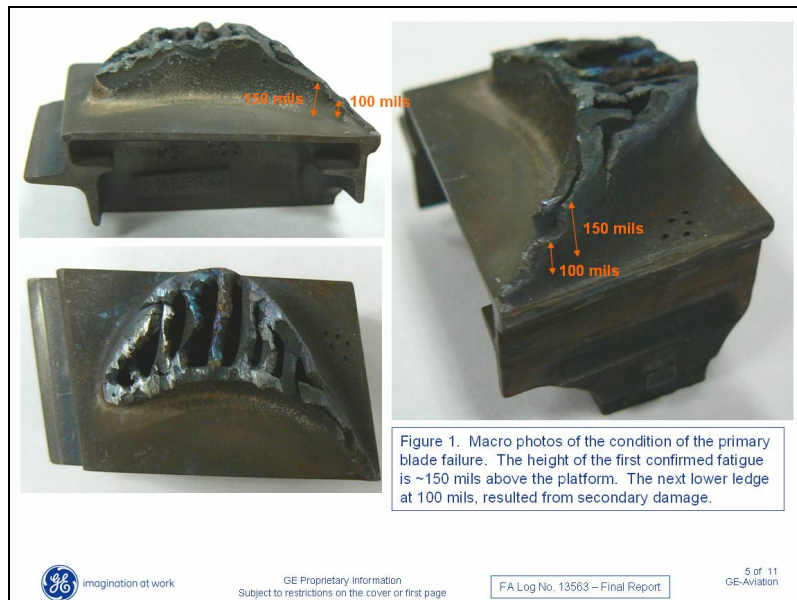
MPED-Metallurgical Investigations GE Aviation performed under Log. No. 2006-01563 of 24th October 2006 a metallurgical analysis of the HPT first stage of the engine CFM56-5B3P ESN 779275. The investigation confirmed the engine manufacturer's hypothesis about a possible root cause. The blade condition is shown in Fig.1. Most of the remaining blade surface was heavily oxidized and deformed, showing marks of fatigue near the trailing edge.

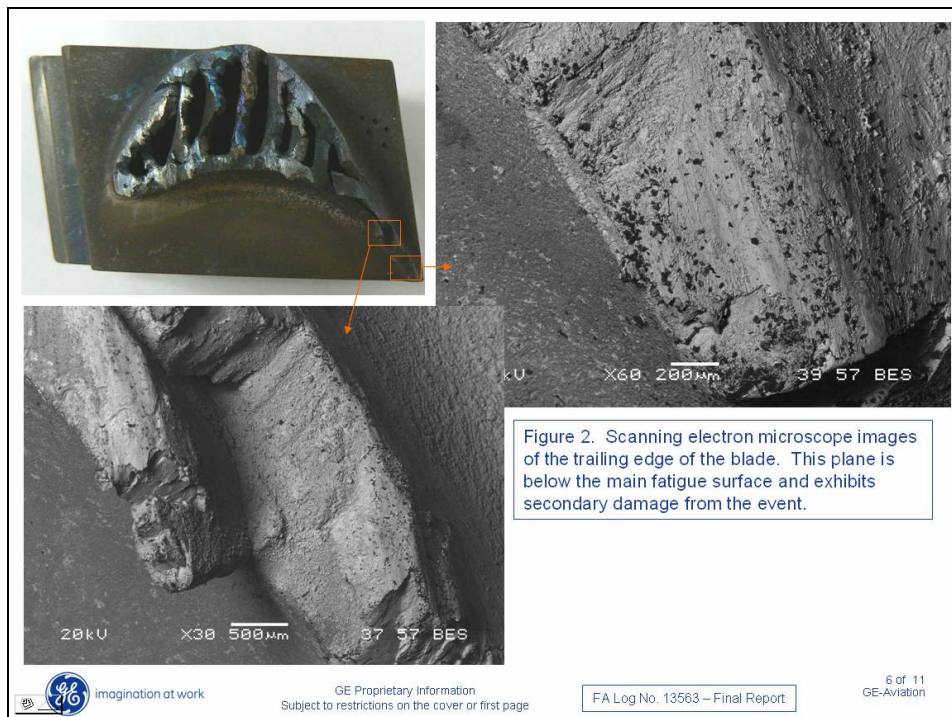
The crack origin was not found, due to surface damage. Fig.2 shows SEM photos of the supposed damage origin at the blade trailing edge root.

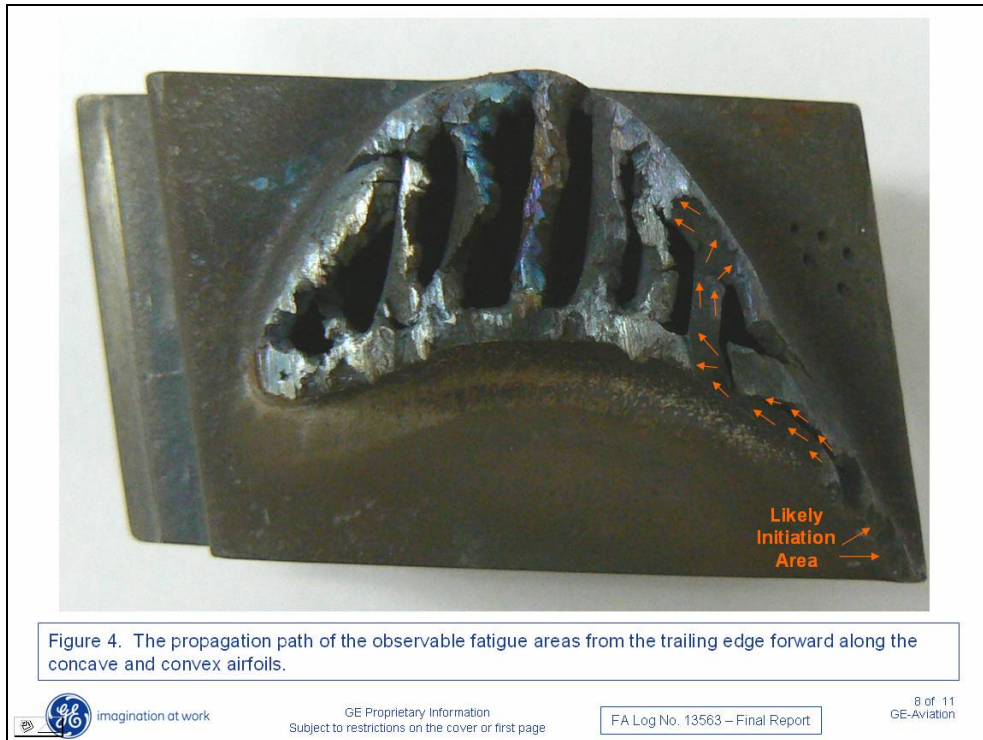
SEM images were showing an extent of fatigue starting near the trailing edge and propagating forward across the seventh blade rib and along the convex wall. The fracture surface condition beyond the surface was too damaged to conduct observations.

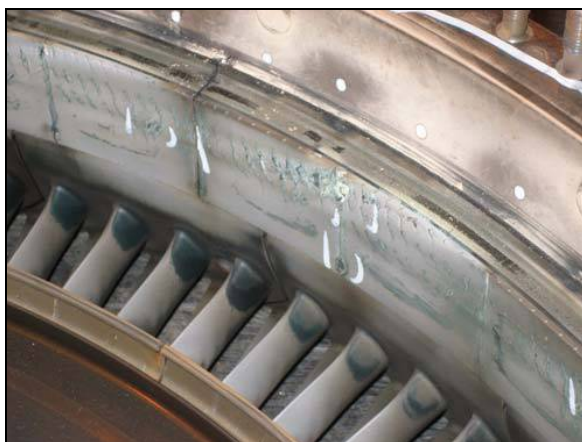
Fig 7 – Severe burning to a couple of HPT Shrouds (removal cause)

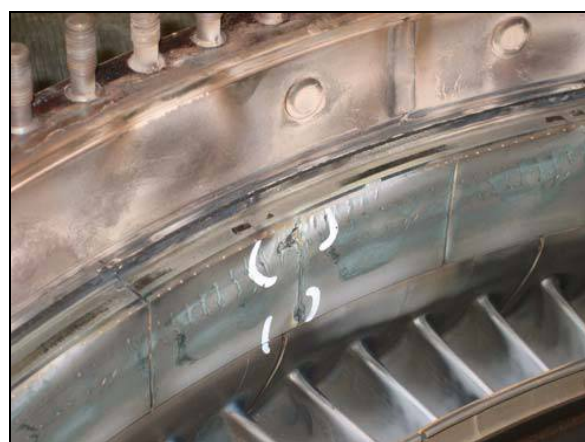
Fig 8 – Burning to more HPT Shrouds. 100% are likely to scrap.
