CZ-13-136

# FINAL REPORT

**Investigation of causes of an air accident  
of Socata TB 10 Tobago aircraft, registration mark D-EANH  
in Lánov  
on 11 May 2013.**

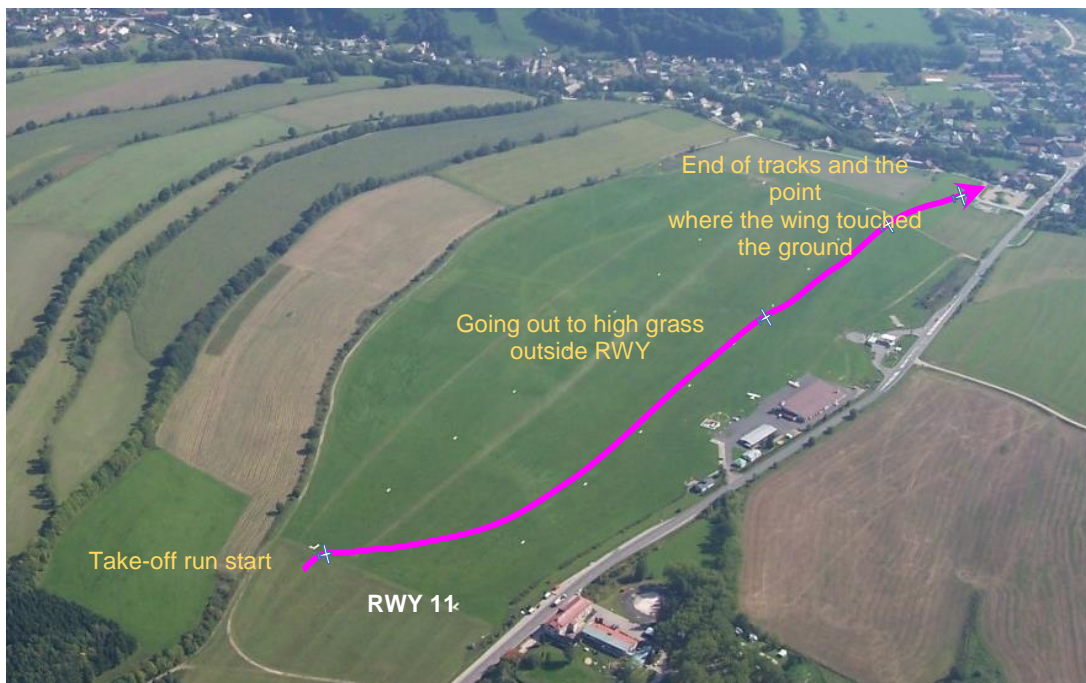
Fig. 1 Situation plan of aircraft movement

The landing gear wheel tracks in grass show that the aircraft during a take-off run went some 600 m, then went out of the right edge of RWY 11. It continued its take-off run on the grass surface of the aerodrome, going slightly to the right off the flight

course. At the end of the aerodrome it crossed a dirt track approximately 204 m away from the hotel building and kept attempting a take-off. The left wheel track and the right wheel track ended approximately 89 m and 65 m away from the hotel building, respectively. Based on the tracks in grass approximately 47 m away from the hotel building, the aircraft wing started catching on high grass. These tracks ended approximately 36 m away from the building. The aircraft in a roll crashed against a fence pale and bushes some 31 m away from the building against which it crashed in a roll of some 45 degrees on the right side, at the level of window woodwork of a penthouse apartment.

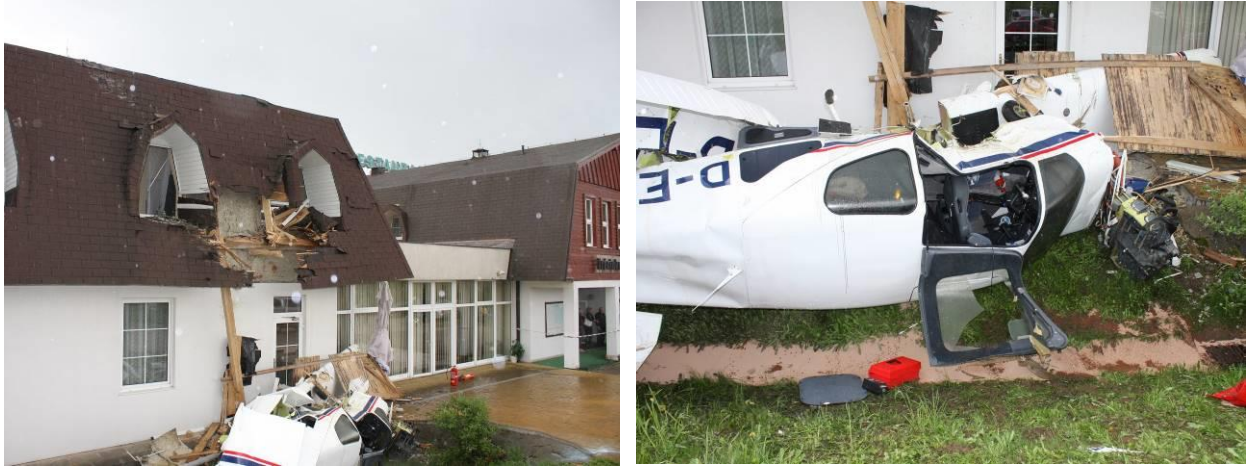
The aircraft crashed against the penthouse apartment of the hotel building at the edge of the village of Lánov. The crash partially damaged the roof structure at the place of the wall of an attic room. The place is located at 607 m from LKVR ARP, 204 m from the left threshold mark of RWY 29 and at 90 m on the left side from the extended edge of the RWY. At the place of air accident the ELEV is 473 m. The geographic coordinates of the final position of the aircraft were 50°37'16,35" N and 015°39'13,03" E.

The aircraft wreckage was located at the right side with its x-axis in a shallow ditch next to the building. The crash pulled the engine with a part of the engine bed away. It was located to the right from the aircraft fuselage and the propeller together with a spinner has been broken off. The engine cover and bed have been deformed. The pilot cockpit had a broken left lateral wall and floor. The cockpit hood on the left side has been lifted. The airframe has been deformed after the cockpit at the place of the fin unit and HTU.

Fig. 2 Place of the air accident

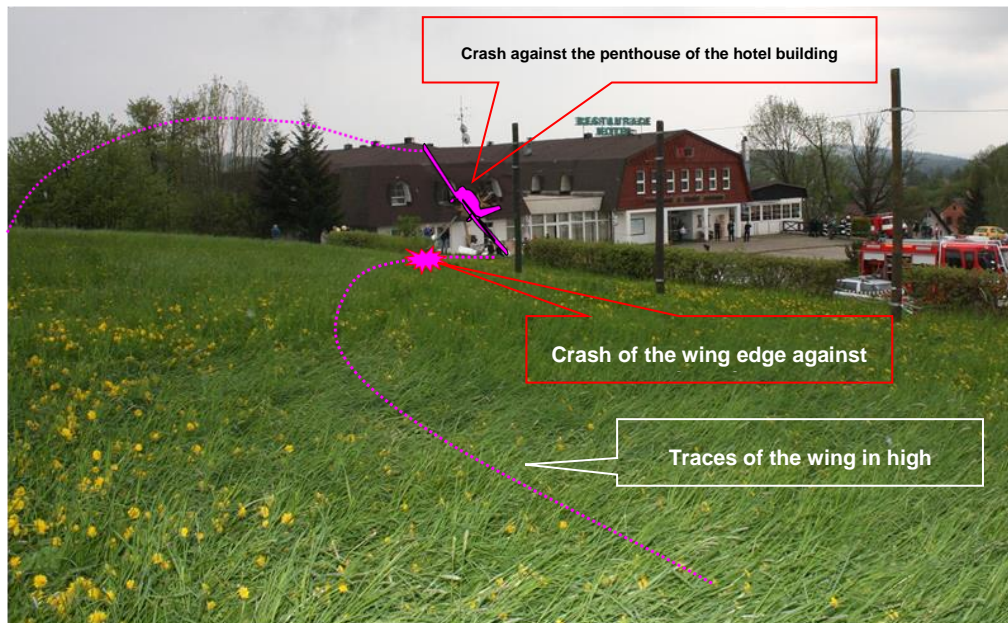
Fig. 3 Situation plan of aircraft movement prior to the crash

- When crossing a dirt track at the end of the operating area of LKVR, the aircraft probably lifted off for a little while, but started catching on grassland with its wing in a positive roll;
- The aircraft bumped against bushes with its right wingtip arc and subsequently against the terrain above a local road; such crash diverged the aircraft to the right;
- Damage to the wing, fuselage and vertical tail unit correspond to the crash against the building in a positive roll of 45 degrees with a nose slightly bent downwards;
- The aircraft was damaged by the effect of forces during the crash against the building and fall on the ground.

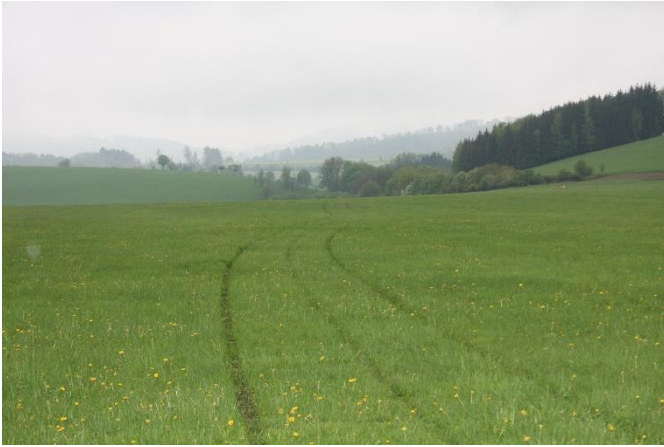
Tracks of aircraft wheels during take-off run

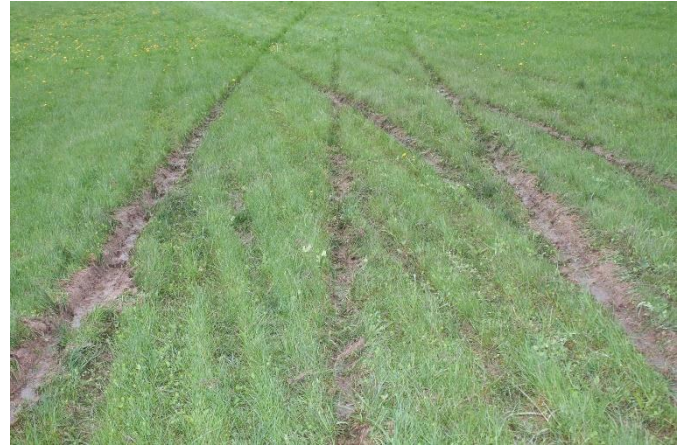
The persistent rainfall during the two preceding days affected the runway condition. With regards to the precipitation amounts the grass LKVR RWY was highly likely to be heavily water-logged at some places, i.e. the surface was soft and easy to sink in.

Tracks of landing gear wheels on muddy RWY

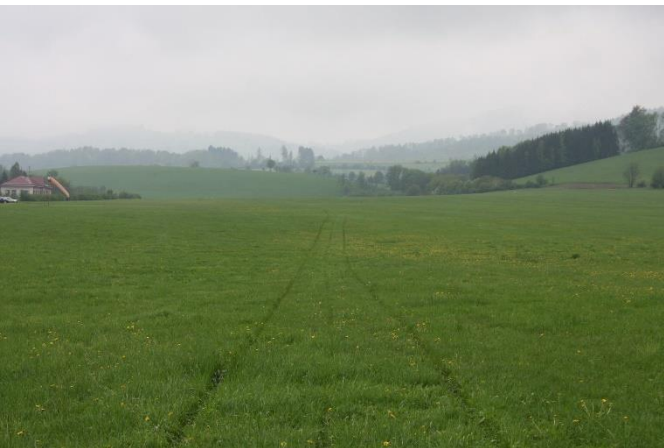
Aircraft wheel tracks after leaving RWY

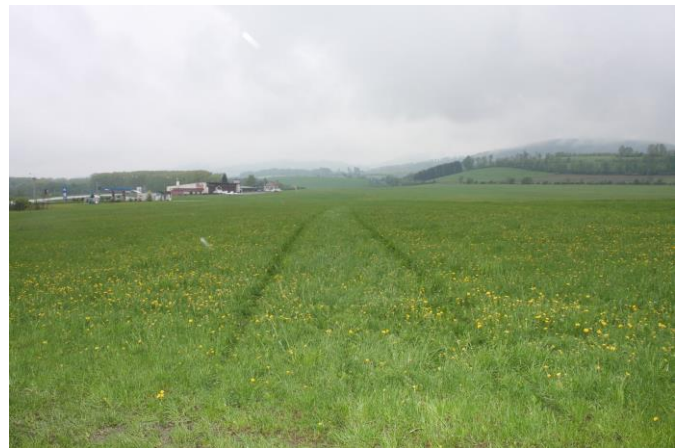
Aircraft wheel tracks at the end of RWY

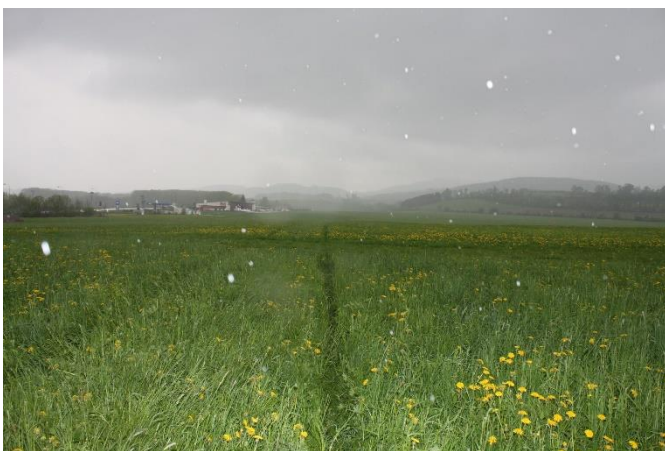
Aircraft wheel tracks when crossing the dirt track

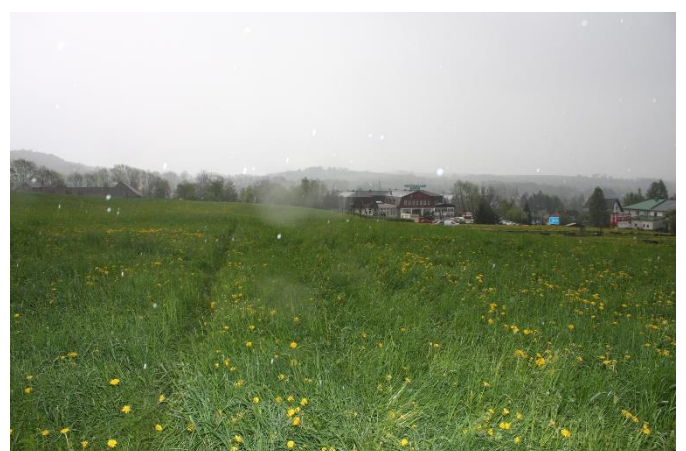
Aircraft wheel tracks in high grass in the direction of the hotel

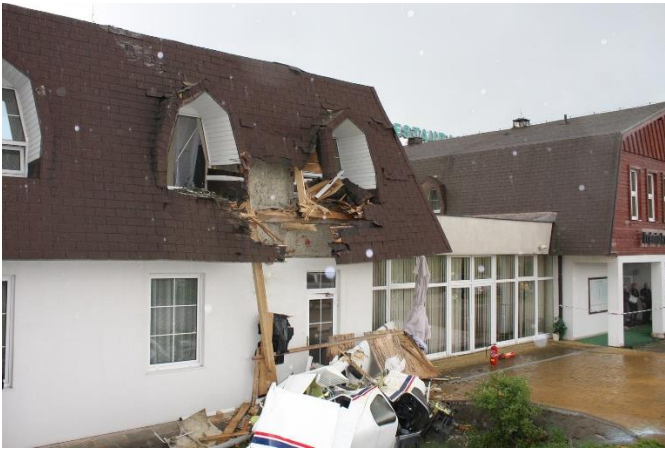
Tracks after the crash against the hotel building

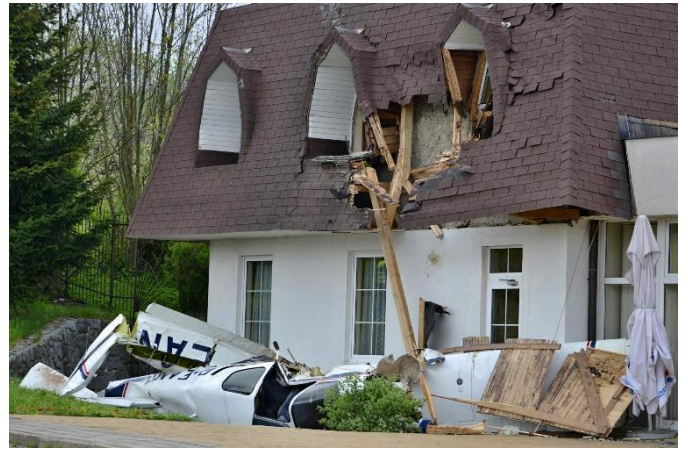
View of the hotel building and aircraft wreckage

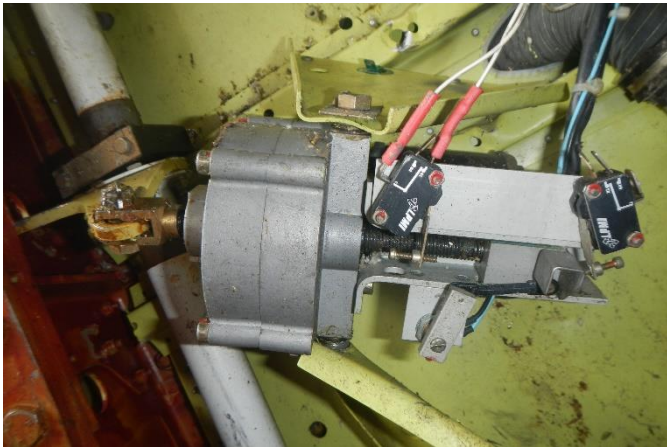
The electromechanical flap control was in the position of "flaps retracted".

Flap power control

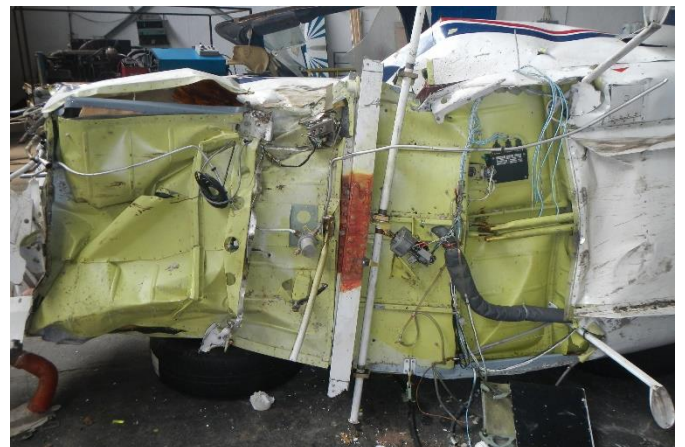
Due to the crash against a wall and the fall down to the ground the engine has been displaced to the right of the fuselage. The propeller together with a spinner has been broken off the crank shaft before the propeller hub flange from the engine. The propeller blades and spinner have been deformed by the crash.

Location of the power plant in the aircraft fuselage
