# Investigation Report

| Date: | 14 February 2010 |
| Location: | Near Reinhardtsdorf-Schöna |
| Manufacturer / Model: | Cessna 550 B Citation Bravo |

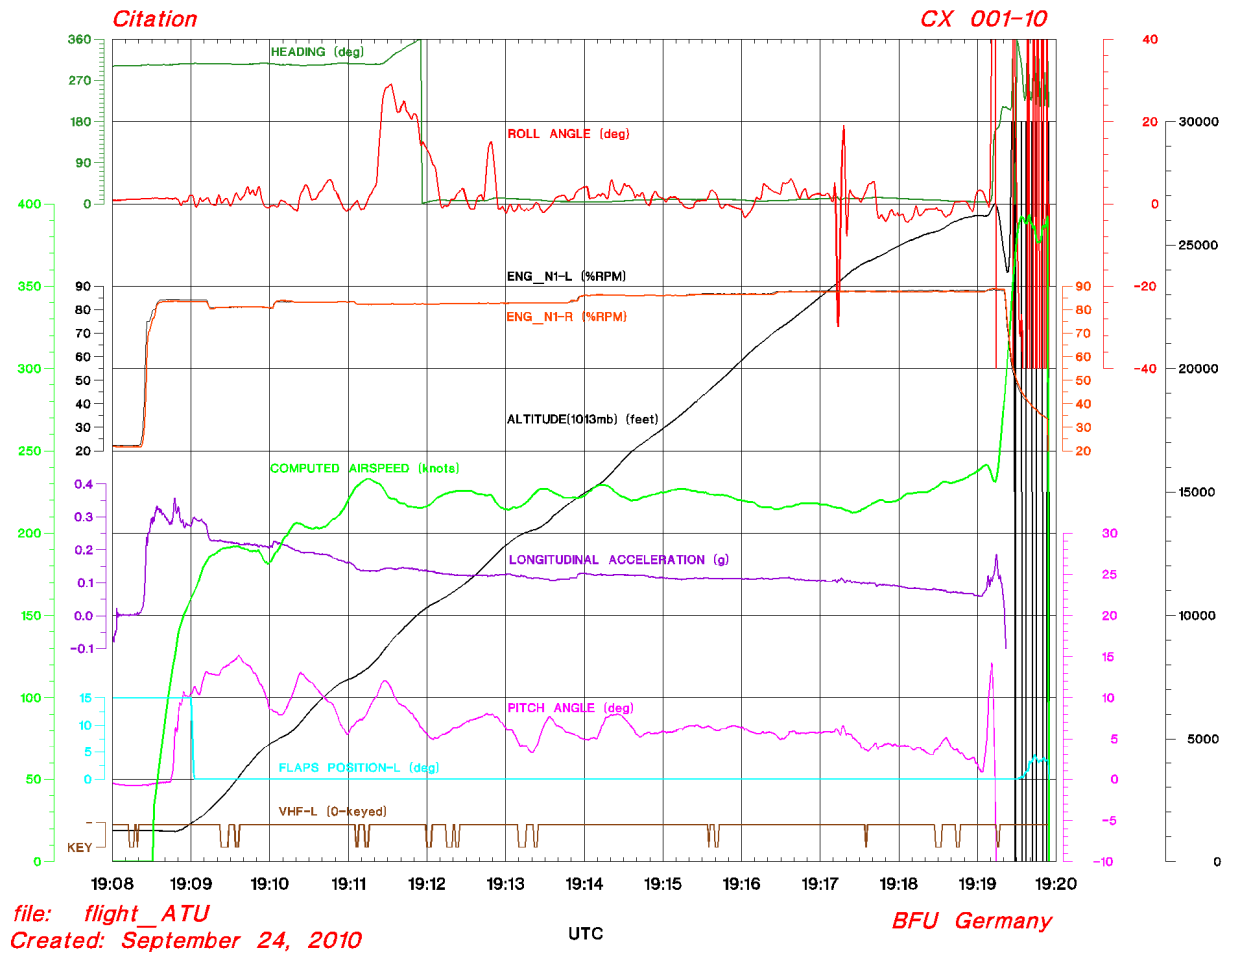
Image 1: Entire flight

Diagram 1 shows the entire flight (time in UTC) and diagram 2 shows the flight from 1918:30 UTC on.

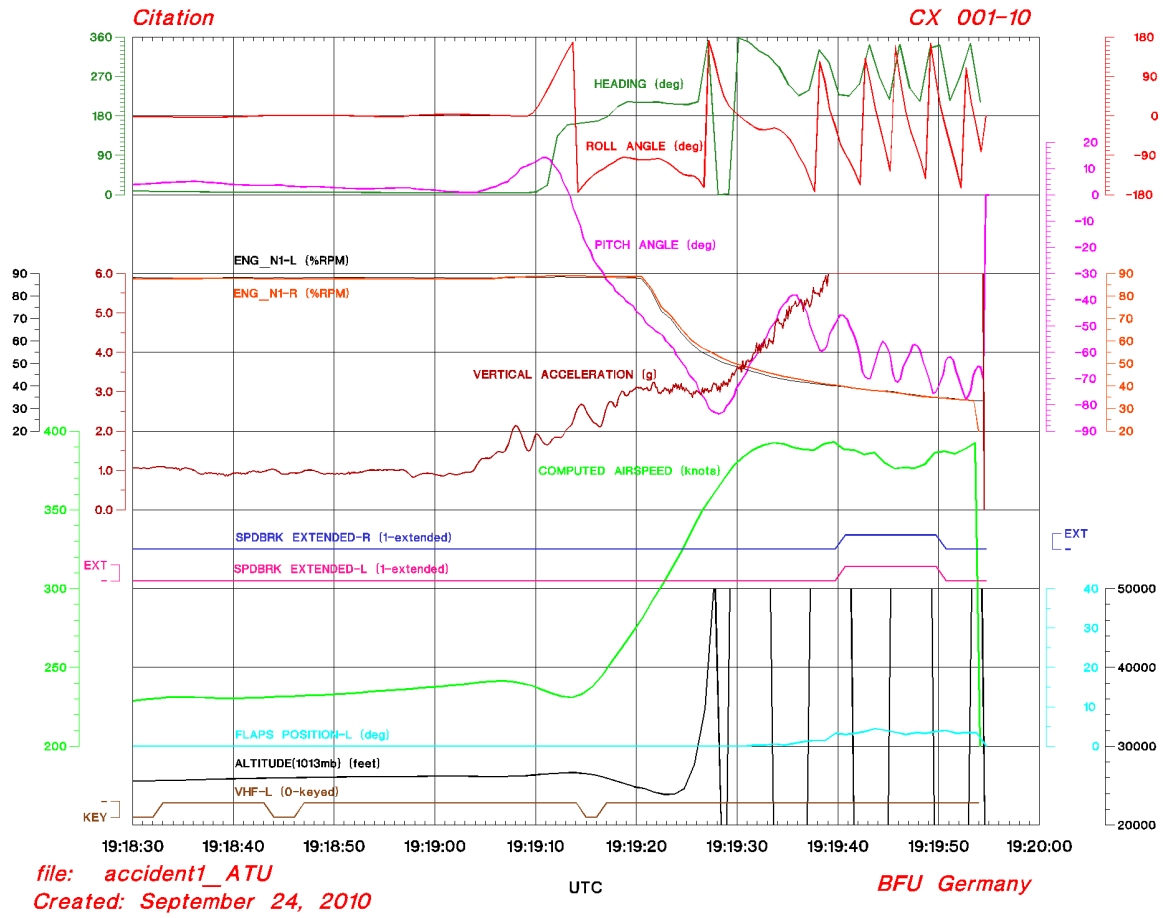
Image 2: Initiation of the roll and the consequences

At 2019:00 hrs the airplane levelled off in FL270, at 2019:05 hrs the airplane nose moved upward until a pitch angle of about 14° was reached. At 2019:09 hrs the aircraft began to roll about its longitudinal axis to the right. Within 4 seconds the airplane reached the inverted flight attitude and in another 4 seconds it rolled another 90°. Simultaneously the heading changed right toward the east, then toward the south and finally toward the west. During the roll the pitch angle decreased to almost -85° which is almost a vertical nose dive. The computed airspeed increased significantly.

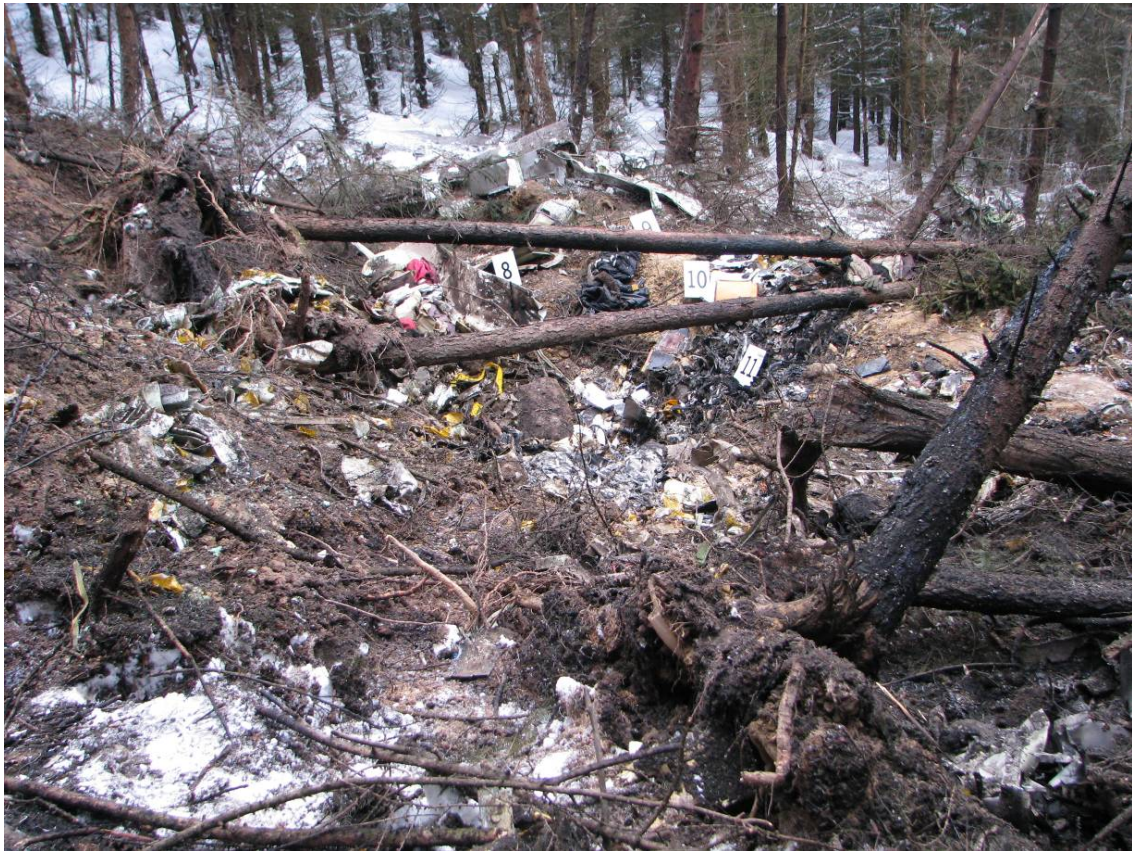
Photo 1: BFU

The crash site was about 4.5 km south-west of Reinhardtsdorf-Schöna, close to the mountain "Großer Zirkstein". The terrain rose by about 20° to the north, was forested with conifers and snow covered. The snow was 30 to 40 cm deep.

The impact crater had a depth of approximately two meters and an expansion of about 16 m x 16 m. Most of the wreckage was in the crater or near its vicinity. The wreckage distribution was 180° (toward the south). Several heavier wreckage parts were found about 120 metres from the main wreckage. In the immediate vicinity of the impact crater traces of an impact fire were found. The snow around the accident site was soaked with fuel. Due to the destruction only bigger and more solid components, such as the engines, the two main landing gears and the tail section, could be identified during the field investigation. For further examination the parts were salvaged and transported to the BFU.

Accident site

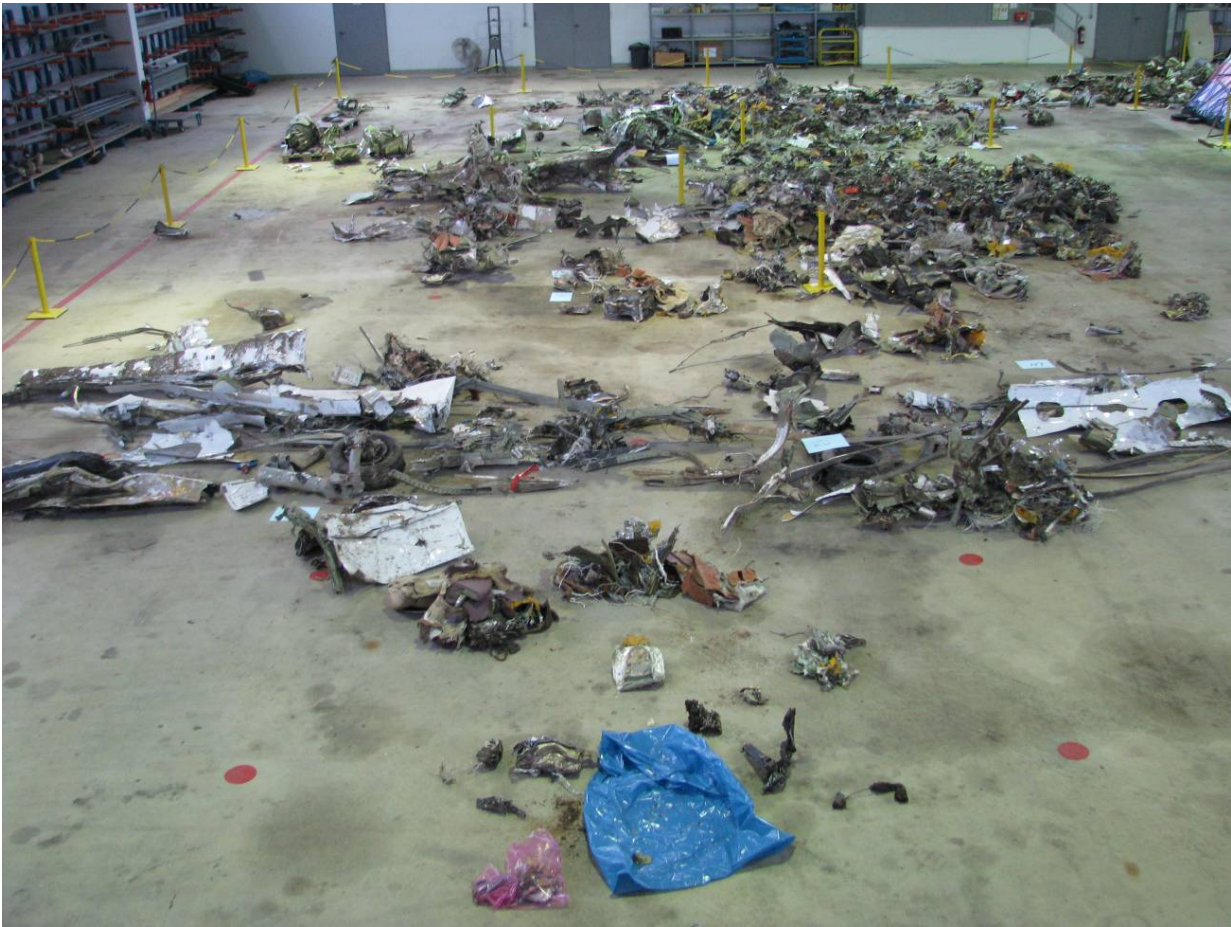
Photo 2: BFU

For the examination of the wreckage parts, the wreckage was laid out in the BFU hangar where the completeness of important structural parts and rudder surfaces was determined.

The situation found at the accident site and the conducted investigations as to the completeness of all significant aircraft components have shown that even though such manoeuvres were not intended for this type of aircraft, up until the impact the aircraft structure remained intact. Therefore, the conclusion can be drawn that the aircraft endured the loads while airborne.

Wreckage parts in the BFU hangar
