**GOVERNMENT OF NEPAL
AIRCRAFT ACCIDENT INVESTIGATION COMMISSION**

FINAL REPORT

**9N-AKY LET 410 AIRCRAFT ACCIDENT
OPERATED BY GOMA AIR PVT LTD**

27 MAY, 2017

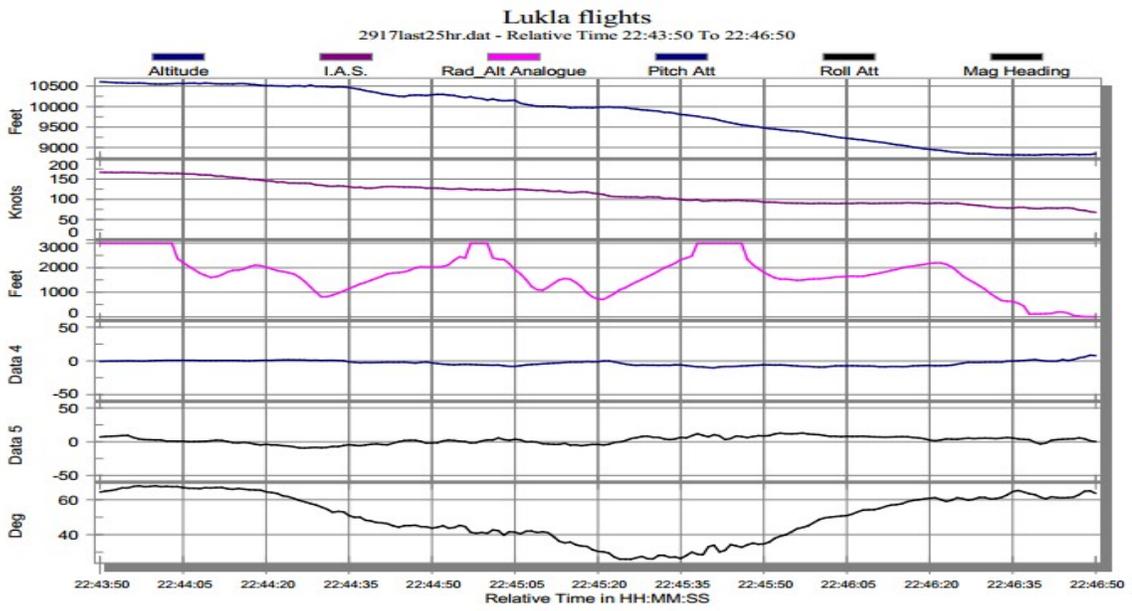
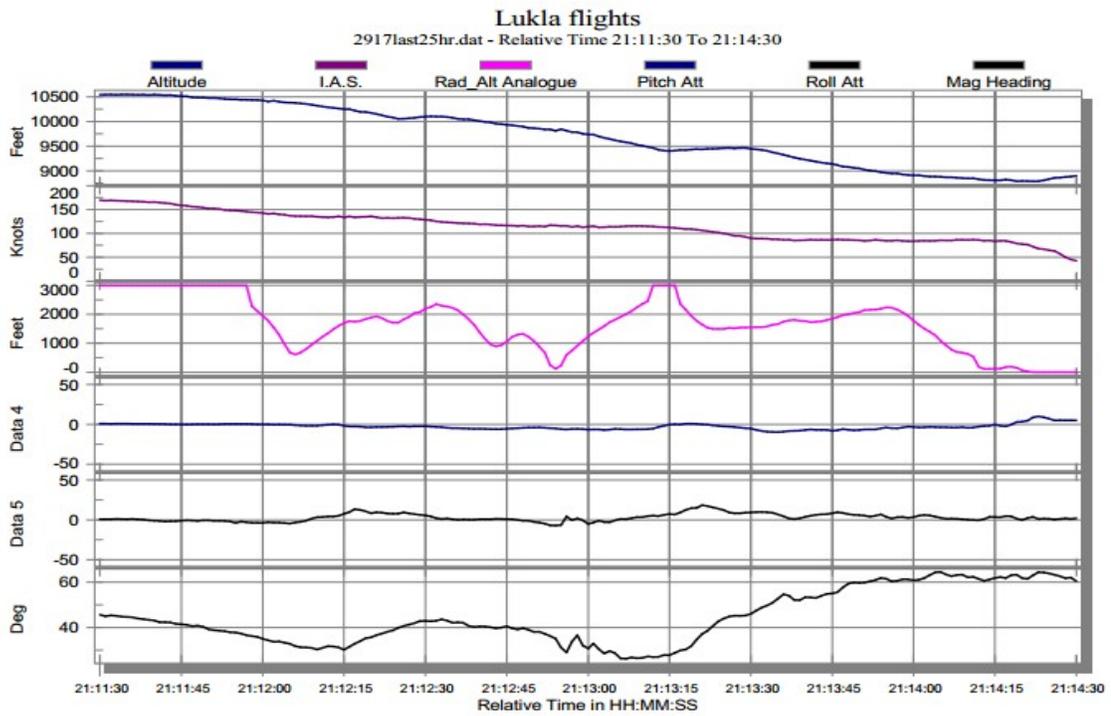
All parameters were found normal and within the limit. To get into the actual cause of accident, the Commission minutely analyzed the FDR data of crashed flight and two previous flights before crash of the same aircraft. Following Fig. ...Shows the comparative data of six different parameters.

Figure 15: Last 3 minutes Data of 5th flight (crashed flight) : at an interval of 15 seconds

Figure 16: Last 3 minutes data of 4th Flight to Lukla: at an interval of 15 seconds

Figure 17: Last 3 minutes Data of 3rd flight to Lukla: at an interval of 15 seconds
