**Accident to an ultralight aircraft VL-3 Evolution,  
national and registration markings LY-VLA,  
that occurred on 19 April 2014  
in Quarter No. 396 of Madžiūnai forest, Madžiūnai village,  
Paluknys neighbourhood, Trakai region, Vilnius district,  
the Republic of Lithuania**

**FINAL REPORT**

**Transport  
Accident and  
Incident  
Investigation Division**

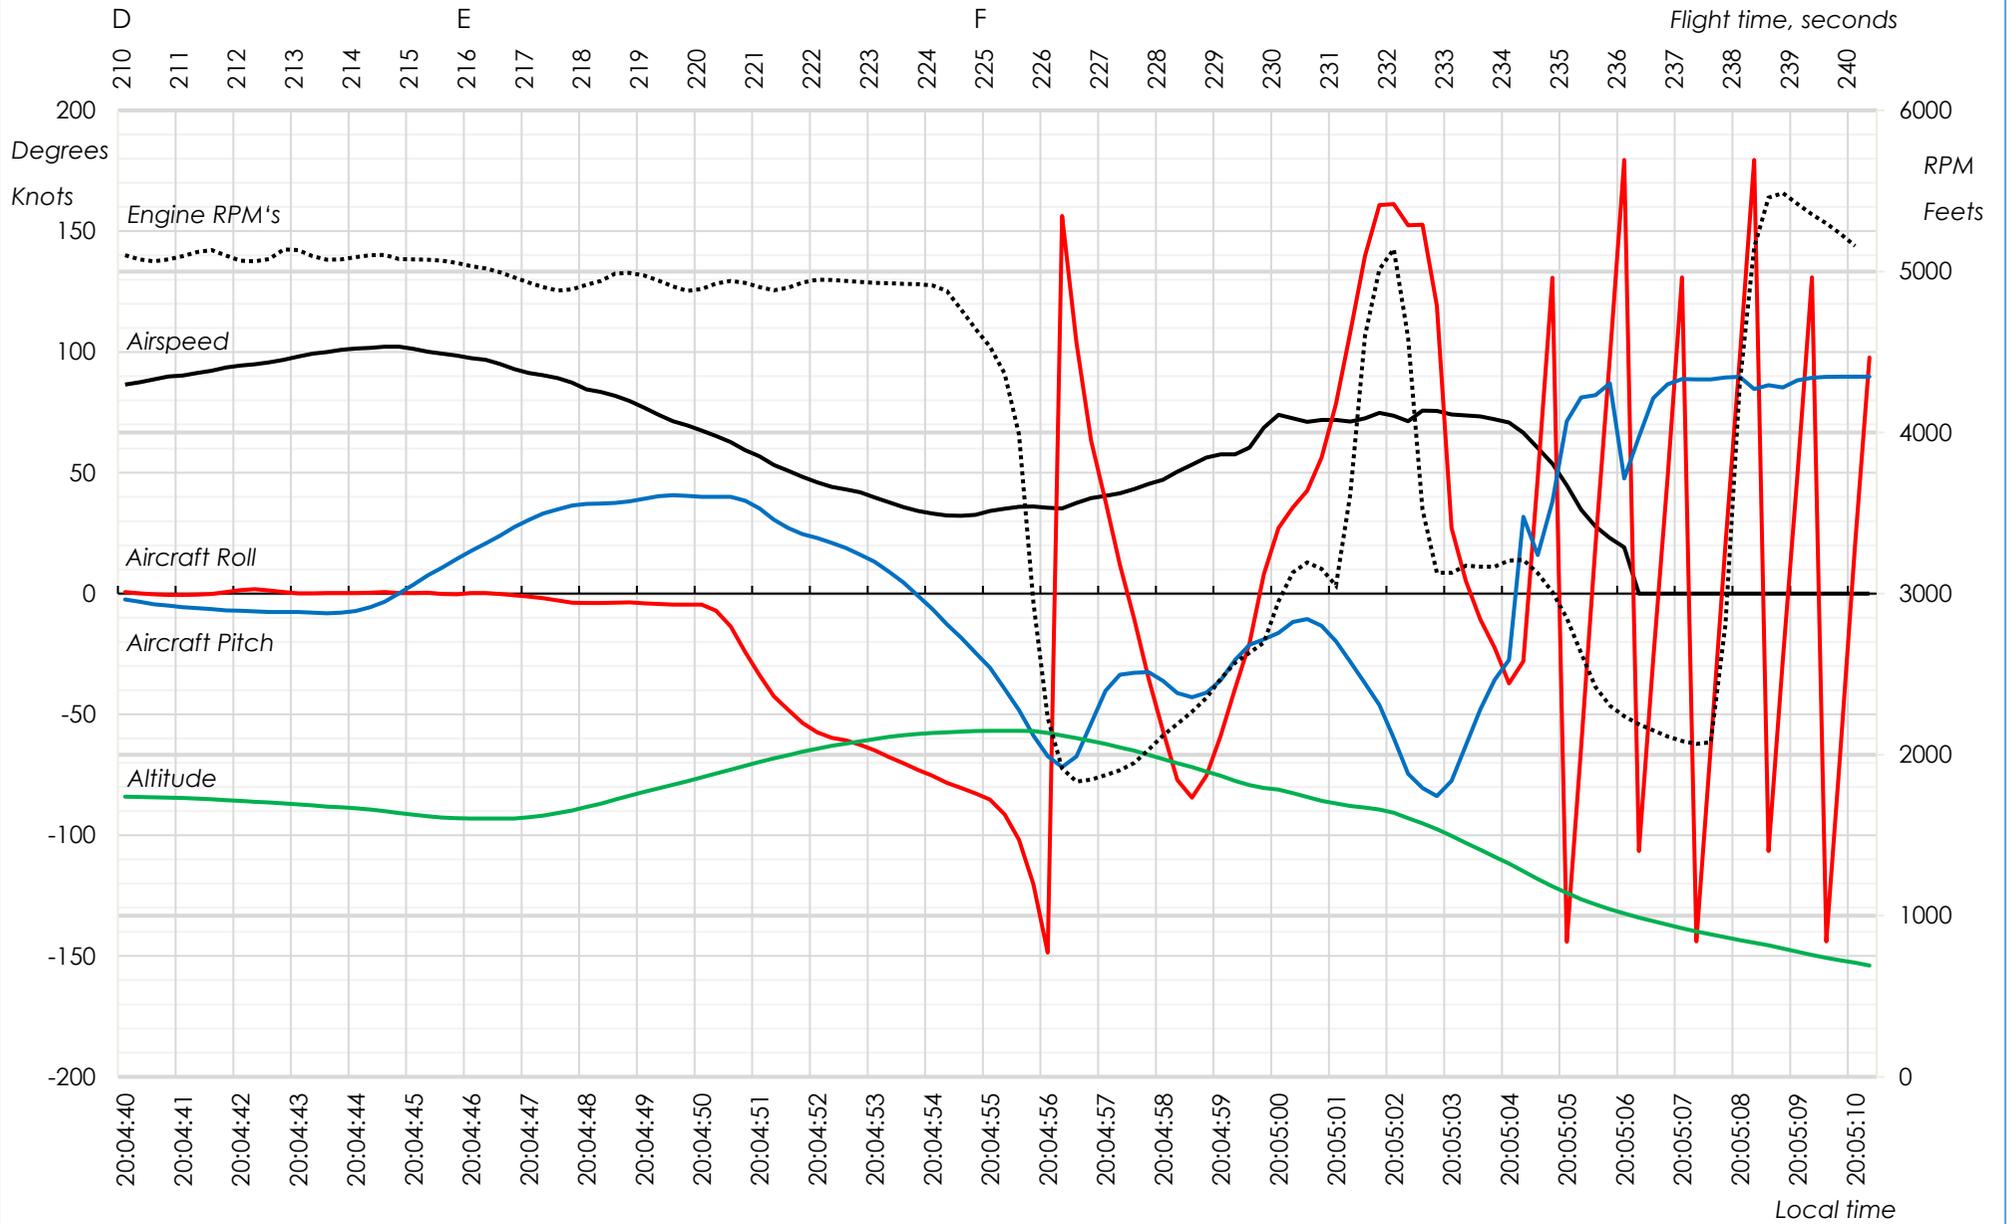
Fig. 5. Flight and engine operation parameter data of the third flight

Fig. 4 shows the flight and engine operation parameters of second flight from point 1 to point 2 and Fig. 5 shows data of third flight.

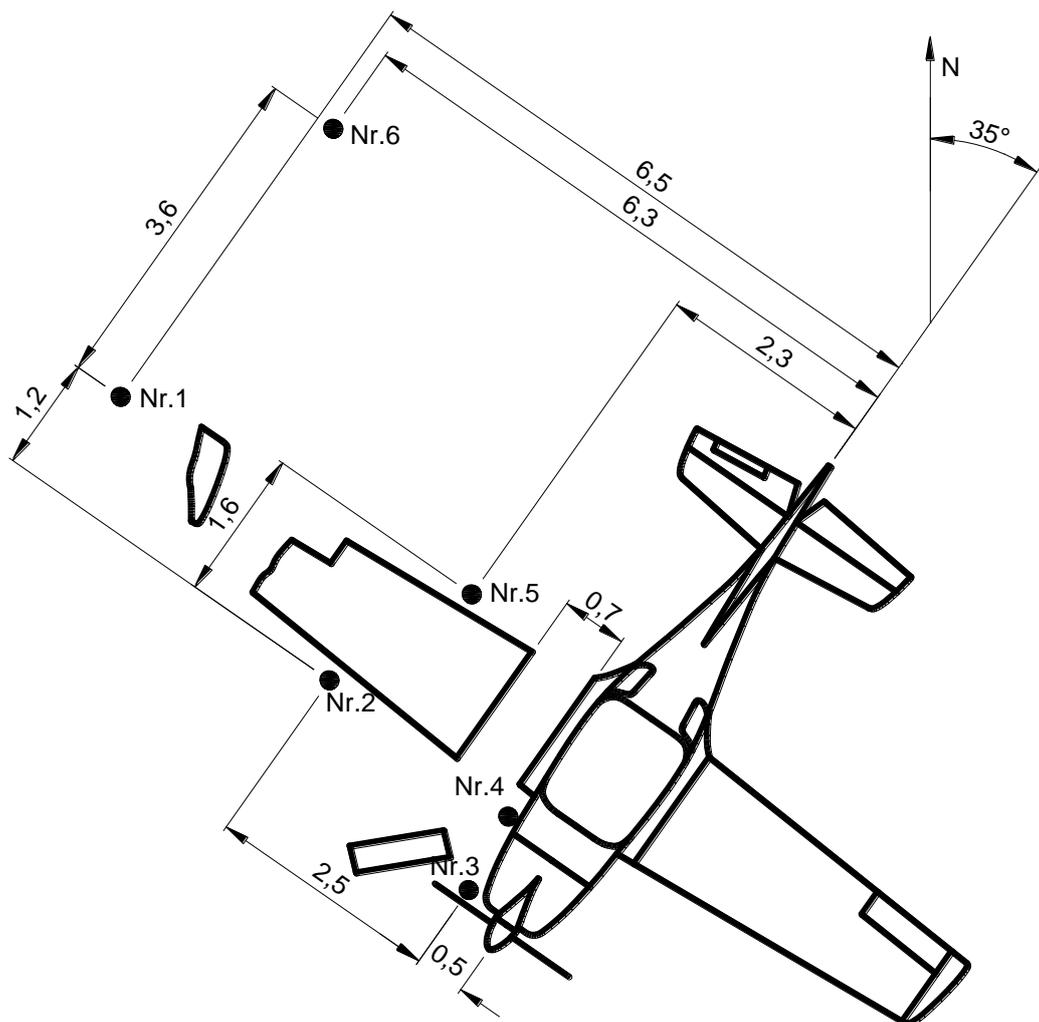
Fig. 6. Scheme of the accident site of the ultralight aircraft VL-3 Evolution

Scheme of the accident site is shown in Fig. 6. Trees numbered from 1 to 6 in the scheme of the aircraft accident site. All the distances are expressed in meters.

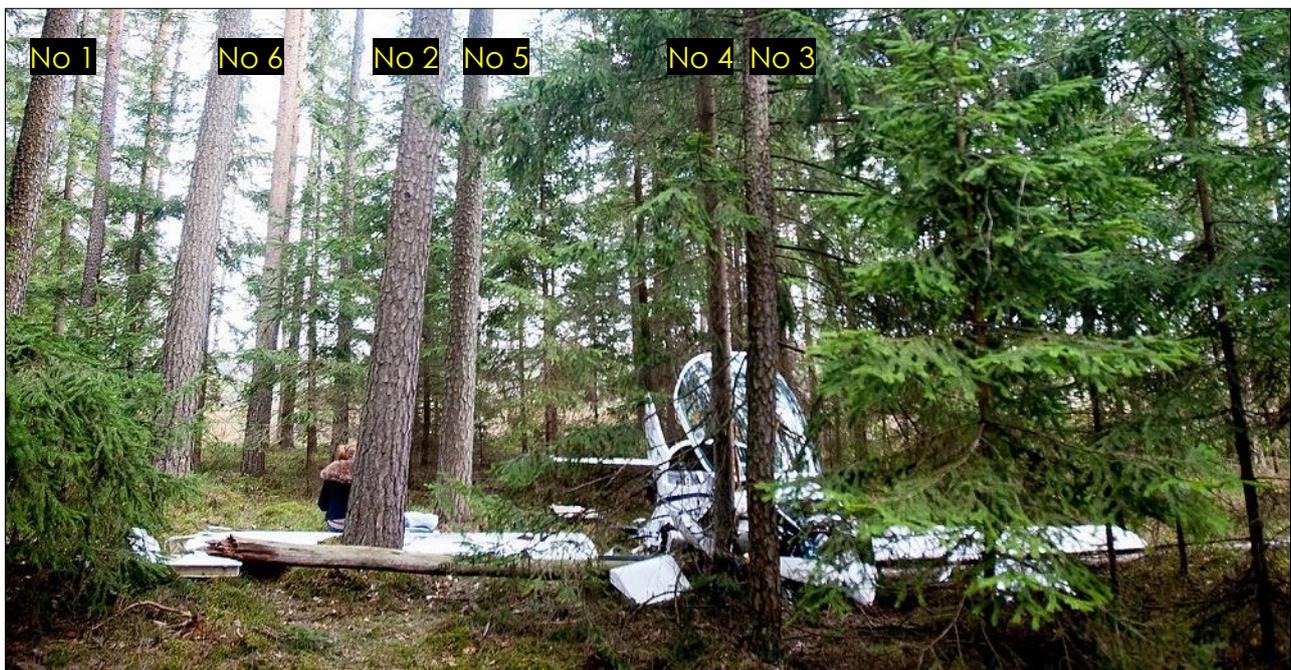
Fig. 7. The ultralight aircraft VL-3 Evolution at the accident site

Due to the impact with the ground and the trunk of the tree that had fallen previously, the engine frame was deformed, the body cracked in several places, the left wing with respect to the body moved forward and up, and the right wing with a shortened end remained somewhat further back among pines No. 5, No. 4 and No. 2 (Fig. 11). The aileron of the right wing was thrown away to pine No. 3, close to the aircraft nose (Fig. 7 and 11).

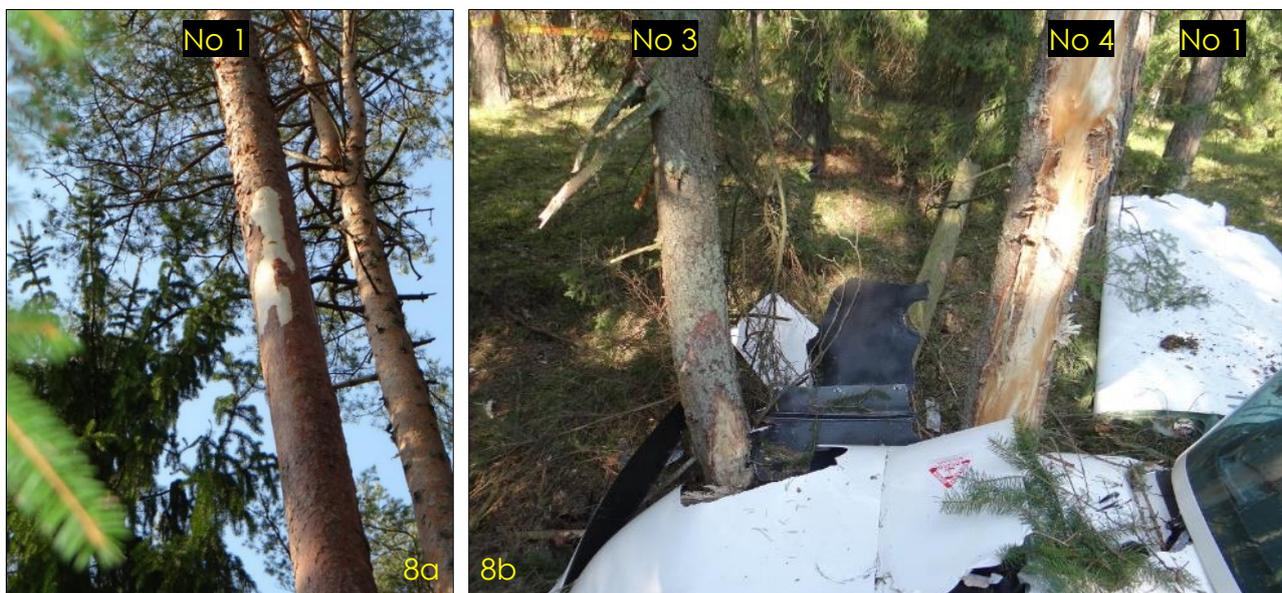
Fig. 8a–8b. Stripped bark from the pines' trunks

At the ultralight aircraft accident site it was observed that the bark was stripped from the trunk of the pine No. 1 at a height of 8-10 m (Fig. 8a). Also the bark was stripped from the trunk of the pine No. 4 at a height of 1.8 m (Fig. 8b) and the trunk of pine No. 2 from a height of 0.7 right down to the ground. Pine No. 3 had branches cut down from a height of 1.7 m right down to the ground and the bark was stripped from a height of 0.3 m to the very ground (Fig. 8b).

The ultralight aircraft spinning in a flat left counter-clockwise spin was vertically descending at high speed, until its right wing hit the trunk of the pine (No. 1) and stripped the bark at the height of 8-10 m (Fig. 8a). Because of the impact to the trunk of the pine, the tip of the right wing of the aircraft was damaged and was cut at about the centre of the right aileron (Fig. 12). Due to this impact the aircraft stopped spinning. As it continued falling, the right part of the aircraft stripped the bark of the trunk of pine No. 4 at a height of 1.8 m right down to the ground (Fig. 8b), and the right side of the wing stripped the bark of the trunk of pine No. 2 from the height of 0.7 m right down to the ground. At the same time the propeller blade cut down the branches from pine No. 3 from the height of 1.7 m right down to the ground, and the engine cowling stripped the bark of the trunk of pine from the height of 0.3 m right down to the ground (Fig. 8b), the ultralight aircraft hit the ground with the underside of the fuselage.

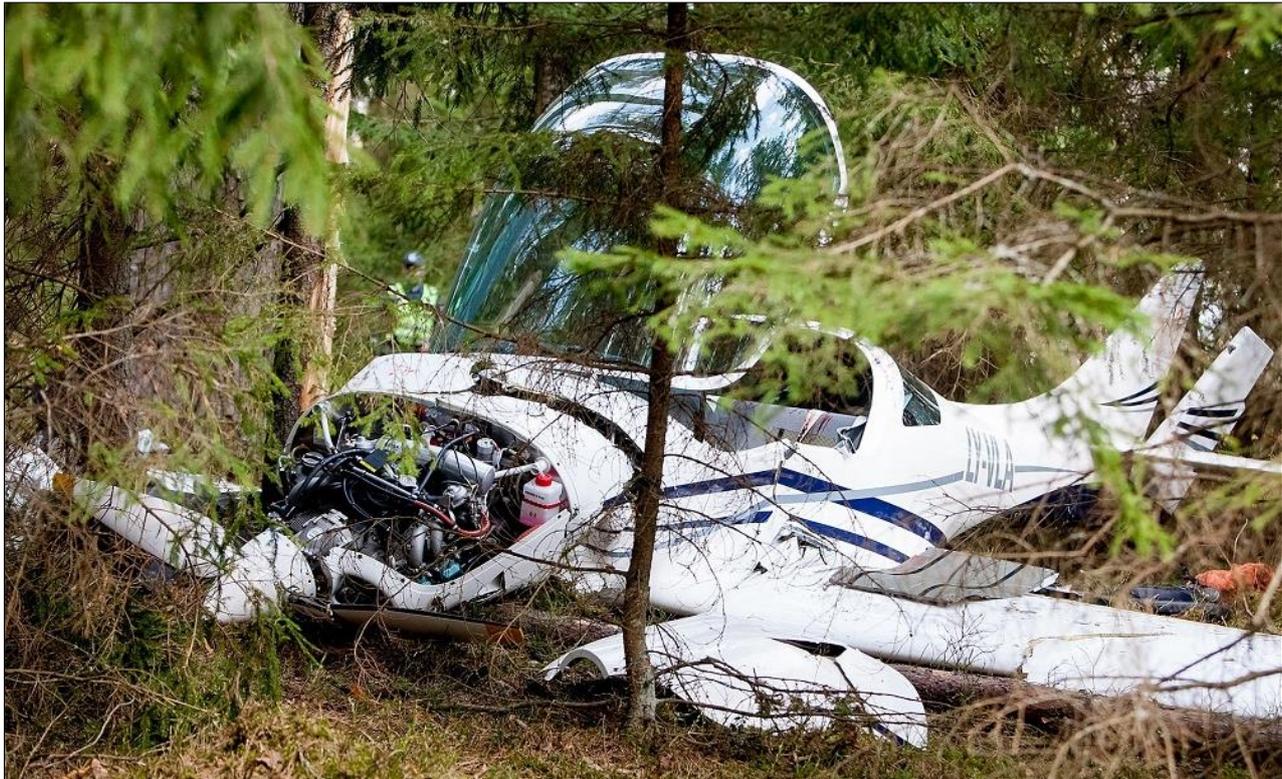
Fig. 9. The ultralight aircraft VL-3 Evolution at the accident site

The front part of fuselage of the ultralight aircraft was near the adjacent pines No. 3 and No. 4 (Fig. 8b-9). Between the pines there was the trunk of the tree that had fallen previously and was found under the engine. The entire upper section of the fuselage was cracked behind the firewall. The left part of the fuselage was cracked at the wing spar. Numerous cracks were visible in the front part of the fuselage, which aircraft was laying leaning on the front part of the fuselage. The rear part of the fuselage cracked at its centre, between the cabin and tail section and the start of the tail section. Cracks were visible from both sides of the fuselage.

The engine frame was bent down and to the right. Deformed parts: air intake box of the engine, carburettor fastening brackets, gas exhaust system pipes and the silencers, upper and lower cowlings of the engine, the firewall. At the part that was not damaged, the engine cowlings were held on their attachment lugs. Slightly damaged propeller fairing. One blade of the propeller was broken close to its root, the other blade suffered minor damage at the front edge (Fig. 9).

The cabin canopy was open and was not damaged (Fig. 9). The canopy attachment was torn out from the frame of the fuselage. The left pneumatic jack kept the canopy open and the right jack was dislocated from its fastening location.

There was no visual damage on the stabiliser (Fig. 9). The operating systems of the elevators and rudder operated correctly. The elevator trim tab was slightly bent upwards. There was not visual damage on the vertical stabilizer, but the rudder had slipped from the suspension hook and remained hanging on the lower unit.

The left wing remained connected to the fuselage, though it had moved several centimetres forward and upward and broke the fairing between the wing and the fuselage (Fig. 9-10). The skin of the left wing had cracked in several places. The steering jack of the left aileron had broken between the left wing and the fuselage.

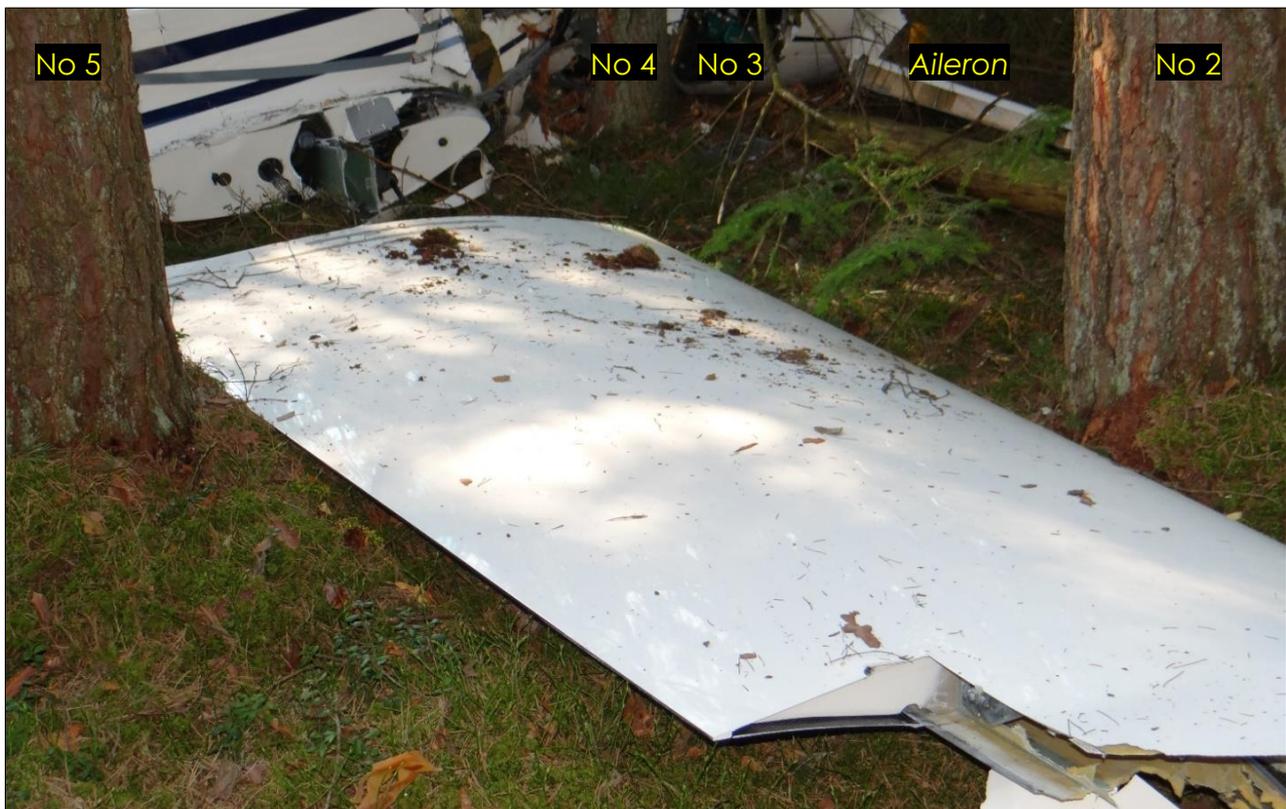
Fig. 11. Separated right wing between pines

The right wing had separated from the aircraft (Fig. 11). The spar of the right wing had broken off at the root rib. The spar was partly pulled out from the fuselage, however, by moving it slightly it could not be pulled out completely. The pin connecting the ends of the left and right spars was torn out with all bushings and was partly pulled out.

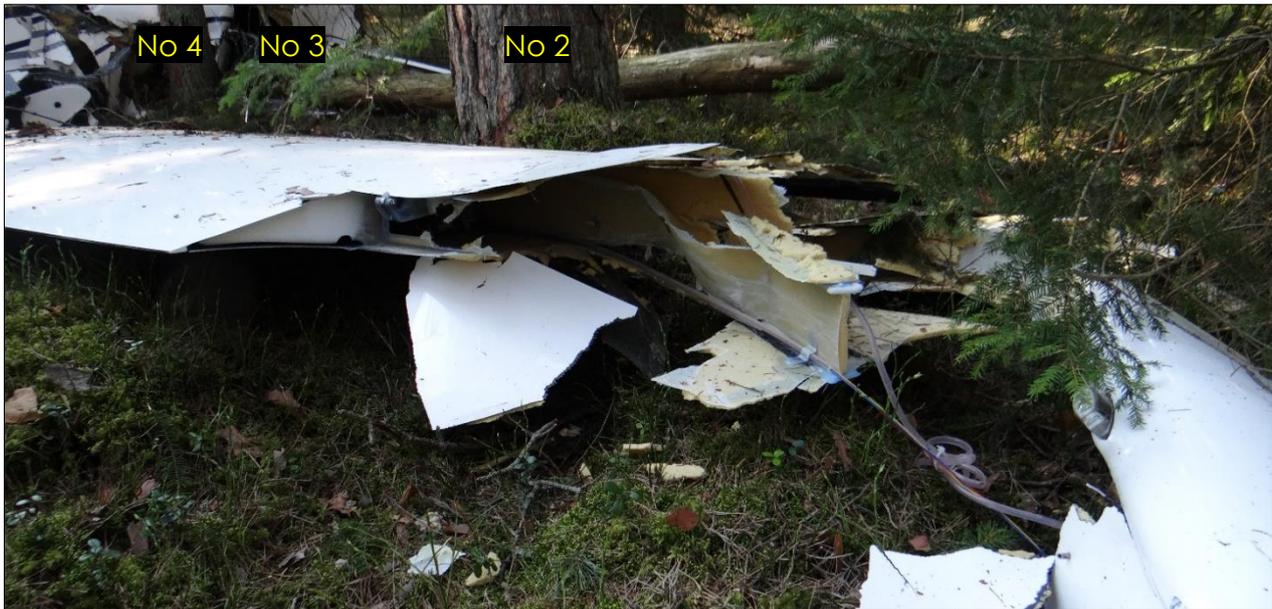
Fig. 12. Crashed tip of the right wing

The tip of the right wing at the aileron location was crushed and was hanging supported only by the wires and the pressure sensor tubes (Fig. 12). Pieces of the tip of the right wing were scattered within a radius of several metres.

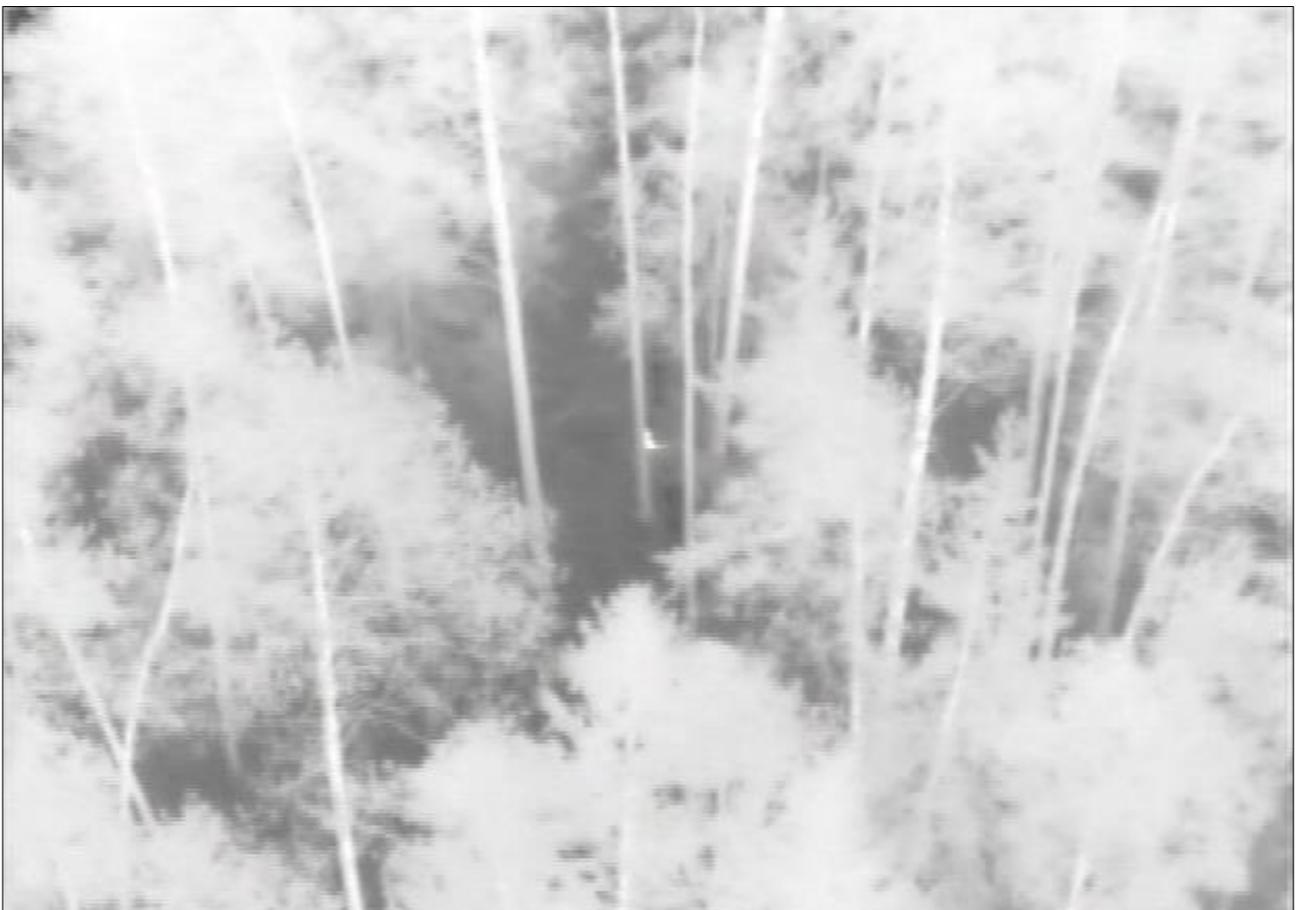
Fig. 13. The accident site through the thermovisor system equipment (Image of the Aviation Unit)

The first helicopter of the Aviation Unit took off for the search of the ultralight aircraft at 22:30, i.e. 50 min. after the receipt of the notification. There are no crew permanently on duty in the Aviation Unit base and a search and rescue helicopter has to take off within 1 hour 30 minutes of the receipt of a notification. The second rescue helicopter took off at midnight. The search (with breaks for fuel refill, crew change and rest for the pilots) continued through the night. During the search night, the helicopters flew over the accident site several times (Fig. 13).

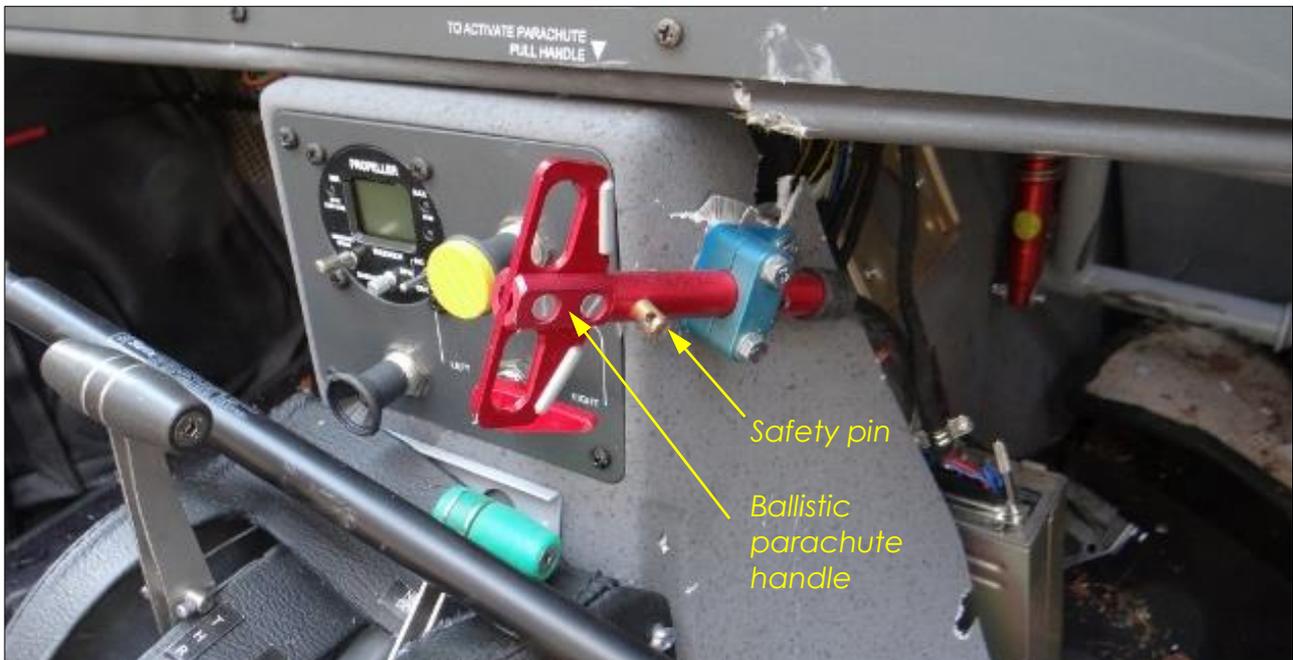
Fig. 14. The ballistic parachute activation handle blocked by a safety pin

The examination of the ultralight aircraft at the accident site established that the activation handle of the ballistic parachute rescue system was blocked by a safety pin (Fig. 14). The flag of the safety pin was found on the cabin floor next to the activation handle. The ring connecting the safety pin with the flag was straightened. The examination of the safety pin showed that it was bent (Fig. 15).
