CZ-18-0869

FINAL REPORT

**Investigation of causes of an air accident
of the Robinson R 44 RAVEN I helicopter
identification mark OK-PLP,
in the Pilsen industrial zone
on 5 September 2018**

Prague
August 2019

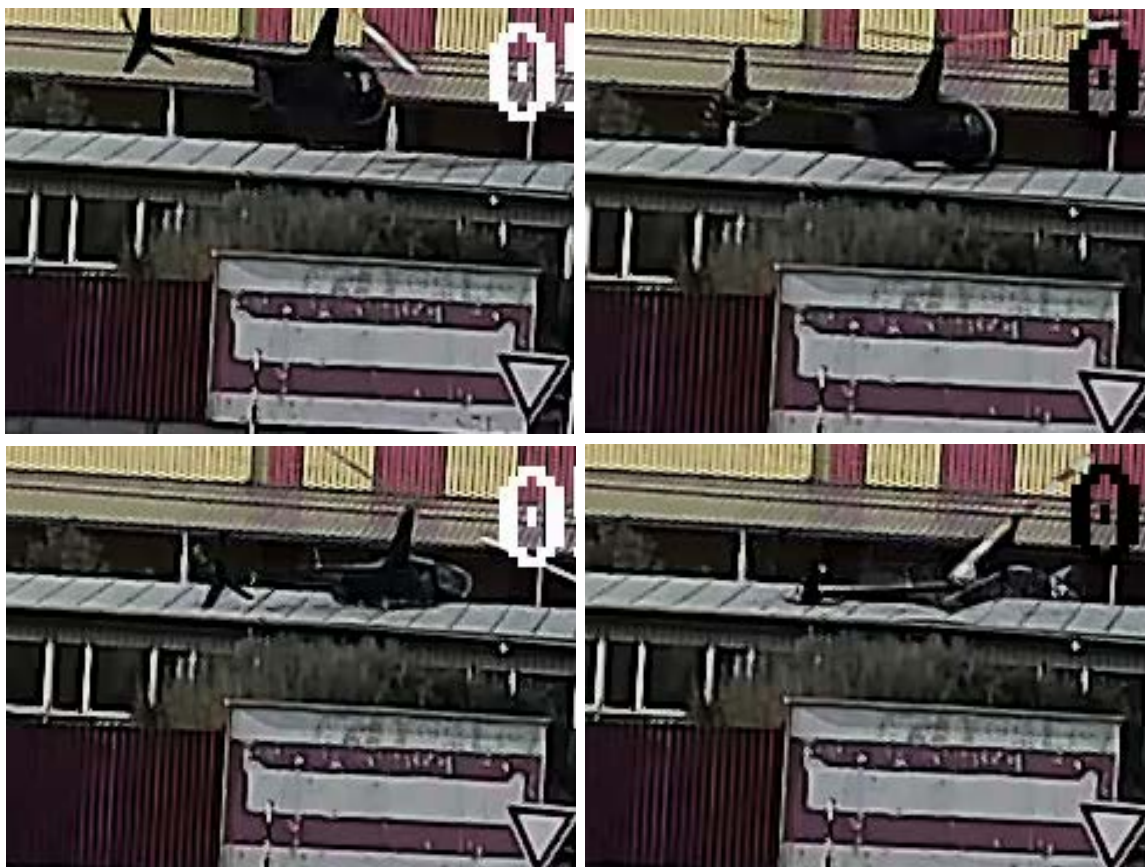
At 17:15:19 SECT, one of the industrial cameras which was placed on the company’s building recorded the helicopter flying in the western direction. The flight at low altitude over Folmavská street was then described in witnesses’ testimonies. They are describing that the helicopter rolled to the left and then made a sharp turn to the right with an extreme roll and pitch. The recovering of this manoeuvre and the crash onto the roof of the building were recorded on the industrial camera at 17:20:39 SECT.

Fig. 1 – Videorecording sequences capturing the crash of the R 44 helicopter onto the roof of the hall

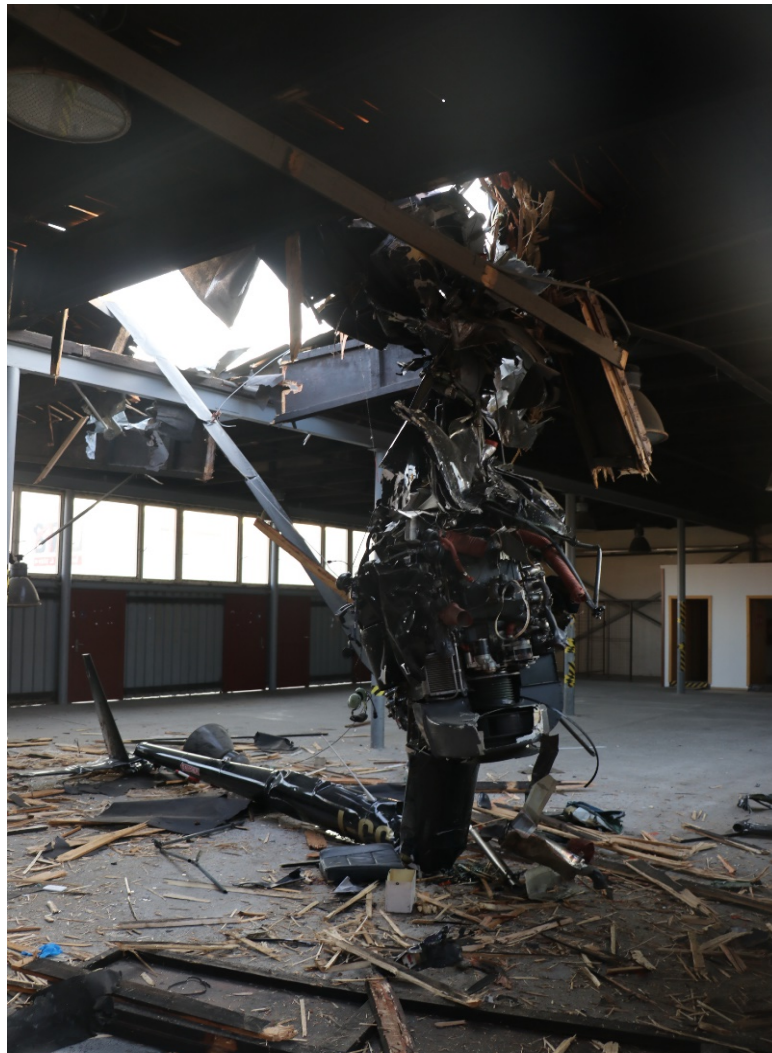
The helicopter was totally destroyed by the crash into the roof of a storage hall.

Fig. 2 – Helicopter R 44 after crash into the hall roof

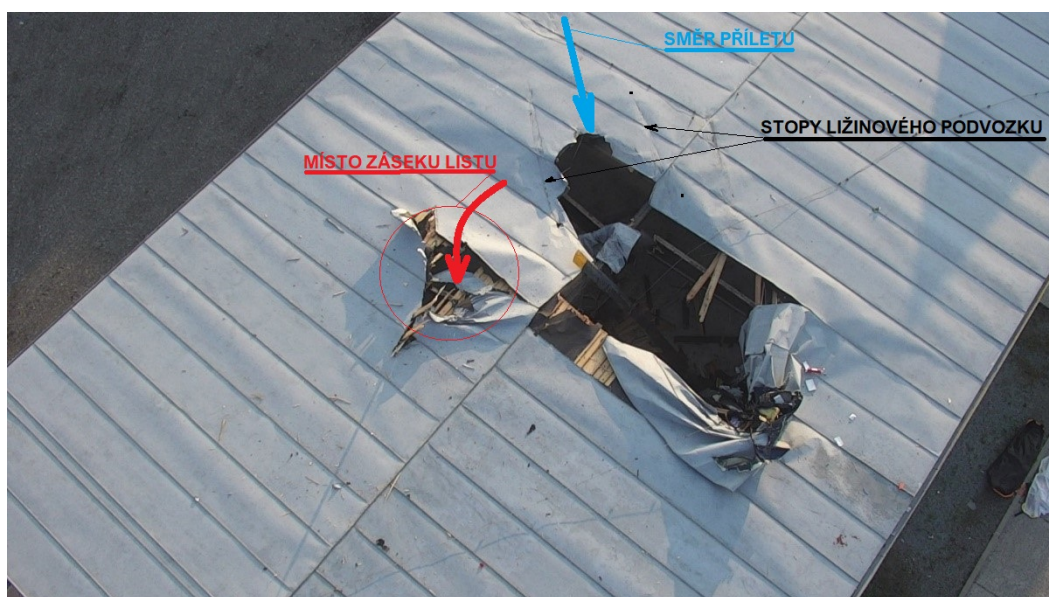
The helicopter crashed into the building, damaged a substantial part of the plate roofing, and seriously damaged the roof supporting structure.

Fig. 6 – View of the broken roof of the MEA hall.

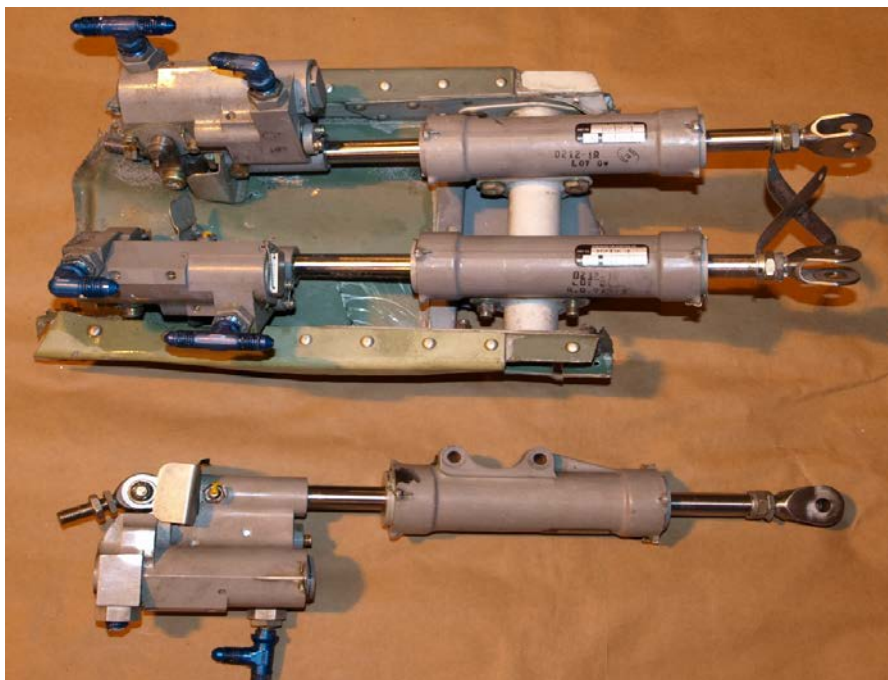
The system of hydraulic boosters, except for the broken "T" screw joint in the collective control, showed no signs of any mechanical damage, leakage, or any other defects.

Fig. 4 – All the three hydraulic boosters after disassembly from the helicopter wreckage.

The condition of all the three hydraulic control boosters shows that up to the moment of the helicopter crash onto the roof, they had been fully functional and operational and operating defect-free. They retained their full functionality also after the helicopter accident. Only the collective control hydraulic booster screw joint of the hydraulic pressure hose was broken

off due to the accident impact. It follows from the stated information that the hydraulic boosters' condition and functionality had no bearing on the air accident origin and cause.
