CZ-19-0369

# FINAL REPORT

**Investigation of causes of an air accident  
of the CASA 1.131-E aircraft, registration mark D-EHDT,  
at the Cheb airport on 1 June 2019**

Prague  
July 2020

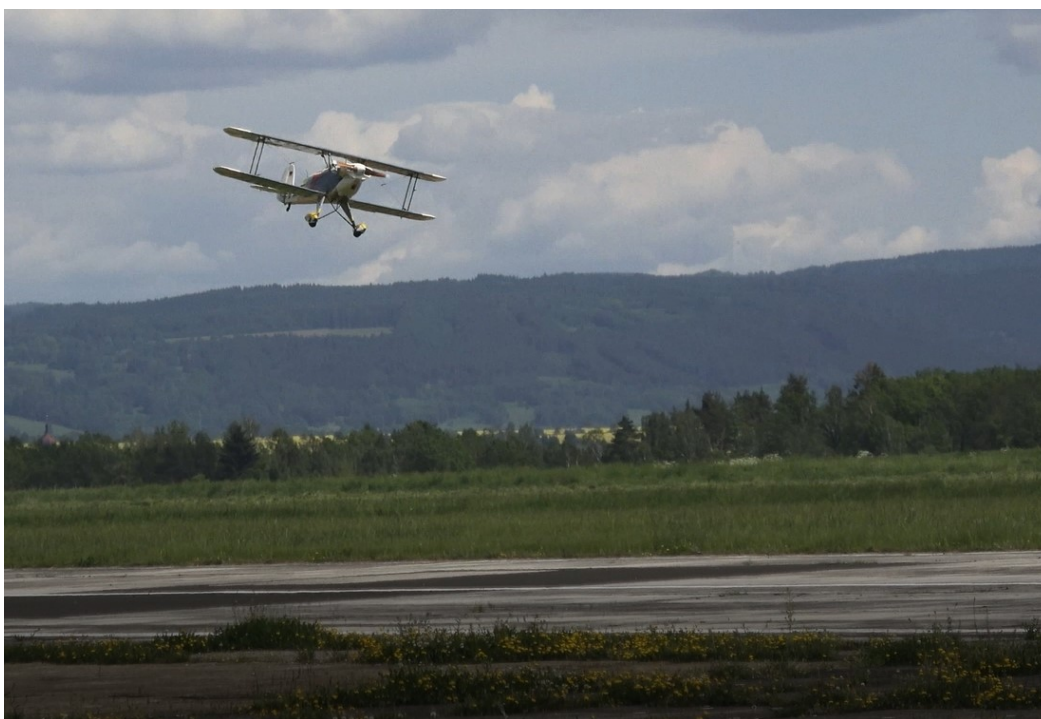
*Fig. 1 – CASA 1.131-E aircraft, registration mark D-EHDT, in approach to landing on the presumed RWY 23.*

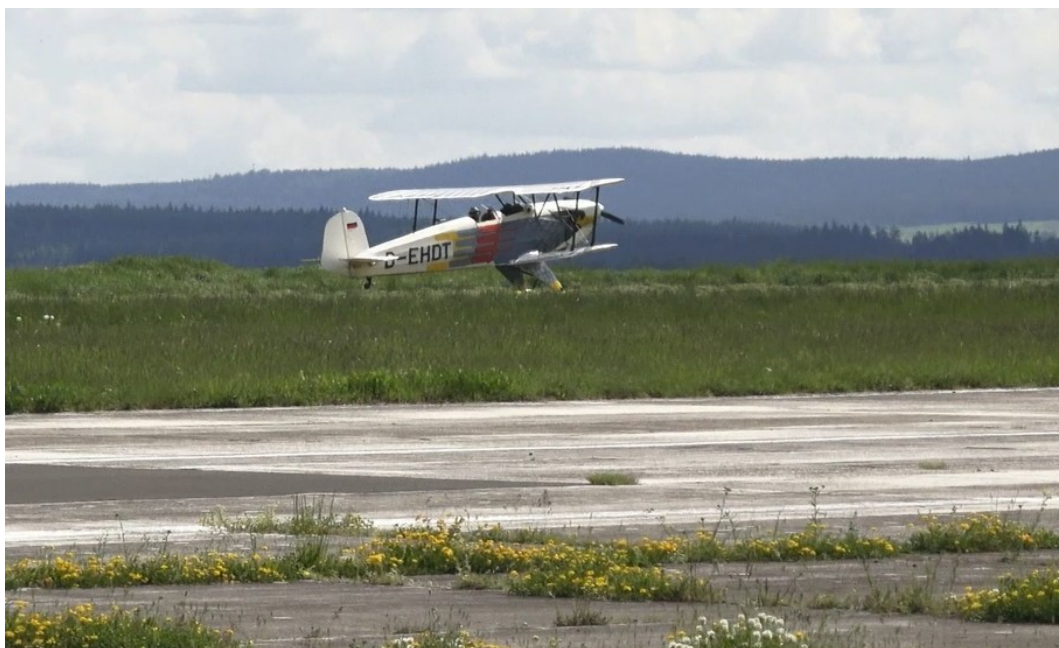
The aircraft landed on the freshly mown area to the left of RWY 23 between the lines of high piles of mown grass at the level of the last quarter of the RWY 23 length (Fig. 2). According to the witnesses' statements, upon touchdown, the aircraft had a higher speed than usual for this type. Upon touchdown, the pilot was braking, but during the landing run, the left gear wheel ran into a small but deep trench in the surface of the area (Fig. 3) where the aircraft landed. The area is used as a gliding strip. However, at the time of the incident, it was not visually marked according to Rule L 14 Aerodromes.

*Fig. 2 – CASA 1.131-E aircraft upon touchdown of the main wheels with the area of the gliding strip to the left of RWY 23. The concrete RWY 24 can be seen in the front.*

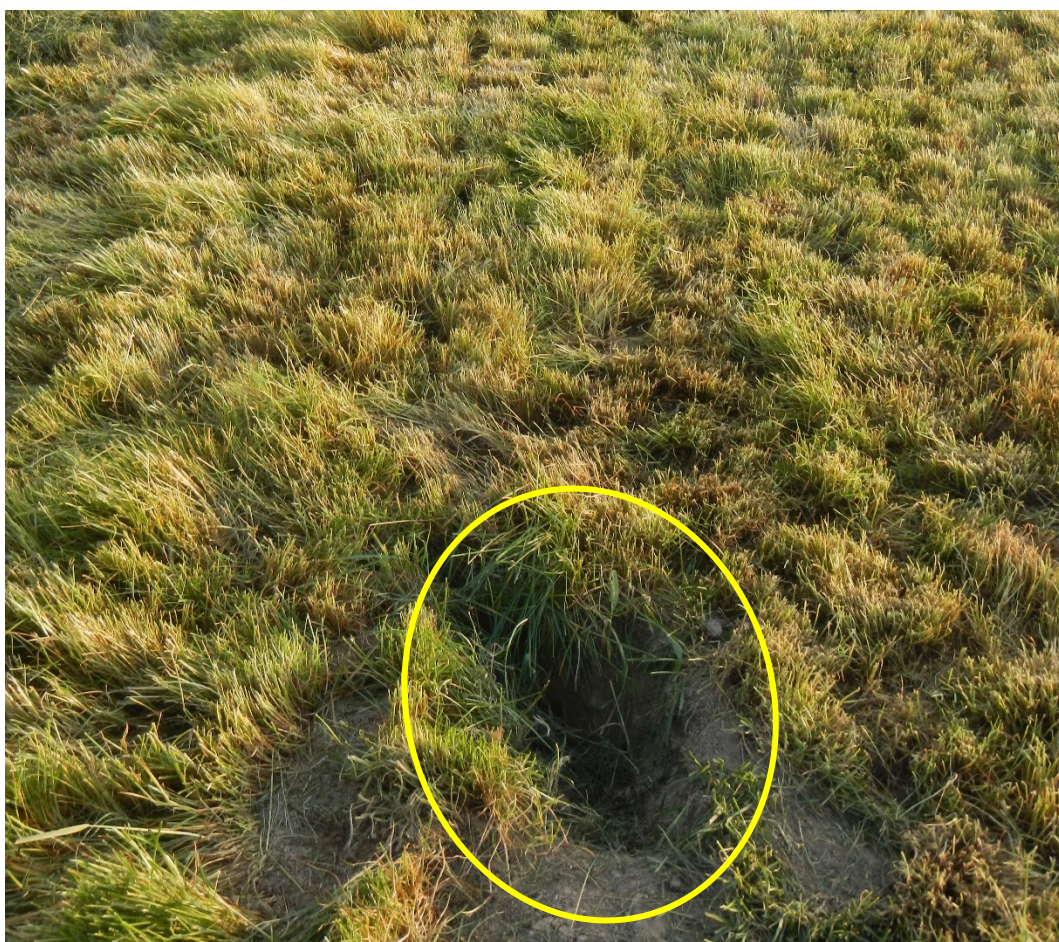
*Fig. 3 – Trench in the surface of the gliding strip into which the left gear wheel ran.*

Left gear wheel's running into a trench caused aircraft bouncing and departing to the left. At the same time, the left wheel leg was damaged. The aircraft then got caught in a line of freshly mown piled grass with its undercarriage and a lower wing. Abrupt deceleration caused by getting caught in the piled grass caused the aircraft turnover (Fig. 5). After aircraft turnover, the pilot closed the fuel feed and switched off the ignition system. She climbed out of the cockpit and tried to help the passenger stuck in the front cockpit.

Shortly after the touchdown, in the landing run, the aircraft ran into a trench with its left gear wheel, causing the aircraft to bounce to the left over a pile of mown grass. Abrupt deceleration caused by a line of piled grass caused the aircraft turnover.

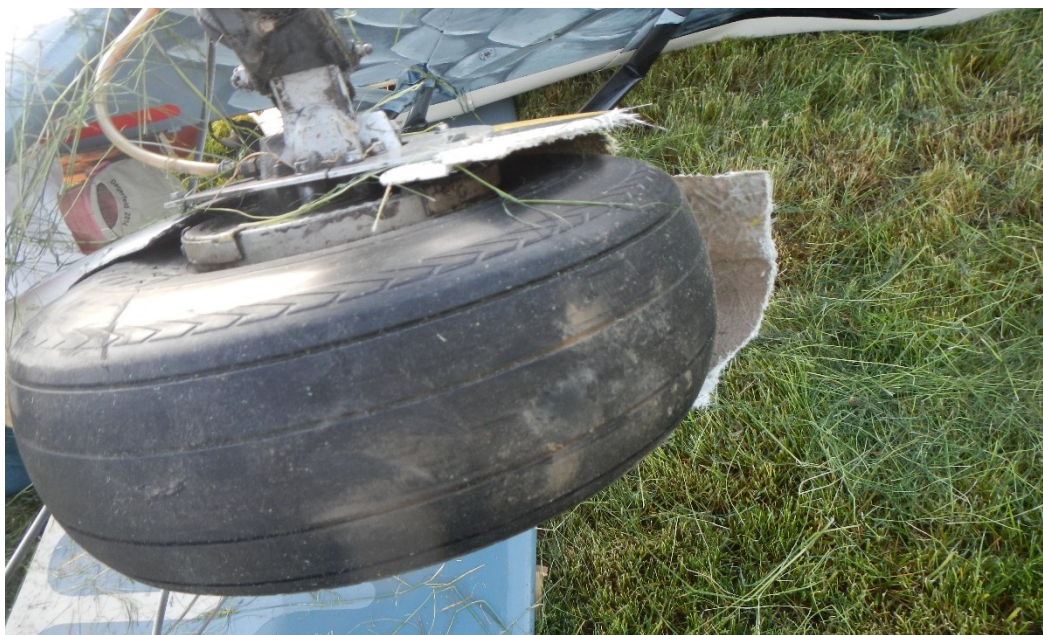
*Fig. 4 – Traces of soil on the left gear wheel and broken streamline fairing of the wheel after running into a trench on the gliding strip.*

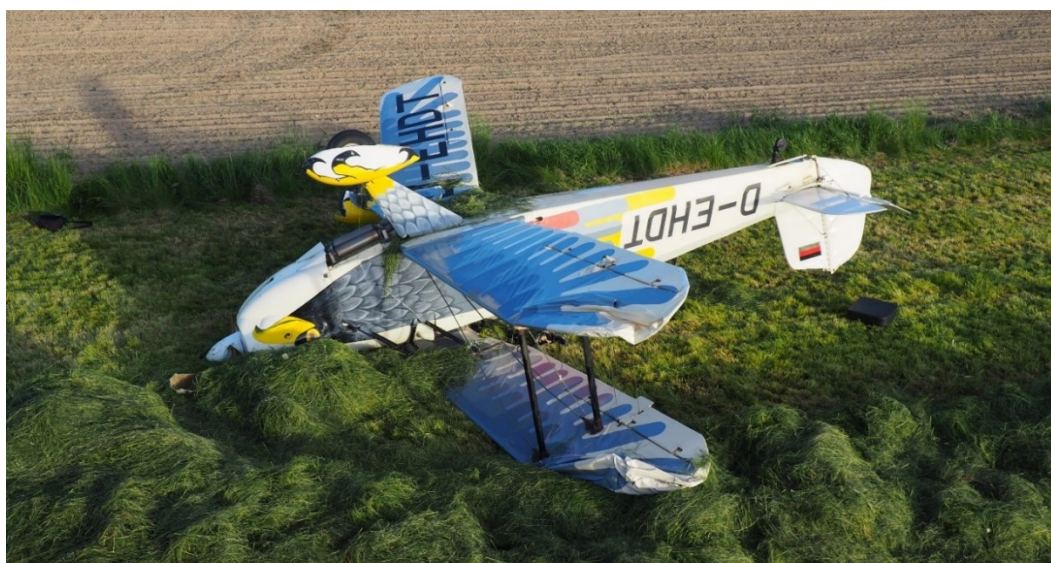
*Fig. 5 – CASA 1.131-E aircraft, registration mark D-EHDT, at the accident site*

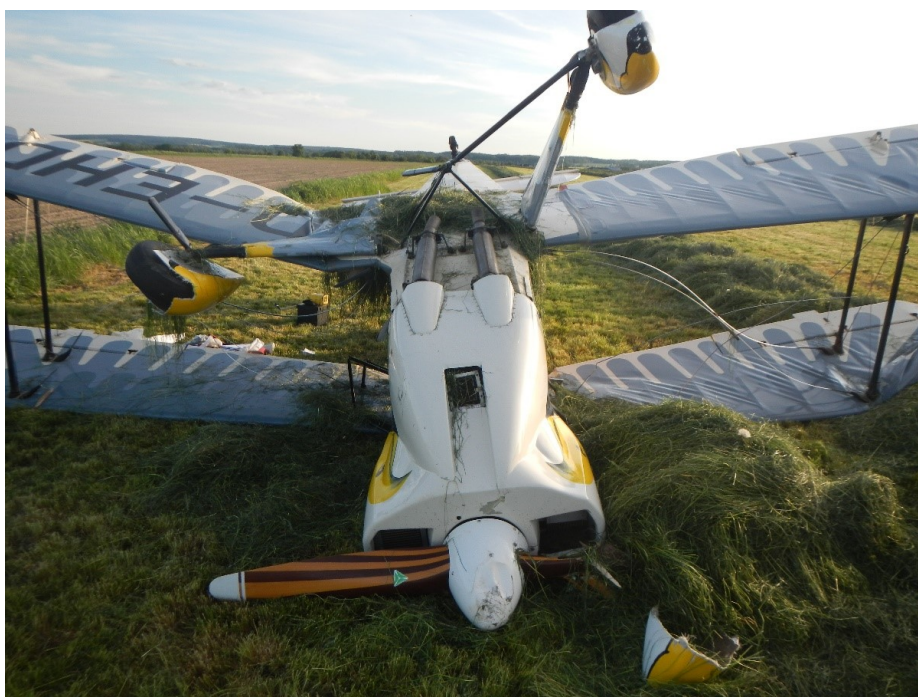
The aircraft was damaged beyond repair in the air accident (Fig. 6).

Fig. 6 – Extent of damage to the CASA 1.131-E aircraft.

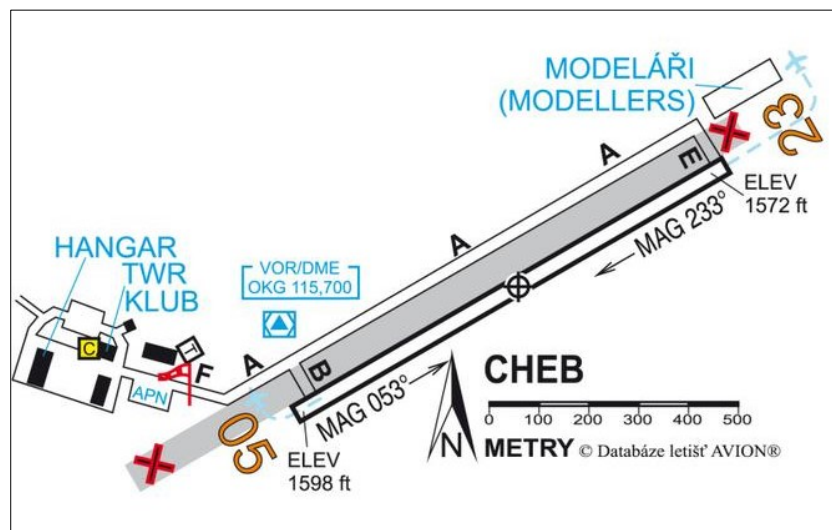
14 Aerodromes. At the time of the incident, the gliding strip (GLD STRIP) was not entered in the airport documentation (Fig. 9).

Fig. 9 – GLD STRIP was not entered in the Cheb airport chart in the VFR Manual of Airports in the Czech Republic issued for 2019.

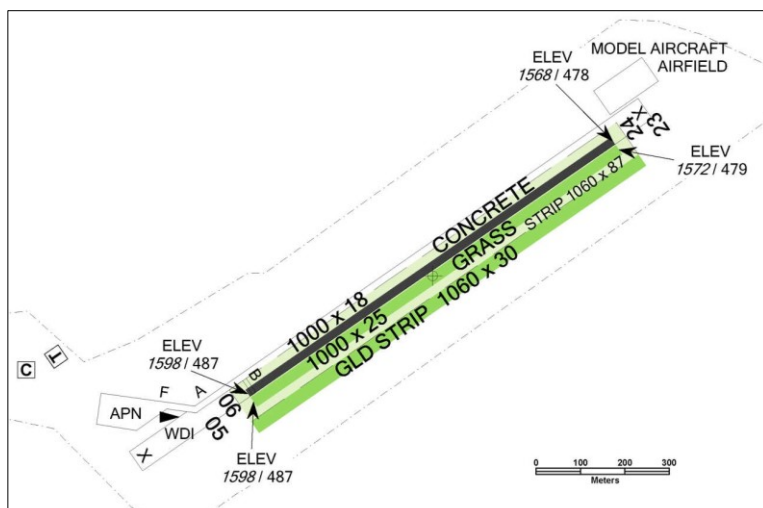
*Fig. 10 – GLD STRIP was already marked in the Cheb airport chart in the VFR Manual of Airports in the Czech Republic issued for 2020.*

The gliding strip (GLD STRIP) appeared in the airport chart in ADC and in the text of the VFR Manual of Airports in the Czech Republic issued for 2020, valid since 5 December 2019 (Fig. 10), i.e. as late as some six months after the air accident.

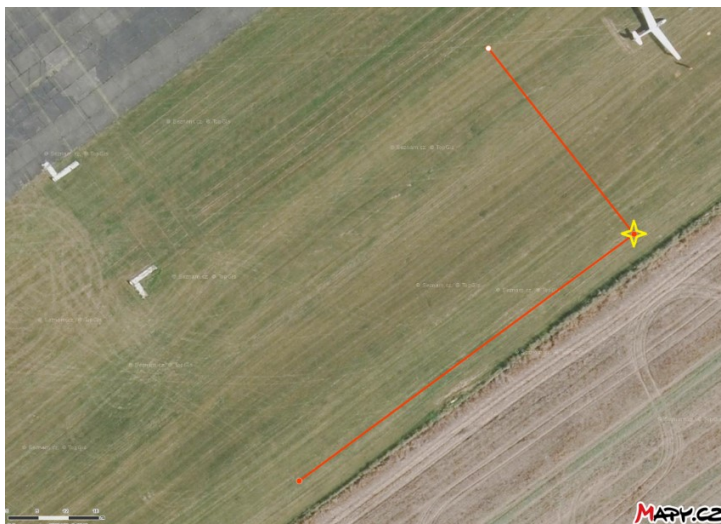
The location of the air accident was the Cheb airport where the aircraft landed not on RWY 23 but on the gliding strip (GLD STRIP). The aircraft crashed and turned over approximately 83 m in front of the end of RWY 23 and 47 m to the left of the left edge of RWY 23 (Fig. 9).

*Fig. 11 – Place of accident on the unmarked GLD STRIP to the left of RWY 23 (in the flight direction) is marked with a yellow asterisk.*

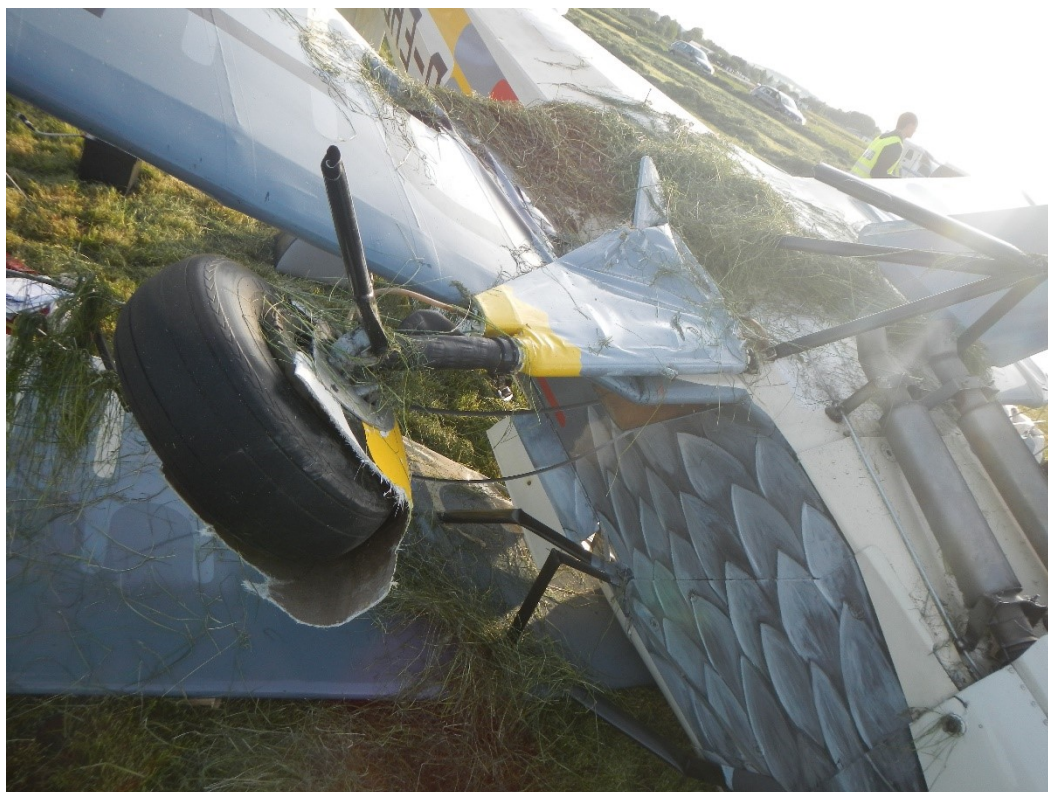
The aircraft engine was shut down forcibly, the wooden propeller had one blade broken off. The aircraft undercarriage was completely destroyed, the tube structure of the left wheel leg was torn apart at the place of force nodes, and the undercarriage was deformed (Fig. 12).

*Fig. 12 – Damaged undercarriage, broken left wheel leg with a damaged wheel streamline fairing. Broken upper wing struts can be seen in the middle of the picture.*

The structure of both halves of the upper and lower wing was deformed both close to the fuselage and at the ends, and the wing fabric was torn at several places (Fig. 9). The left half of the lower wing was badly deformed in the downward direction at the place of mounting to the fuselage. The wing strut system was deformed and the upper wing mounting to the fuselage was destroyed (Fig. 12).

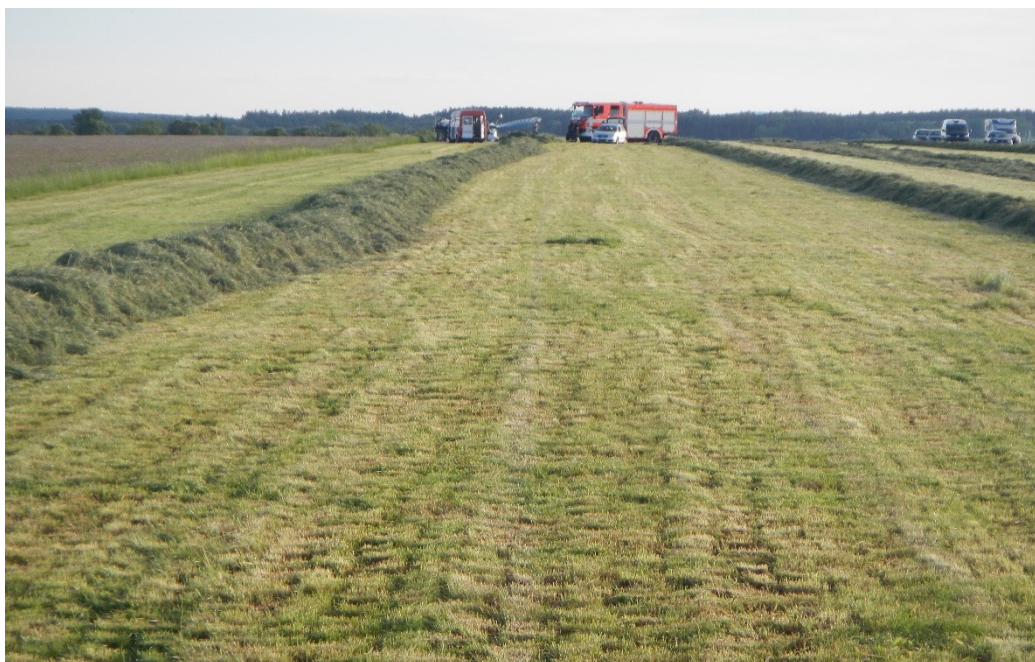
At the time of the incident, the gliding strip was freshly mown, and the grass was piled in longitudinal 50–70 cm high lines. The distance between the lines was approximately 8 m, and the distance between the lines where the aircraft landed was 17 m (Fig. 13). Other grass areas to the right of the concrete RWY 24 were also freshly mown.

*Fig. 13 – View of the gliding strip in the aircraft landing direction between the lines of mown and piled grass.*

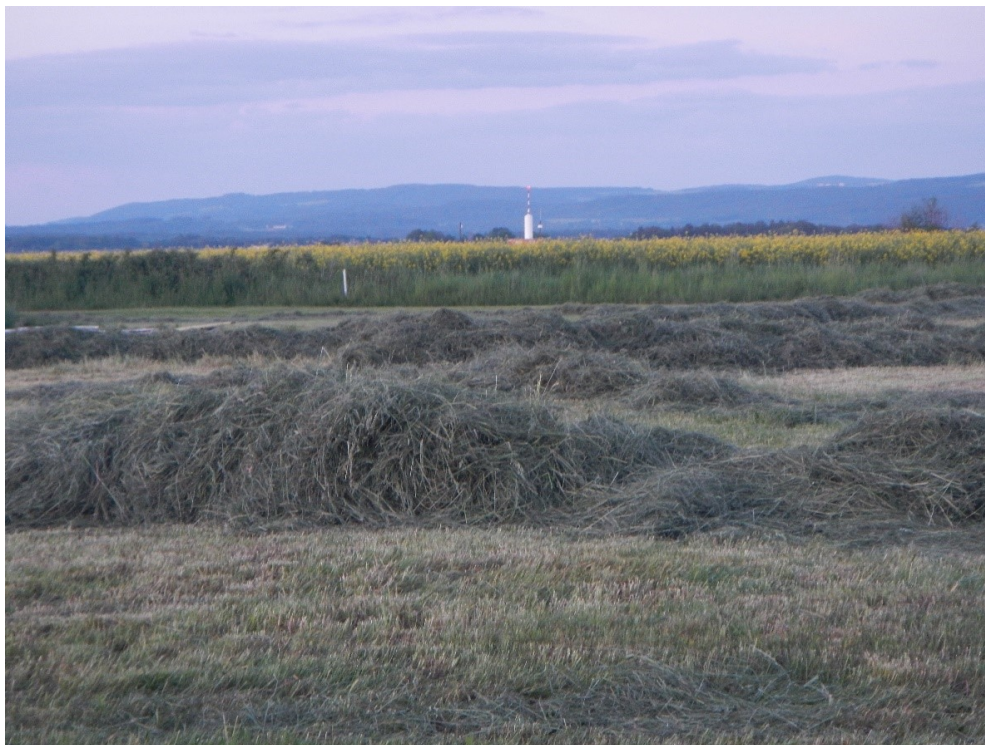
*Fig. 14 – Mown areas with piled grass next to the concrete RWY 06/24. View in the direction from the runway.*

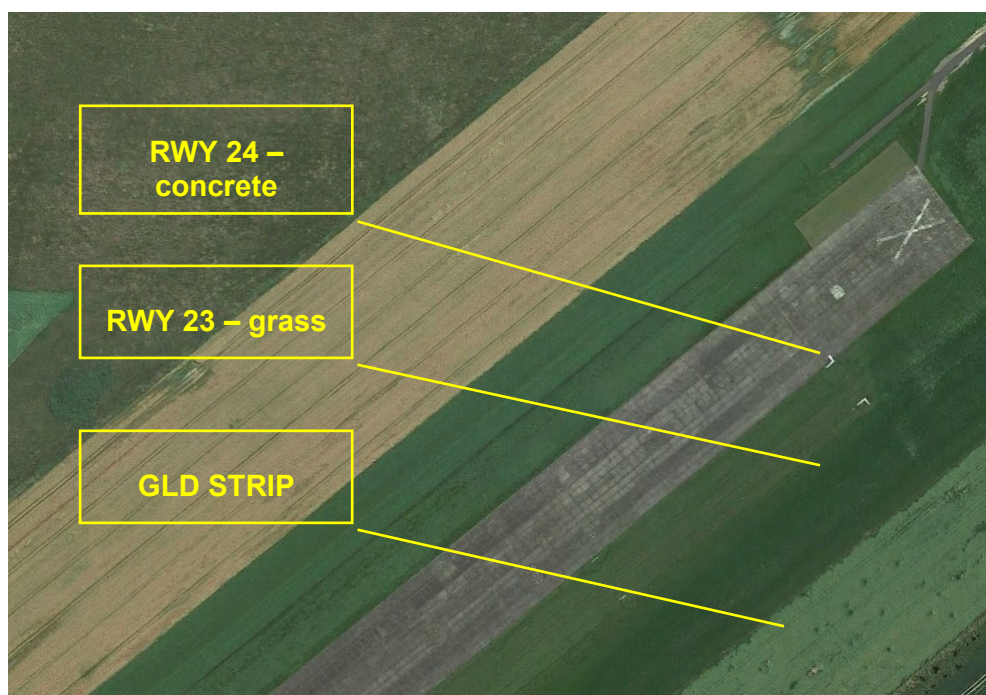
markings (of RWY 06/24 and GLD STRIP) failed to comply with the requirements of Rule L 14 Aerodromes (Fig. 15 and 16).

*Fig. 15 – Visual markings of RWY 24 and GLD STRIP non-compliant with the requirements of Rule L 14 Aerodromes and RWY 23.*

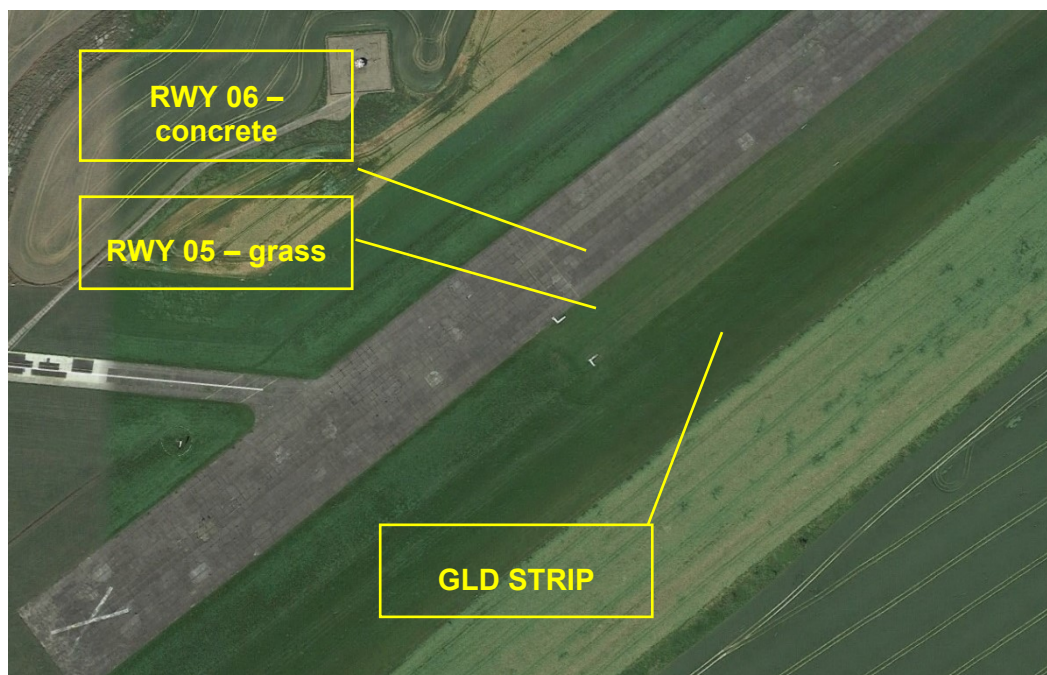
*Fig. 16 – Visual markings of RWY 06, RWY 05 and missing GLD STRIP markings.*

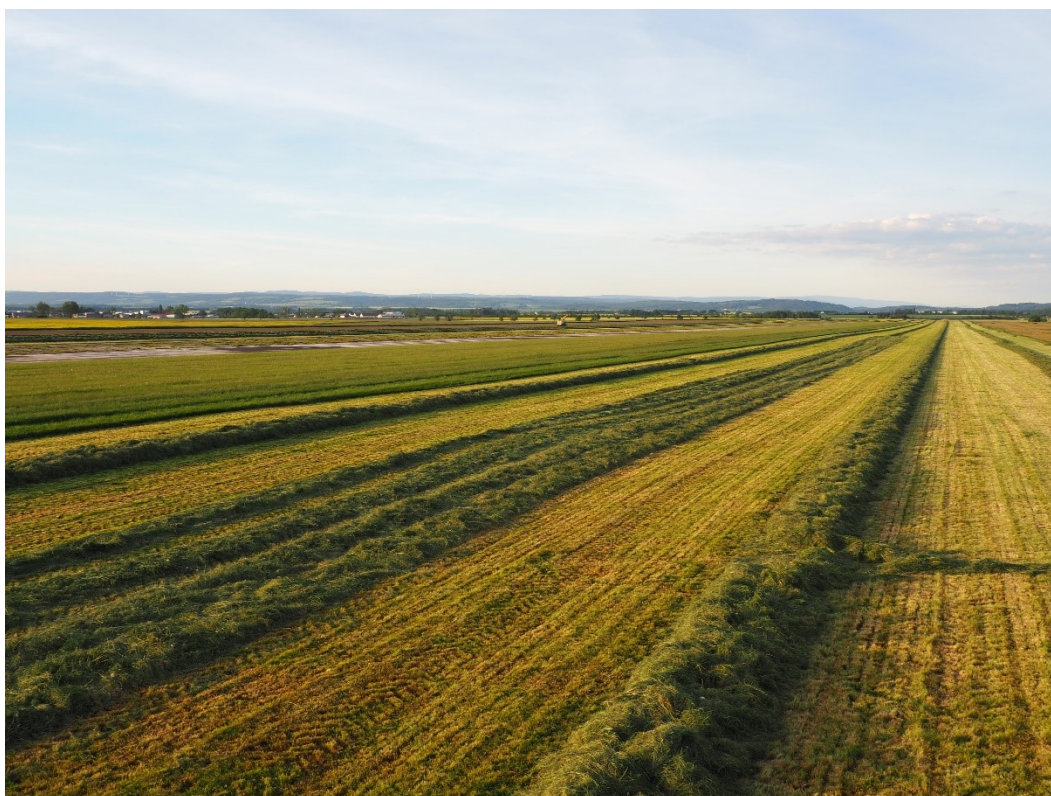
The above facts probably resulted in mistaking the gliding strip for RWY 23 (Fig. 17).

*Fig. 17 – View of RWY 06/24 (far left), RWY 05/23 (unmown area next to the concrete runway) and the gliding strip (GLD STRIP) with mown piled grass.*
