AIR ACCIDENTS
INVESTIGATION INSTITUTE
Beranových 130
199 00 Prague 9 – Letňany

CZ-23-0869

FINAL REPORT

**on investigation of causes of an air accident of the PIK-20D glider,
registration mark OM-5133,
in a field south of Podhořany near Ronov
on 12 August 2023**

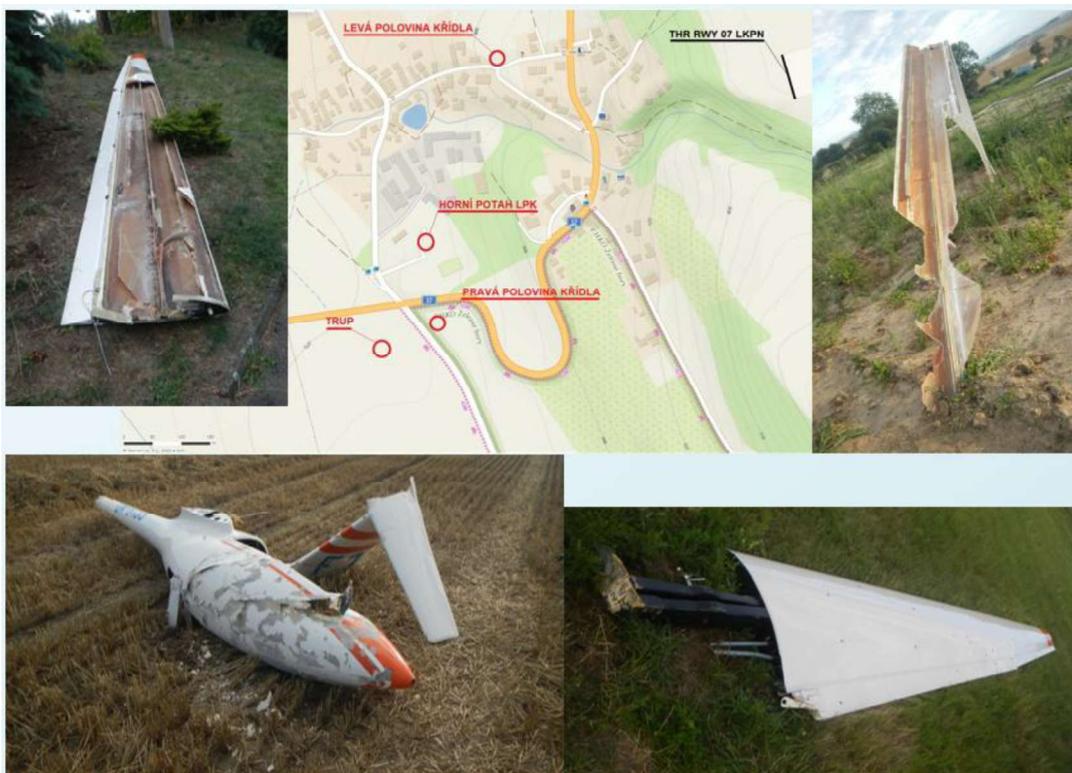
Fig. 9 – Position of the individual parts of the glider wreckage

The components that separated from the glider fuselage during the flight were found in various parts of the village Podhořany near Ronov. It was the right half of the horizontal tail unit, which was located about 20 m east of the glider fuselage. The right half of the wing was located in a meadow adjacent to cycle path No. 4179 at a distance of approximately 750 m south-west of LKPN RWY 07 threshold marks. The upper part of the left half of the wing skin was found approximately 580 m south-west of the LKPN RWY 07 threshold marks and was driven into the ground with the root end in the area of building plots in the southern part of the village. The left half of the wing was found on the lawn by the road near the garden of house No. 2 at a distance of approximately 470 m west of the LKPN RWY 07 threshold marks. The elevator was subsequently found in the former site of an agricultural cooperative on the south-eastern edge of the village.

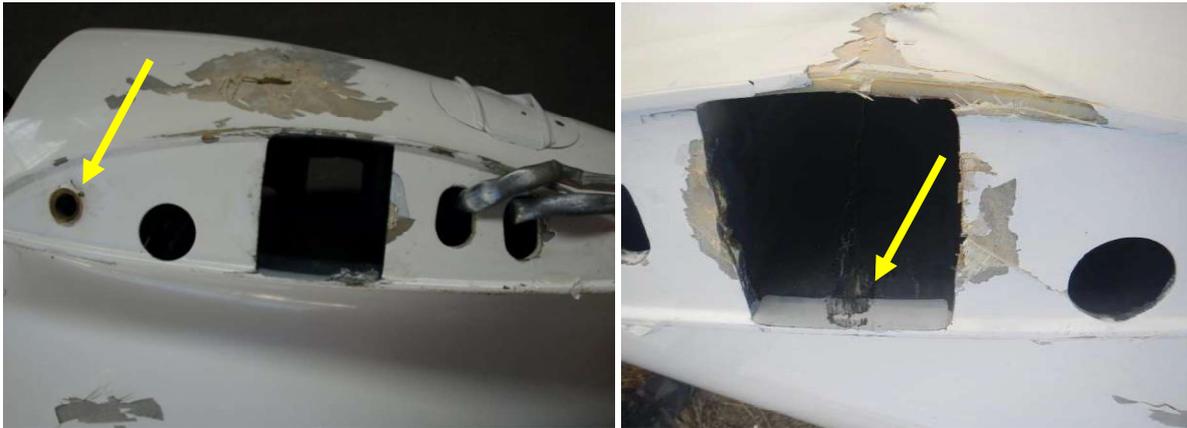
Fig. 10 – Left and right fuselage sections profiled to join the wing halves in the root rib plane

The glider fuselage was completely destroyed when it hit the ground at a steep angle. The right side of the fuselage was torn from the level of the foot controls up to the main landing gear. The lower fuselage was broken in several places. The rear part of the fuselage was cracked longitudinally for about 2 m. Further damage in the form of cracks was on the upper side of the fuselage in the plane where the spars (spar stubs) of both wing halves pass. On the right, there were bent rods for controlling the left aileron and the left aerodynamic brake. There was a noticeable deformation of the front pin bushing. An abrasion mark was visible on the bottom edge of the spar hole (Fig. 10).

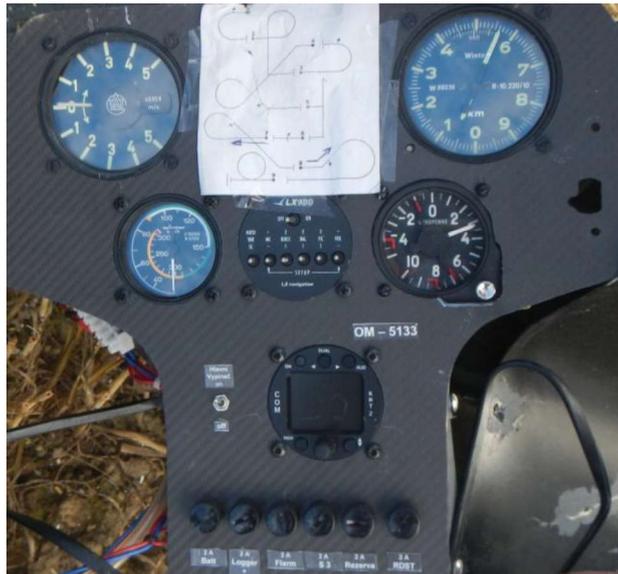
Fig. 11 – Glider instrument panel after ground impact

The instrument panel was cracked, but contained all the instruments, including the LUN 1722-8 accelerometer.

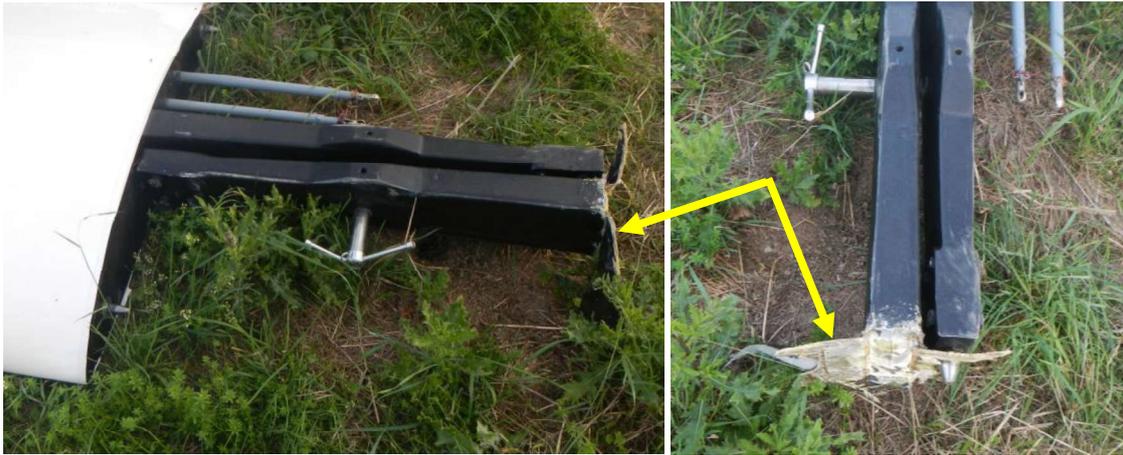
Fig. 12 – Remnants of the root rib on the spar of the left half of the wing.

The two wing halves were found at a relatively large distance from each other. The left half of the wing was damaged extensively. The upper and lower spar flanges were fractured at the root rib. There were remnants of the root rib of the left half of the wing on the spar stub of the left half of the wing (Fig. 12). The spar web was torn along the length from the root rib to a point about 40 cm from the end bow. The entire upper wing skin, except for the last 40 cm from the end bow, was separated from the left wing structure.

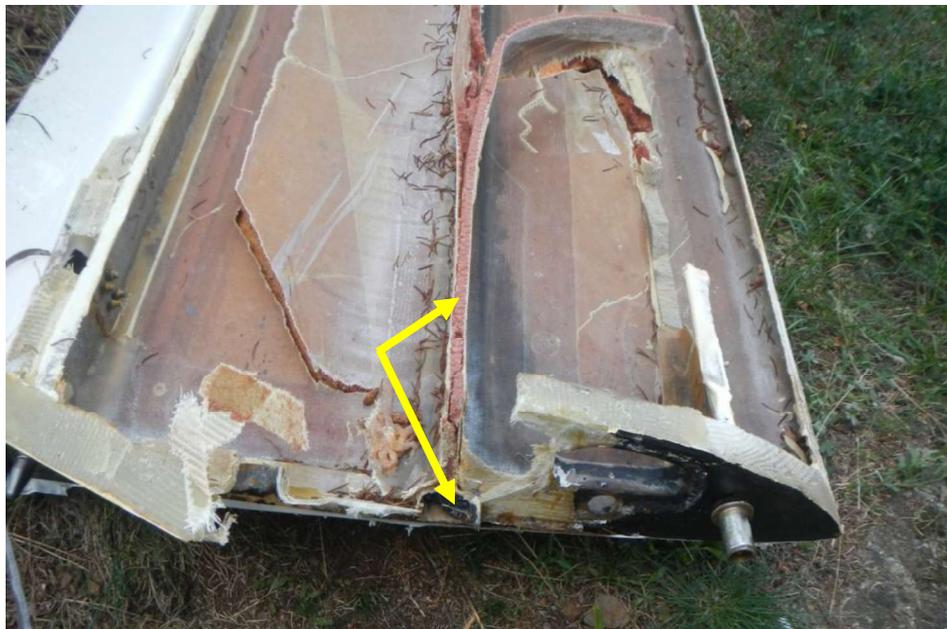
The right half of the wing was damaged to a small extent. On the lower skin of the right half of the wing, there was a crack about 60 cm long at a distance of 120 cm from the outer edge. The left corner of the flap was broken. The spar of the right half of the wing was connected by a pin to the broken spar stub of the left half of the wing (Fig. 13).

Fig. 13 – Left half of the wing with the remnants of the root rib. An arrow shows the broken lower flange and torn spar web under the upper flange of the spar are shown.

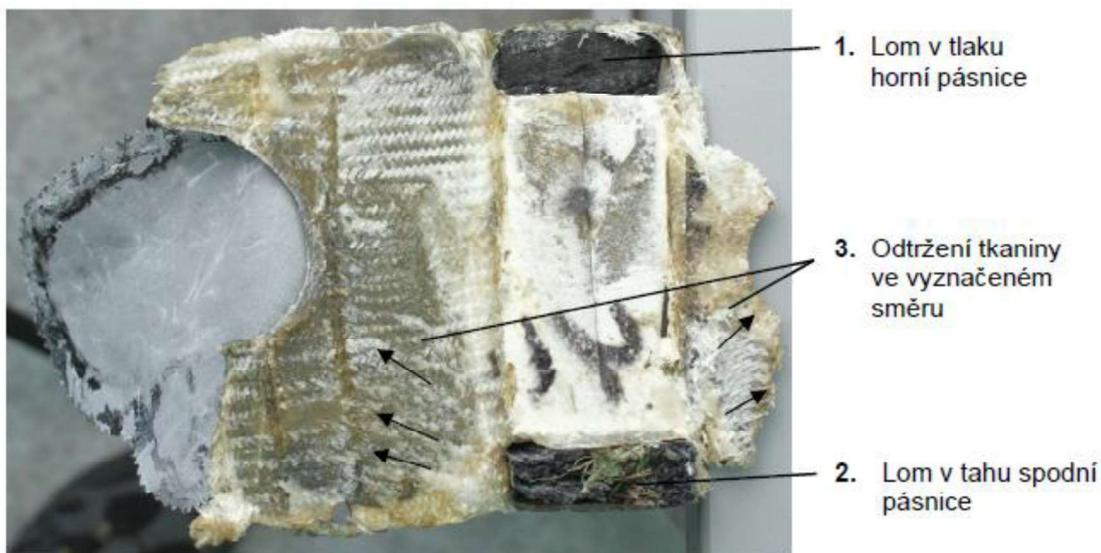
Fig. 14 – Probable sequence of failure of the left wing spar

The fractographic analysis of the fracture areas of the damaged wing spar of the glider was performed. The fatigue failure hypothesis was not confirmed because the flange fracture did

not show longitudinal separation of individual fibres. Nevertheless, the hypothesis of flange breakage or other damage in the vicinity of the fraction after the previous accident has not been refuted because the fracture contained remnants of the binder from the surface spar layers that may have been deposited there by abrasion from the previous accident. Porosity was observed on the fracture surface of the lower flange and unsaturated fabric on the delaminated layer. Significant porosity was also observed on the sections of the intact parts of both flanges. Porosity has a particular effect on the compressive load capacity of the composite. The observed porosity during the manufacture of the flange could be considered as a permissible defect that was considered when sizing the aircraft. According to the typical strength of the reinforcing fibres used and the macro- and microfractographic signs found, the probable sequence of failure was determined. The wing failure began with a compressive failure of the upper flange with almost immediate subsequent tension fault of the lower flange and subsequent tearing of the fabric overlay between the spar web and the root rib.

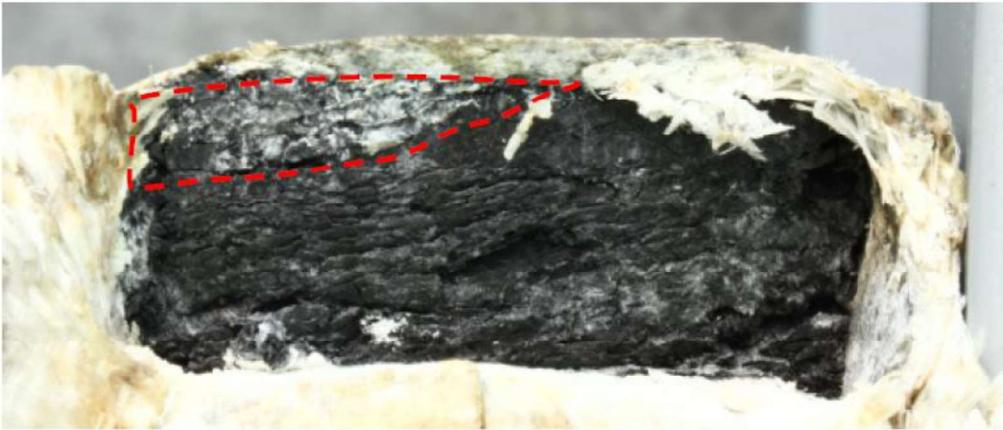
The fractographic analysis of the fracture areas of the failed spar confirmed the hypothesis of breakage or other damage in the vicinity of the fractured upper spar flange, probably during the 2015 accident (Fig. 16).

Fig. 16 – Marked failure area at the fracture point of the upper spar flange

The cause of the air accident was the destruction of the left wing spar during an aerobatic flight, caused by breakage of the upper spar flange. The failure of the flange was probably caused by the glider's accident in 2015 and was not identified during the subsequent repair of the glider.

Given the cause of the air accident, the Air Accident Investigation Institute recommends that the European Aviation Safety Agency consider conducting a study on the possible use of a more sophisticated methodology for the detection of failures in composite structures to replace the tapping test method used to date.

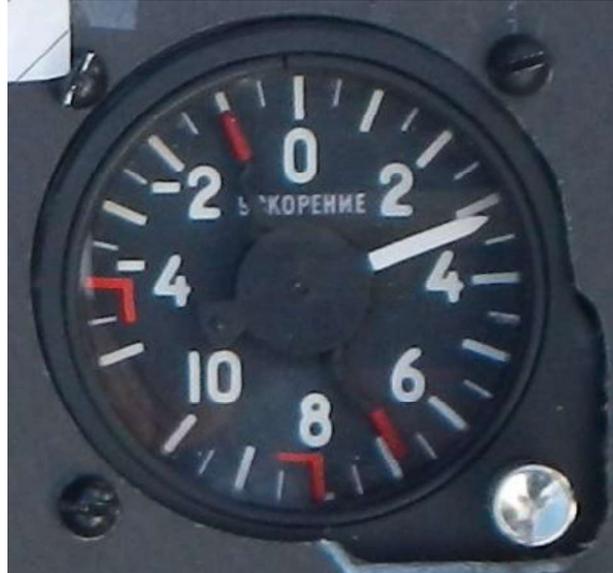
Fig. 17 – Accelerometer values after the glider hit the ground

The glider was not equipped with any recording device from which the flight parameters could be determined and the pilot described the flight as standard. The LUN 1722-8 accelerometer (Fig. 17) recorded the values of -1.0 g and +6.9 g. These values were probably significantly affected by the inertial forces when the fuselage hit the ground and

therefore cannot be taken as decisive. The limit values of -4 g and +8 g were probably set by the instrument manufacturer and did not meet the requirements of the PIK-20D Specific Airworthiness Specification document, page 6 of 10, issued by EASA on 27 August 2021.

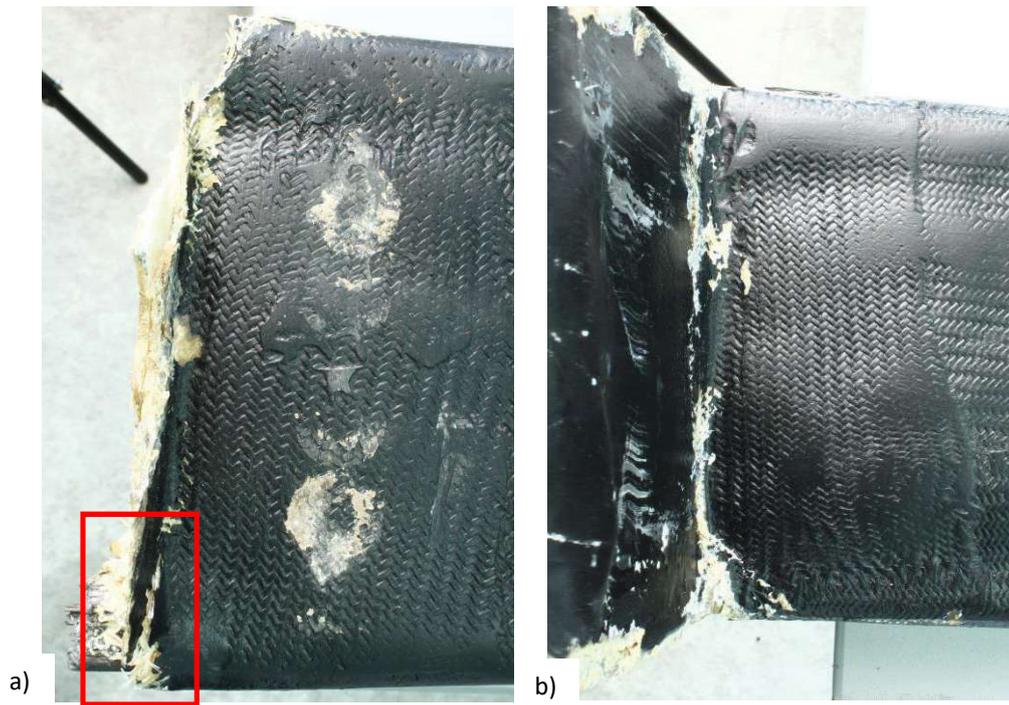
The overview images of the entire fracture surfaces are shown in Fig. 5.1 to Fig. 5.4. Fig. 5.3a shows the back side of the spar, where the tearing of the fabric occurred when the lower flange was fractured.

Fig. 5.3 – Overview image of a) the rear side of the spar, showing the tear in the fabric caused by the fracture of the lower flange, and b) the front side of the spar. The upper flange is always pictured on top.

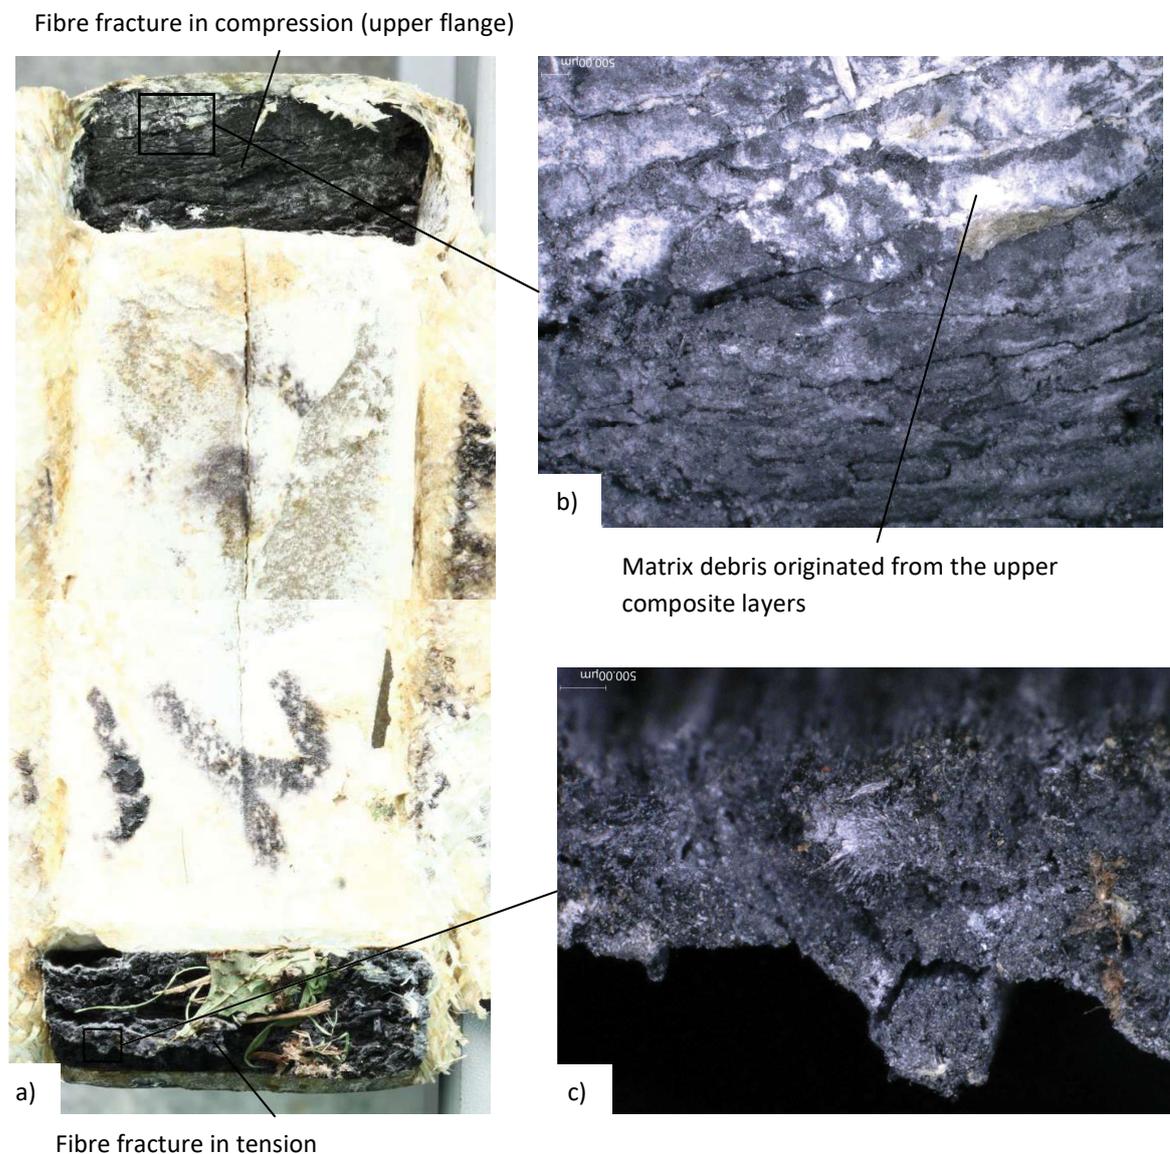
The detailed micrographs in Fig. 5.5 show the typical smooth fracture surface caused by the failure of the fibres in compression when the upper flange was subjected to compressive loading. Matrix debris on the fracture surface in compression may indicate fracture in a previous accident, after which the debris from the surface fabric crumbled into the compression fracture surface during service. In contrast, the lower flange shows the typical pull-out fibres caused by tensile stress. The pulled fibre tows do not show the splitting of individual fibres otherwise typical of fatigue failure. It can be deduced that the upper flange was fractured first because typically the compressive strength of the composite is less in compression than in tension.

Fig. 5.5 – Overview image with detailed micrographs of carbon fibre fracture, b) detail of the fracture surface of the upper flange fractured in compression with matrix debris from the surface layers, c) detail of the fracture surface of the lower flange fractured in tension.

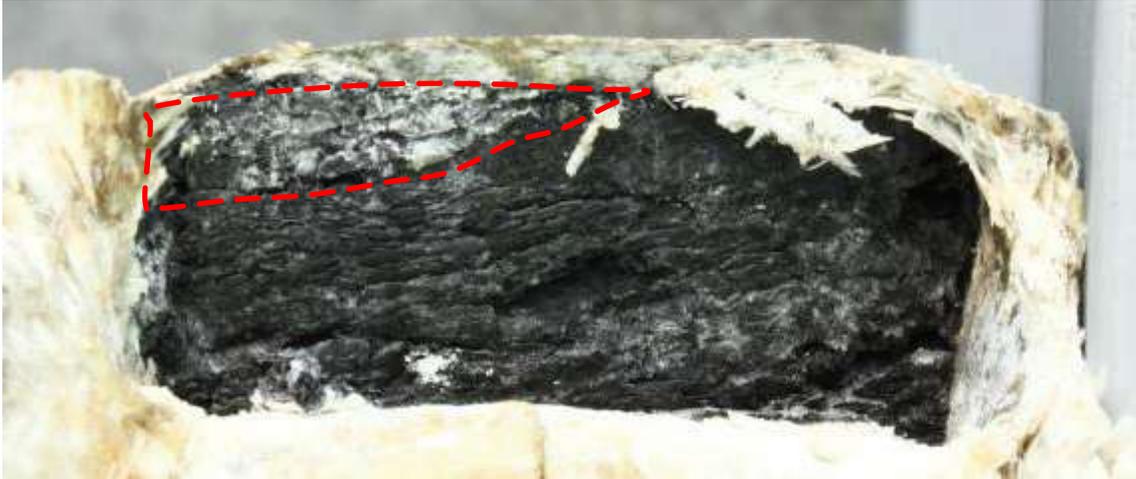
The detail of the fracture of the upper flange in Fig. 5.6 shows a marked area of matrix debris. Therefore it is suspected to had been fractured in a previous accident.

Fig. 5.6 – Detail of the fractured upper flange with the area suspected to have been fractured in the previous accident. The area contains debris of the matrix from the glass fabric surface layer.

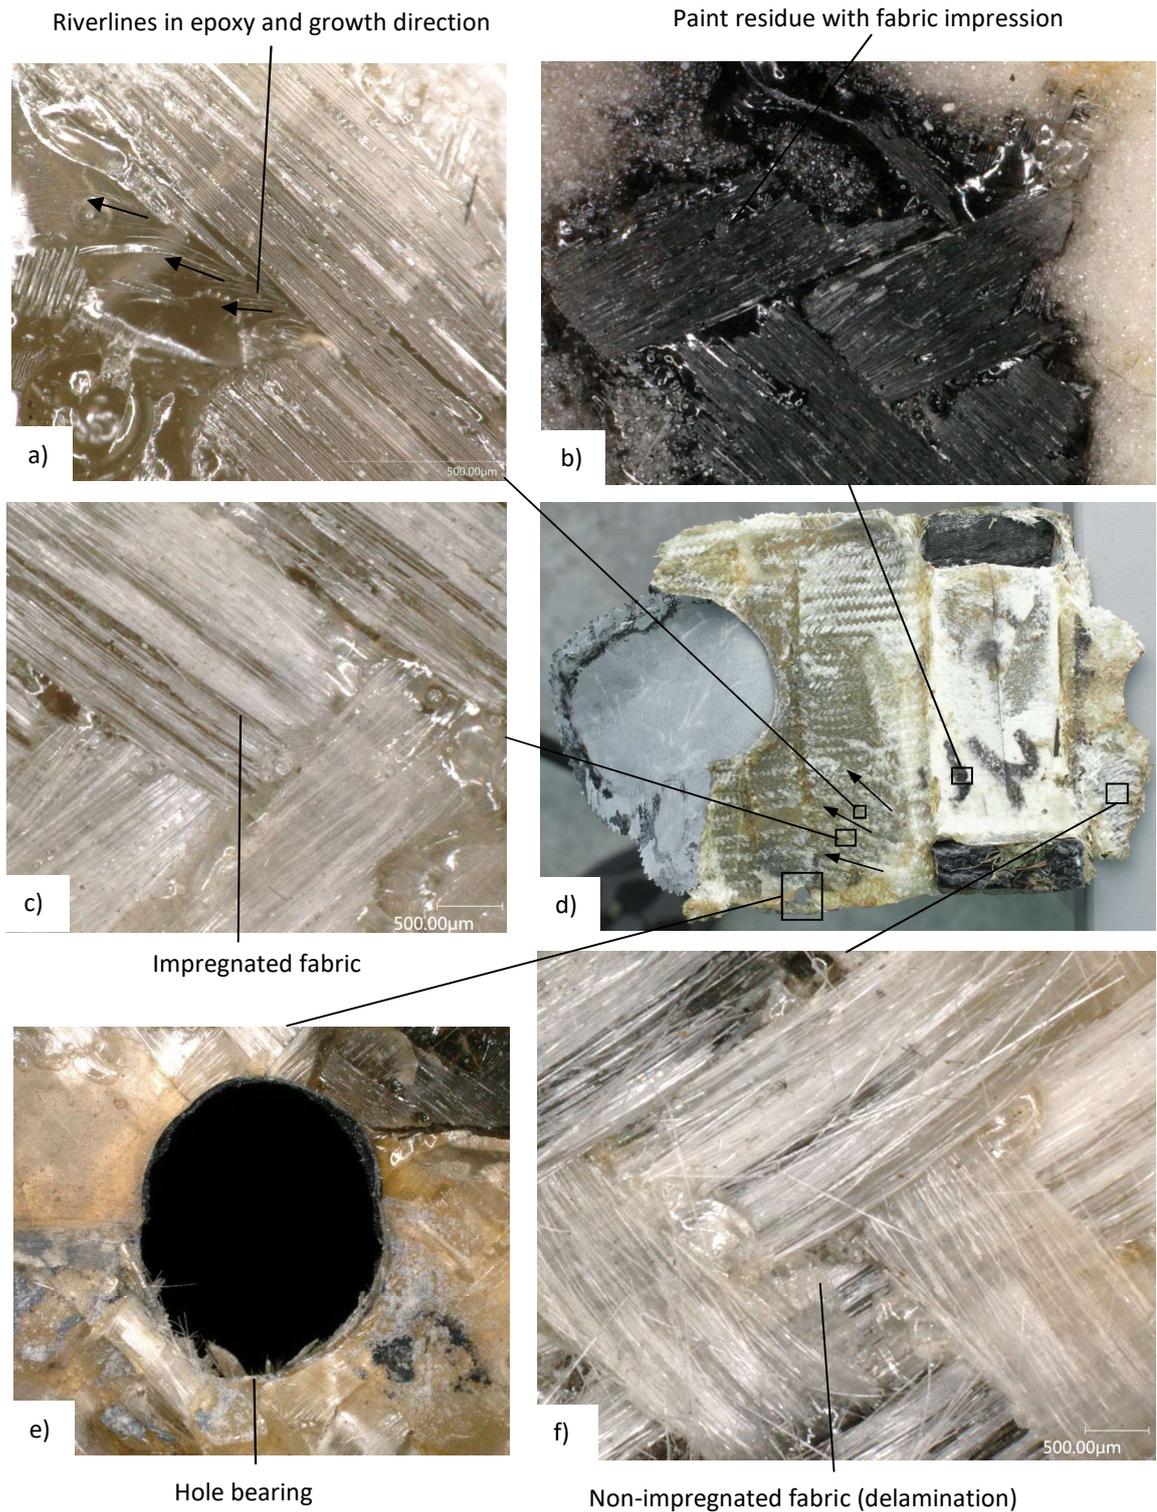
From the detailed micrographs of the fracture surfaces in Fig. 5.7, the following theory of a failure sequence can be confirmed: the glass fabric was torn away after the bottom flange was torn away in tension. This is supported by the river lines in the epoxy that show a local direction of crack propagation from the lower flange, while the overview macrograph shows a radial structure pointing in the same direction. Furthermore, the indentation of the hole at the bottom edge also indicates tearing of the fabric in the direction away from the lower flange. In addition, there was a non-impregnated fabric on the surface of the delaminated composite and black paint residue with fabric impression.

Fig. 5.7 – Marked detailed micrographs of the fracture surface: a) Riverlines in epoxy showing the local direction of crack propagation, b) black paint residue with fabric impression, c) impregnated fibres, d) overview image of the fracture surface with marked radial structure indicating the probable direction of propagation, e) hole bearing at the lower edge indicating fabric tear in the direction from the lower flange, f) non impregnated fabric.

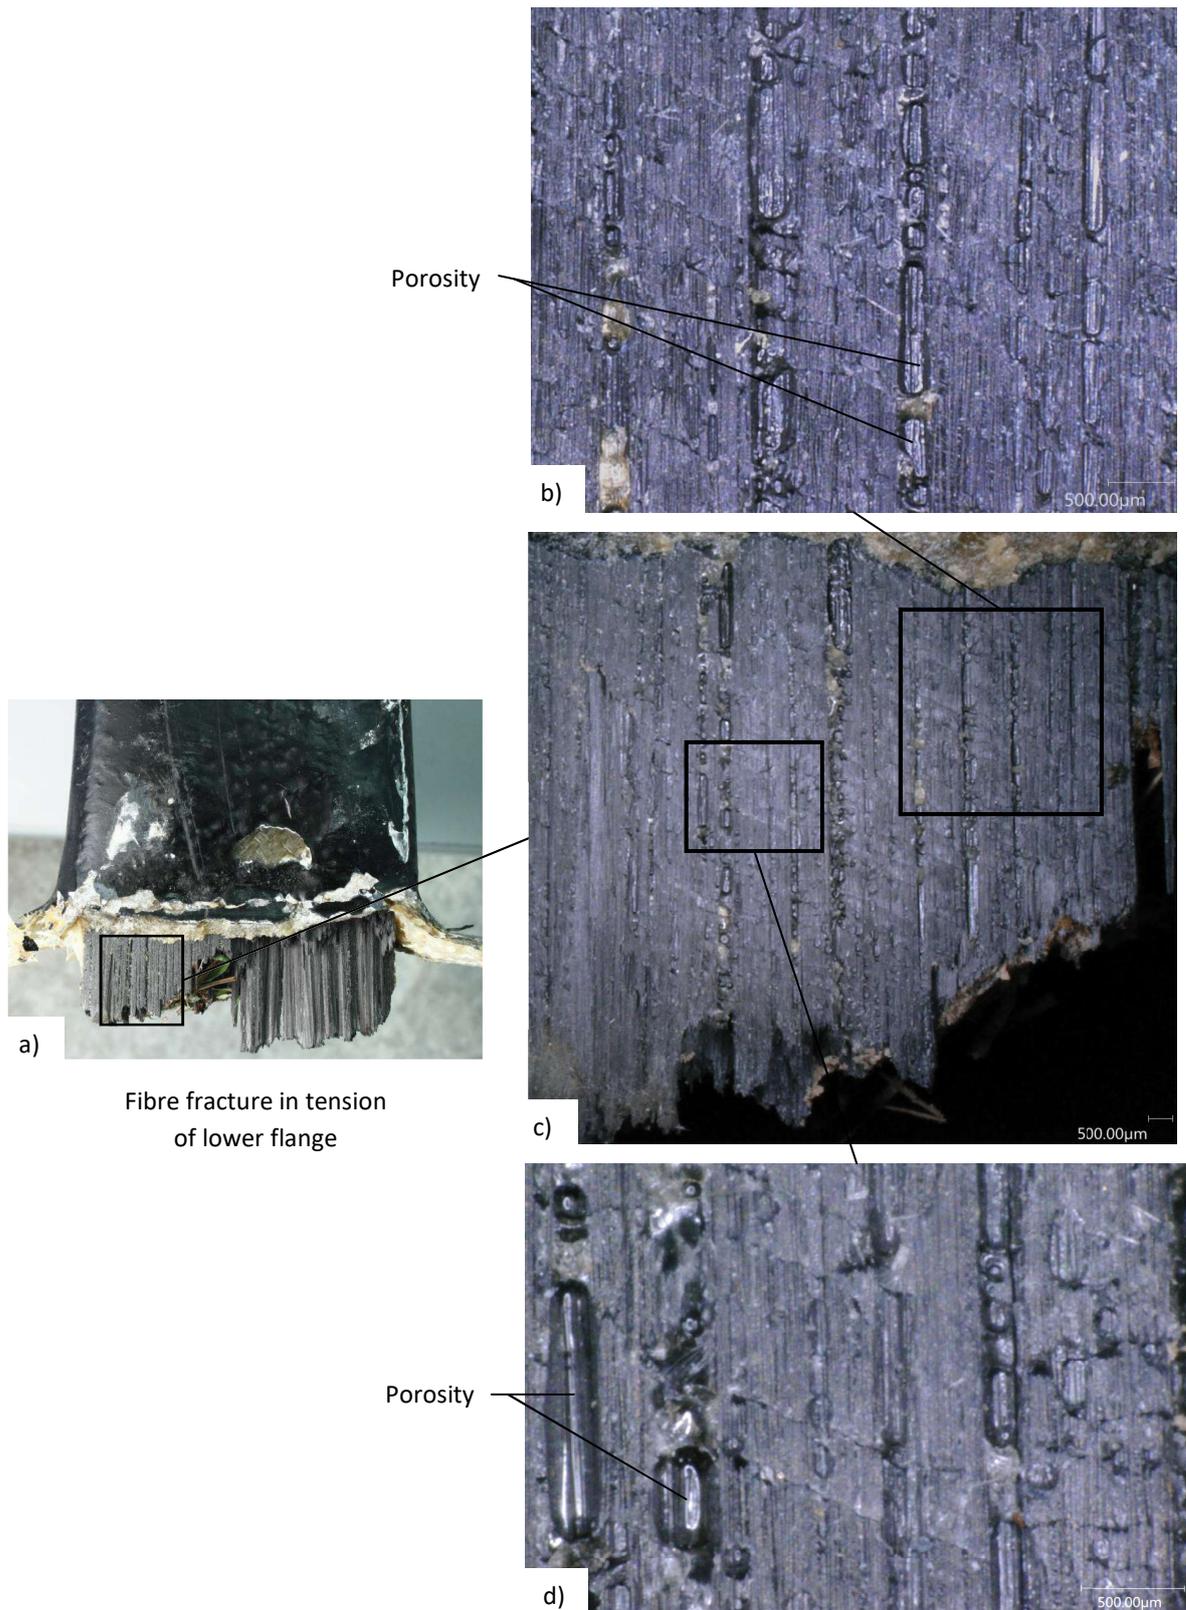
Porosity was evident in the close-up images of the pulled fibre tows of the lower flange. This was observed on both the outer surface at the original interface with the outer fabric (Fig. 5.8) and also on the inner fibre bundles (Fig. 5.9).

Fig. 5.8 – Overview and details of the outer surface of the fractured lower band with observed porosity.

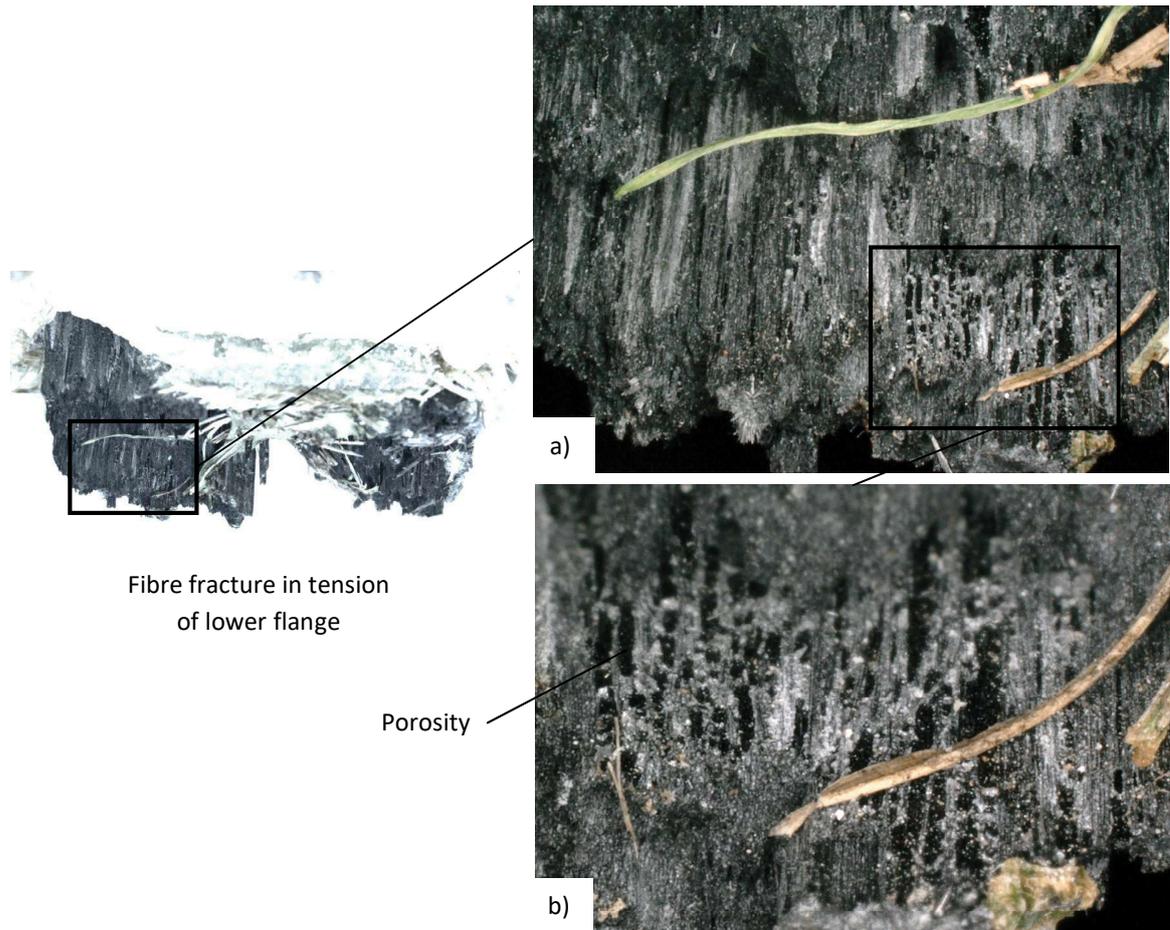
Fig. 5.9 – Overview and details of the internal fracture surface of the lower flange with observed porosity.

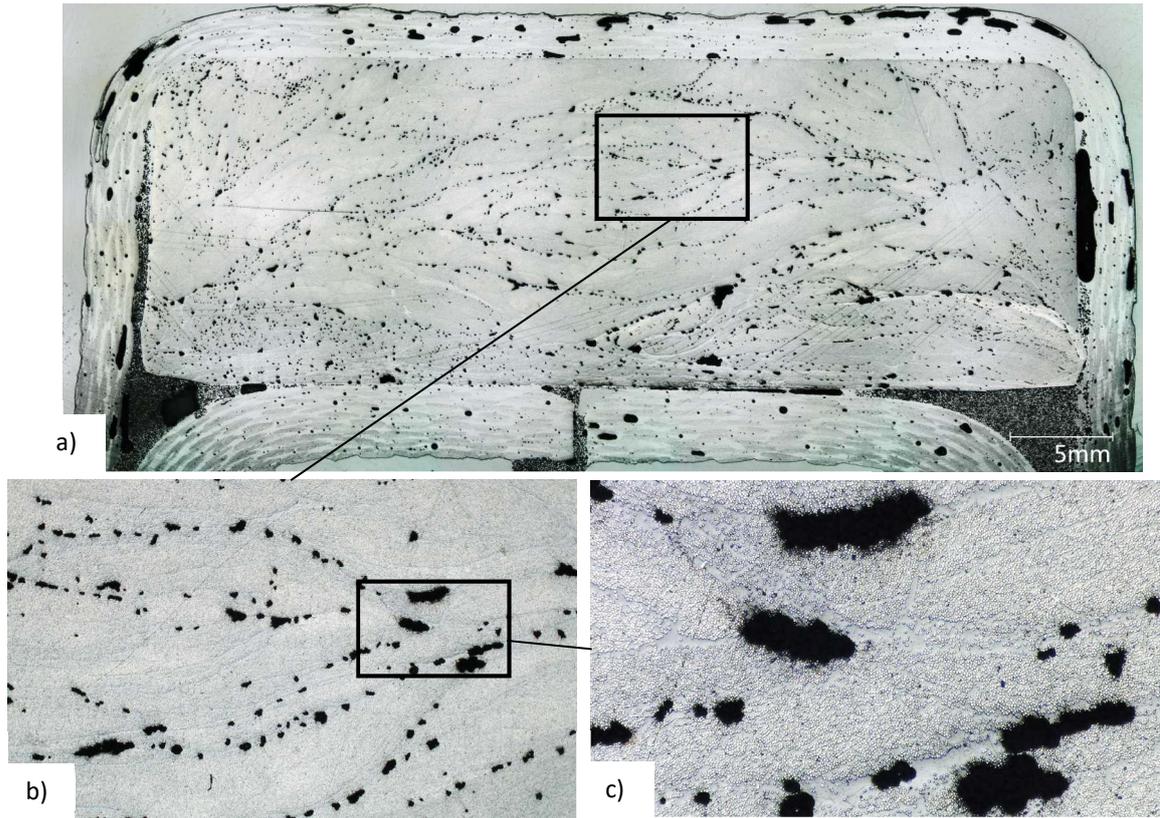
Based on the observed porosity in the flange, metallographic analysis of both flanges was carried out at a section approximately 10 cm behind the fracture (Fig. 5.10). In Figs. 5.11 and 5.12, significant porosity is visible on both flanges, particularly at the interface of randomly placed fibre tows. The pore size was 100 to 500 μm . Large pores were also observed at the interface of the inner carbon fibres and the surface fabric, which supported the observed delamination of the fabric at the fracture.

Fig. 5.11 – Section of the upper flange at H2 with significant porosity (black spots) observed: a) Overview image, b) detail at 50x magnification and c) detail at 200x magnification.

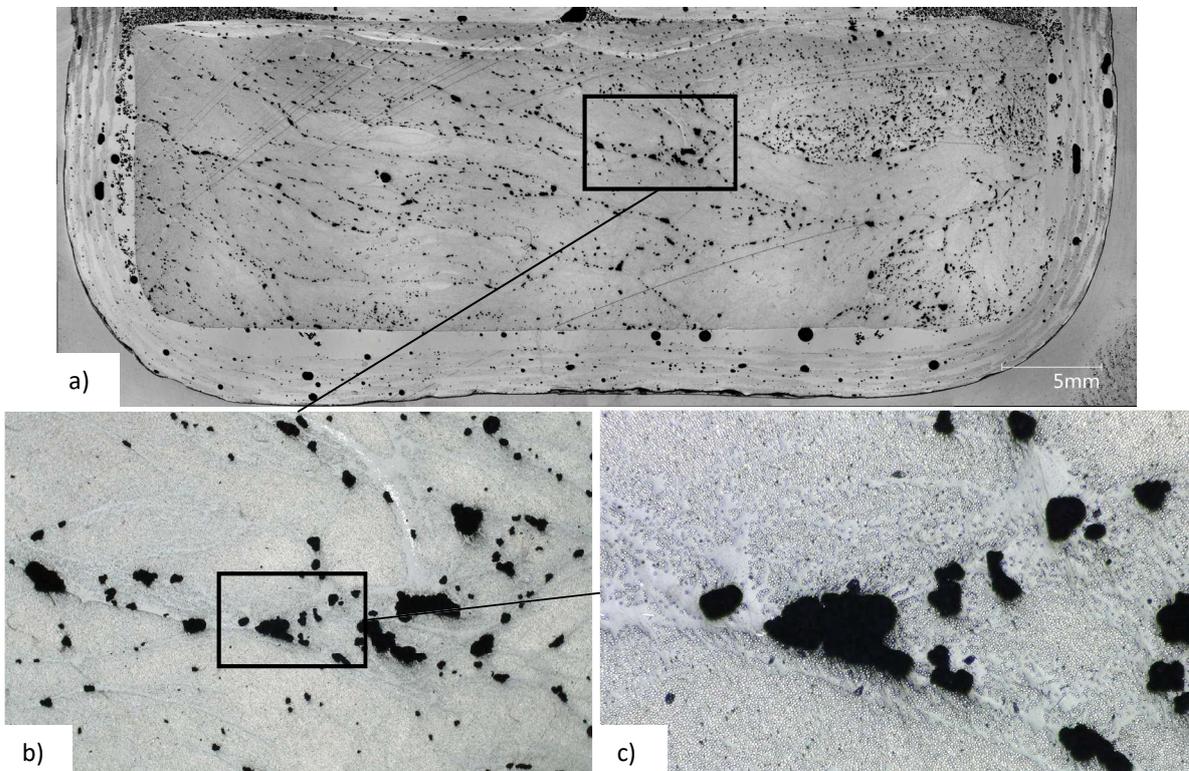
Fig. 5.12 – Section of the lower flange at S2 with significant porosity (black spots) observed: a) Overview image, b) detail at 50x magnification and c) detail at 200x magnification.

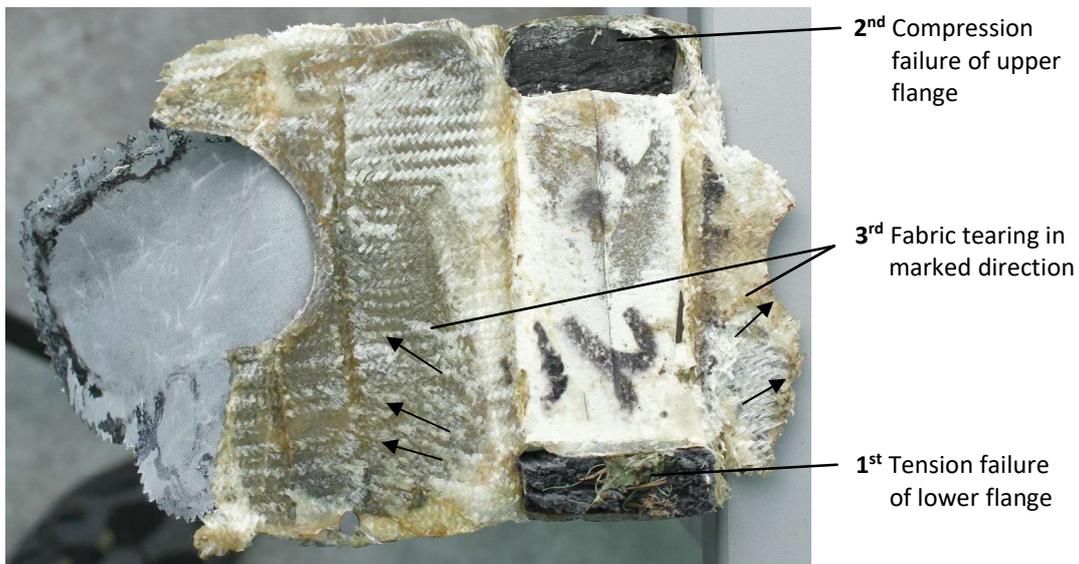
Fig. 6.1 – Probable sequence of the spar failure

According to the typical strength of the reinforcing fibres used and the macro and micro fractographic features found, a probable failure sequence was determined. The wing failure began with a compressive failure of the upper flange with almost immediate tensile fracture of the lower flange followed by tearing of the fabric overlap between the spar flange and the butt rib (Fig. 6.1).
