AIR ACCIDENTS INVESTIGATION
INSTITUTE
Beranových 130
199 00 Praha 9 - Letňany

CZ-24-1093

FINAL REPORT

**on the investigation of the causes of
the accident to Cessna P210N registration OM-DKA,
at Bartošovice, 4,7 km SW THR RWY 04 LKMT
on 9. 8. 2024**

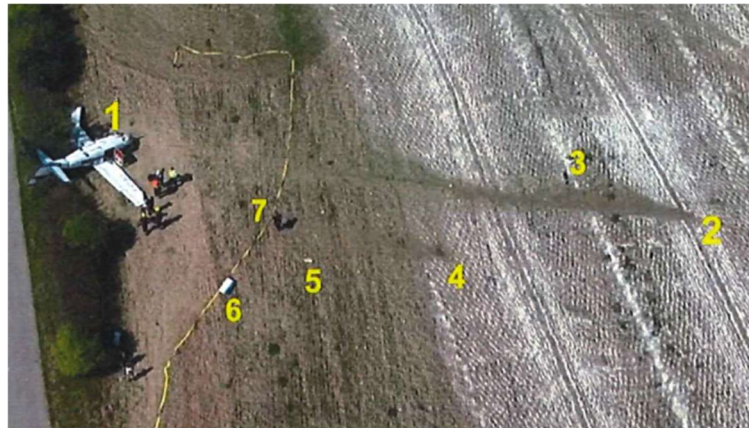
The track of the first ground impact and the beginning of the gouge (2) in Fig. 5 was approximately 45 m from the final position of the nose of the aircraft. The gouge corresponded to the impact of the lower part of the nose of the aircraft at a very slight angle in the landing direction of about 175°. The coordinates of the inverted aircraft were 49°40' 13.8" N and 18°01' 50.1" E, while the altitude was 255 m.

At a distance of about 10.5 m from the beginning of the gouge, a detached part of the exhaust (3) was located on the right, at a distance of 19 m and 5.5 m on the left, there was an impact mark of the edge of the left wing half (4), and a part of a heavily deformed engine piston was found in the gouge, at a distance of 29.5 m and 7.5 m to the left, a fragment of the rib of the left wing tip was found (5) and at a distance of 35.7 m and 10 m to the left, a fragment of the left wingtip arc was found (6).

Fig. 5 – Wreckage of the aircraft at the site of the accident (image from the Czech Police drone)

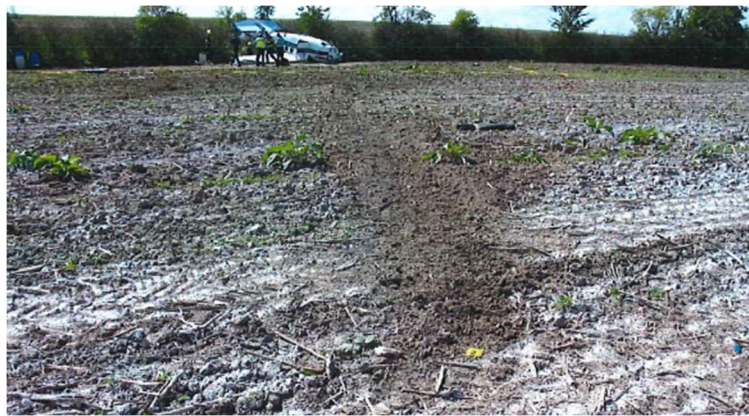
Fig. 6 – View of the accident site and the gouge in the landing direction (source: PCR)

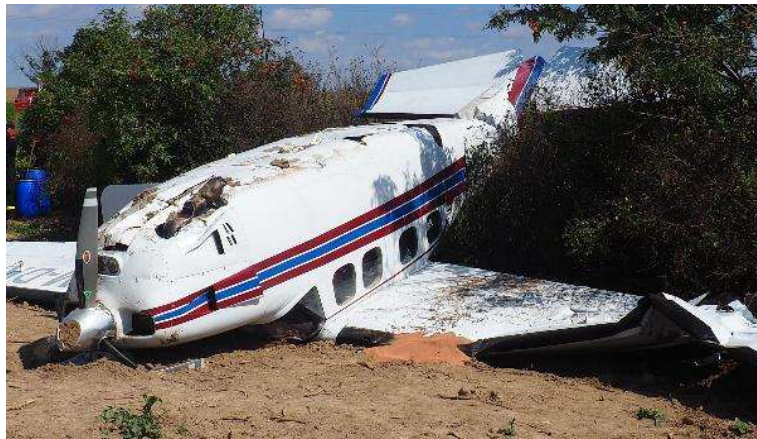
The aircraft was destroyed by the forces of impact to the ground and inversion. The fuselage was broken in the rear part, about 0.5 m before the leading edge of the stabiliser, with a partially torn covering. The landing gear was in the retracted position. The starboard cockpit door was open, the lower part of the nose had a deformed cover and the nose gear shaft door. The three-bladed propeller had one blade bent backwards by about 90° in the middle, the other two blades were bent backwards by about 15°. The propeller cone was deformed. The left engine cover was partially open. The crashed aircraft is shown in Fig. 7.

Fig. 7 – Condition of Cessna P210N after emergency landing and inversion

- The destruction of the aircraft was caused by the aircraft inversion with the right wing half and keel surface striking the ground.

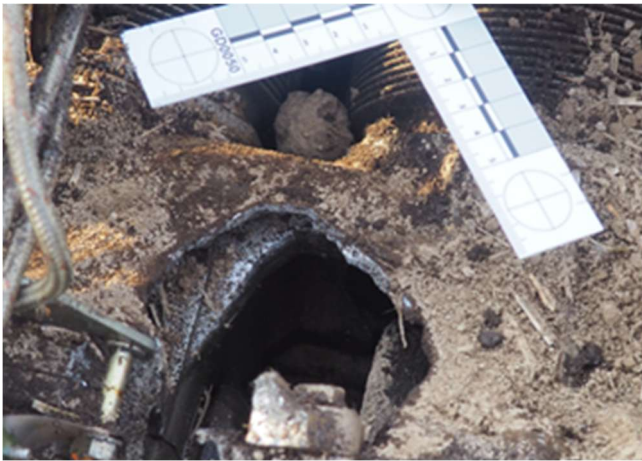
Both magnetos on the Continental-TSIO-520-P5B engine were torn off. The engine nacelle was heavily polluted with dark brown liquid and soil. An irregular oval hole (approx. 80–150 mm) was found pierced on the upper side of the nacelle body in the area of cylinder 2, see Fig. 8. The oil filler hole was closed, the dipstick was inserted. No other significant visual damage to the engine body, cylinder heads, aggregates, fuel and ignition systems was found.

Fig. 8 – Punctured hole in the upper side of the engine

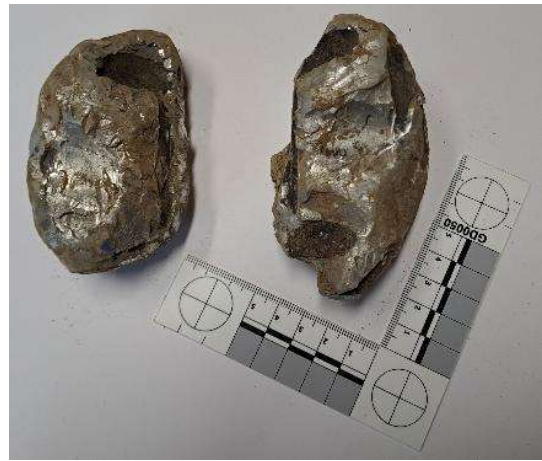
A part of a severely deformed piston was detected under the engine in the engine compartment. A sample of oil was taken through a hole made in the engine nacelle, which was found at the bottom of the nacelle and oil pan after the fuselage was turned to its normal position.

Fig. 9 – Deformed piston parts from the engine

At some point, the piston in cylinder 2 broke and the piston fragments separated from the engine. Several fractures on the underside around the perimeter of the cylinder 1 piston, additional contact marks, and metal fragments in the engine bay indicated that the failure had a progressive effect on the engine failure. Due to the large extent of deformation of the piston halves, it was not possible to describe the damage process and determine that the breakage was due to the stem breakage and separation of the exhaust valve head.

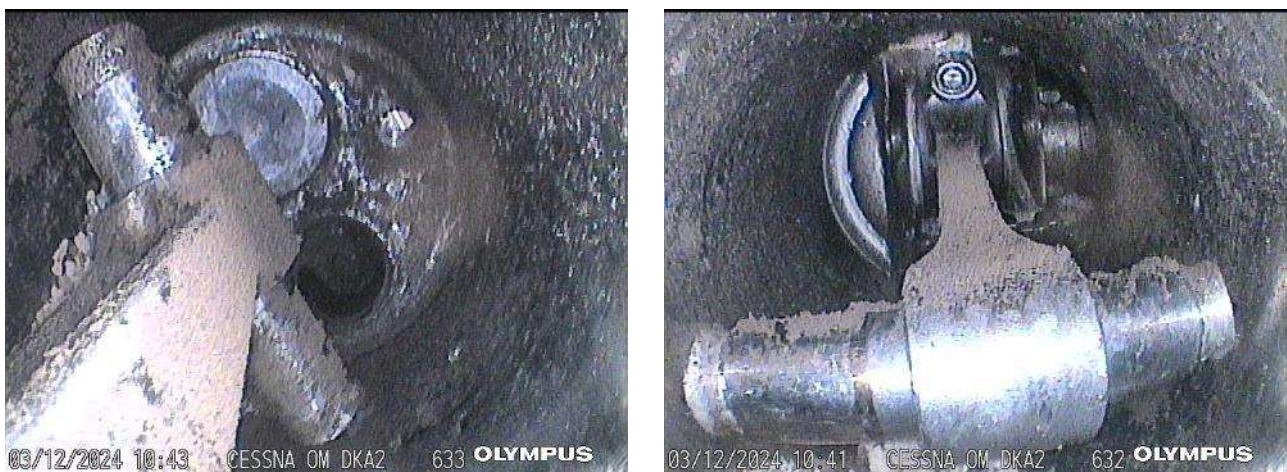
Cylinder 2 – The piston was completely missing, only the pin and connecting rod remained. The exhaust valve was missing from the cylinder head, the stem of which remained in the guide sleeve, see Fig. 10. The valve stem was removed for subsequent examination of the fracture surface.

Fig. 10 – Missing exhaust valve head and piston in cylinder 2

The cause of the air accident was engine failure due to fatigue fracture of the exhaust valve stem in cylinder 2 and piston breakage.

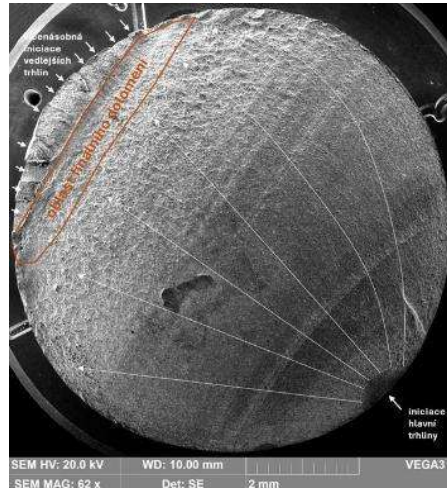
microscope. It has shown that the fracture surface of the delivered part exhibits fatigue failure, see Fig. 11. The fracture surface was nearly perpendicular to the longitudinal axis of the shank without significant shear edges or shank diameter contraction, i.e. the failure occurred without significant plastic deformation that would indicate large deformation stresses on the part in any mode. This was confirmed by the presence of a relatively large number of closed secondary surface micro cracks near the initiation areas of the main or secondary cracks on the valve stem surface.

Fig. 11 – Surveillance image of the fracture surface of the broken shank with marked areas of initiation of fatigue failure and directions of propagation of individual cracks

The fractographic analysis of the fractured exhaust valve stem confirmed the fatigue nature of the failure. The failure occurred without significant plastic deformation which would indicate large deformation stresses on the part in any mode.

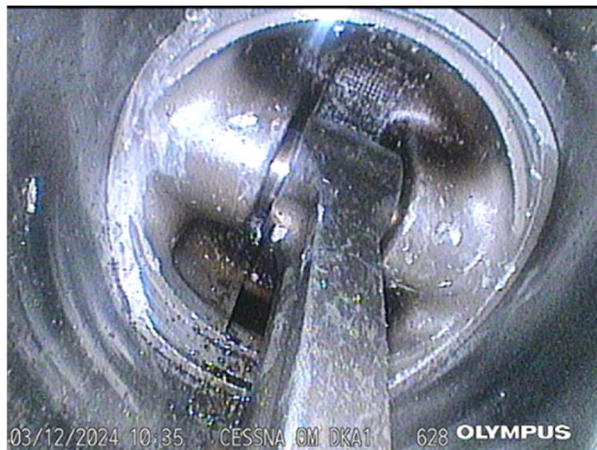
Cylinder 1 – The piston was damaged by fractures in several places on the underside around the circumference. There was no significant visual damage.

Condition of connecting rod and piston underside in cylinder #1

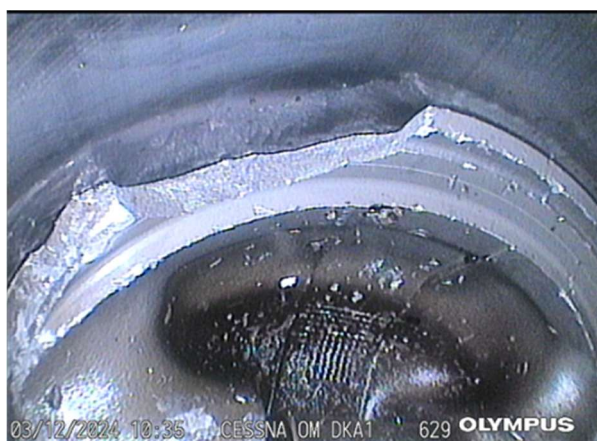
Detail of condition of connecting rod and fracture on bottom of piston in cylinder #1

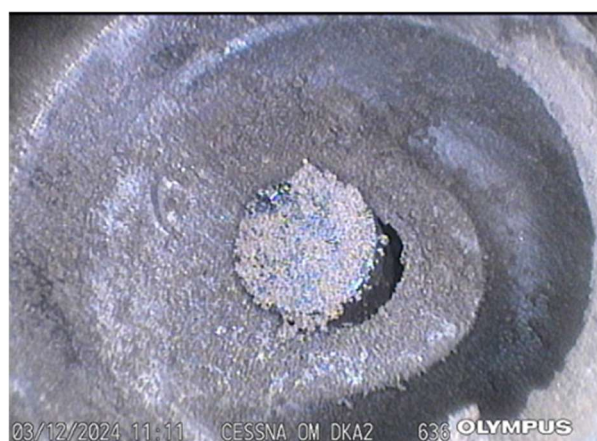
Detailed view of condition of exhaust valve bore in cylinder #2

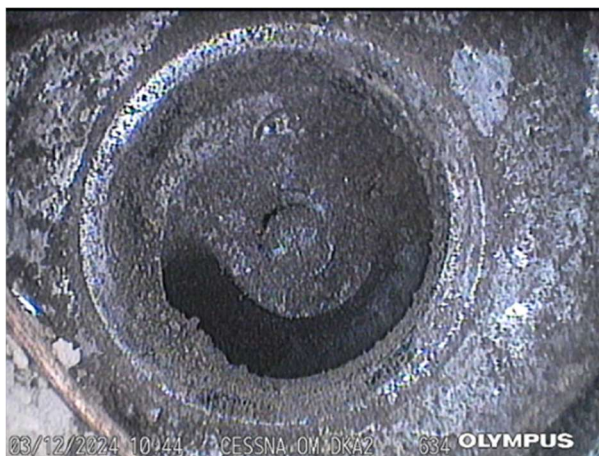
Detailed view of condition of exhaust valve opening in cylinder #2

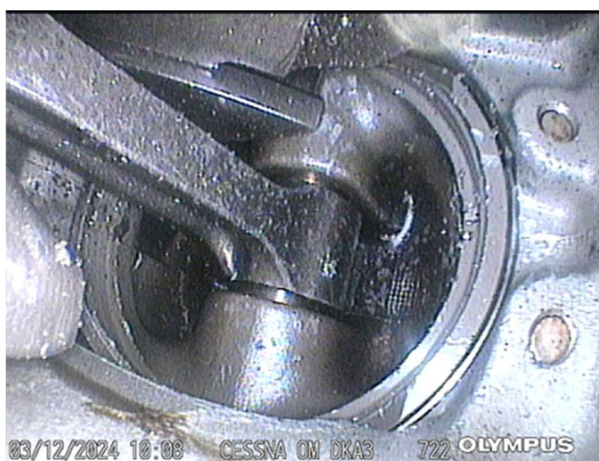
Detailed view of condition of connecting rod and piston in cylinder #3

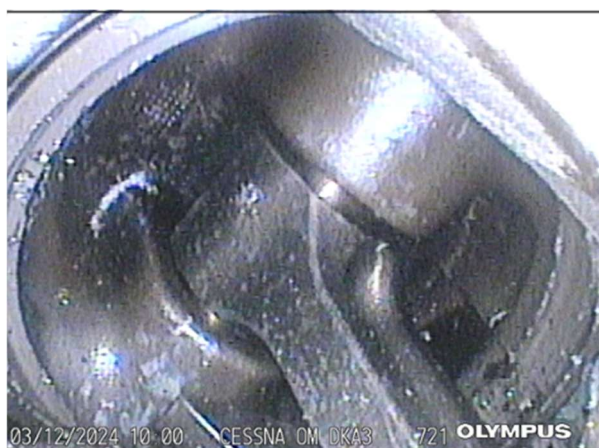
Detailed view of condition of connecting rod and piston at piston pin location in cylinder #3

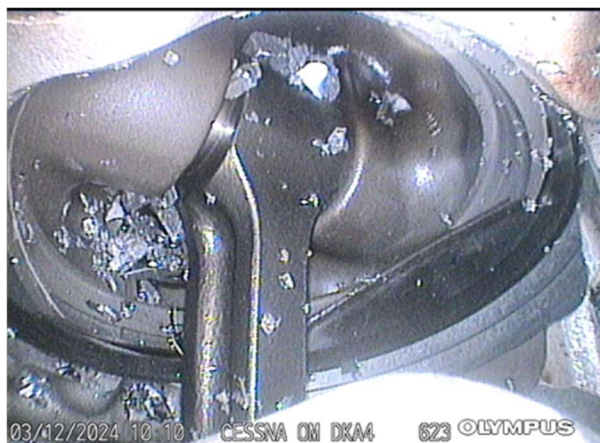
Small pieces of metal particles were found in cylinders 3–6, in the internal spaces under the pistons and in the crankshaft area, while the connecting rods and pistons did not show significant damage.

Detailed view of condition of connecting rod, piston at piston pin location and metal fragments in cylinder #4

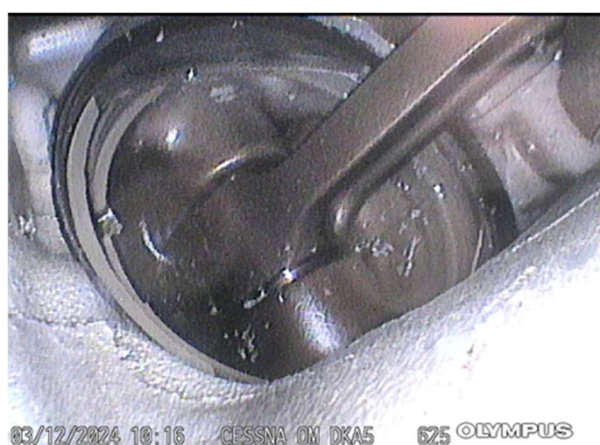
View of condition of connecting rod and piston at piston pin location in cylinder #5

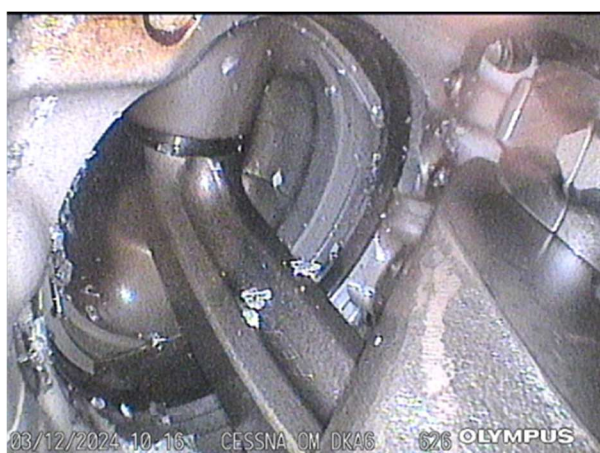
View of condition of connecting rod and piston at piston pin location in cylinder #6
