CZ-15-354

FINAL REPORT

Investigation of Causes of a Parachute Jump Accident at the Příbram Airport on 15 July 2015.

Prague
October 2015

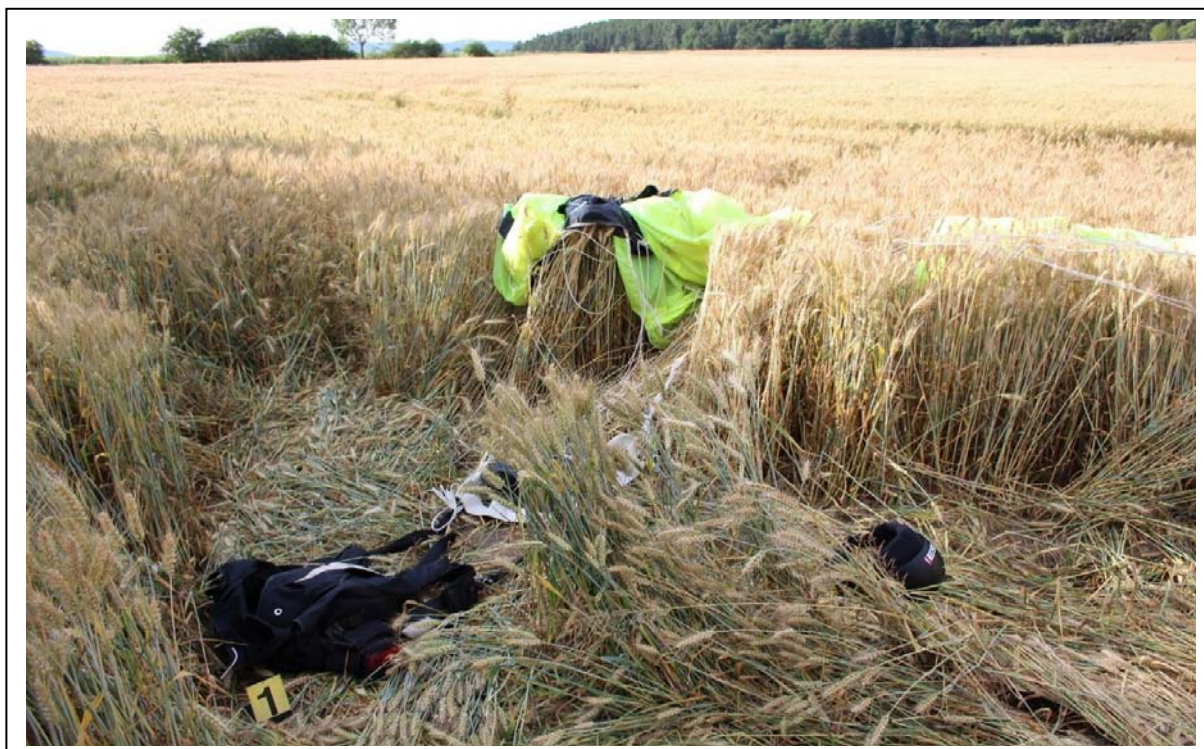
Fig. 1: Place of parachutist's fall

The parachutist fell on the field with wheat 70 cm high. The place of fall was located approx. 322 m north-westwards from the LKPM reference point.

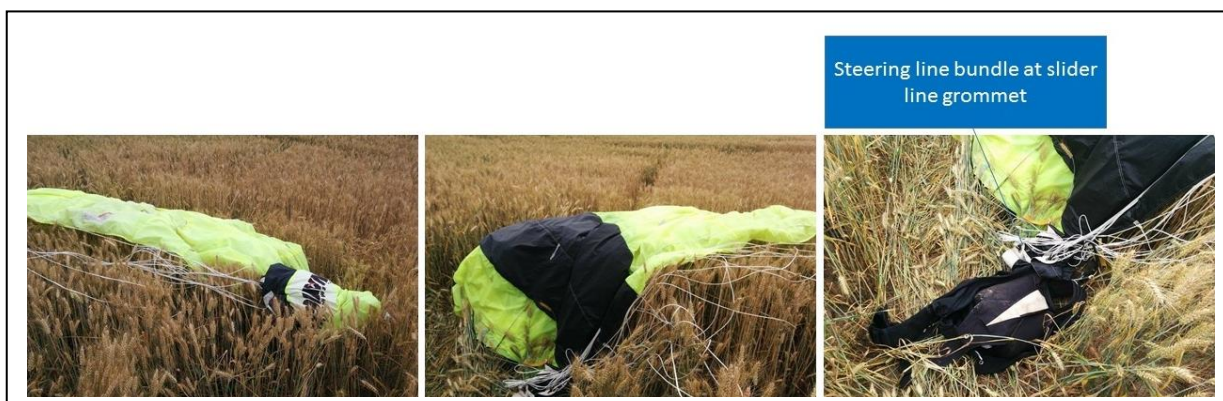
Fig. 2 The parachute set at the time of providing the lay first aid

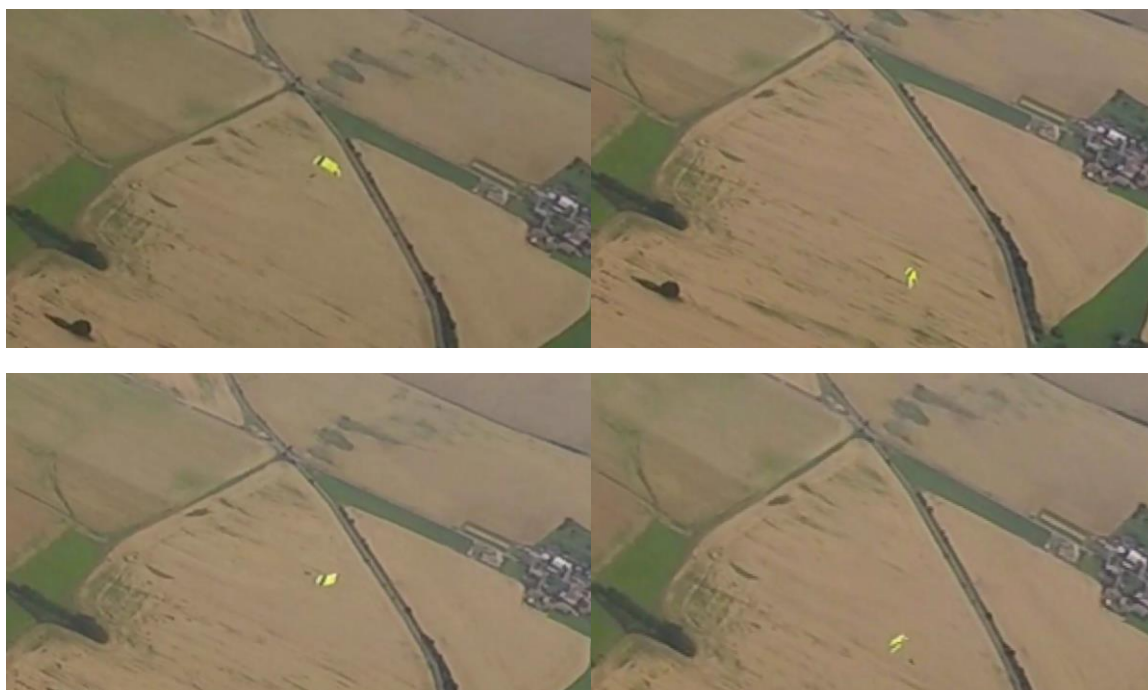
Fig. 3 Sequenced recording of one rotation in the spiral

The parachutist did not negotiate the situation by an immediate cut-away of the main parachute, but was probably attempting to compensate the rotation with the steering toggles. According to the data of the activation device and also the witness testimony the rotation started at the moment of opening of the main parachute and the

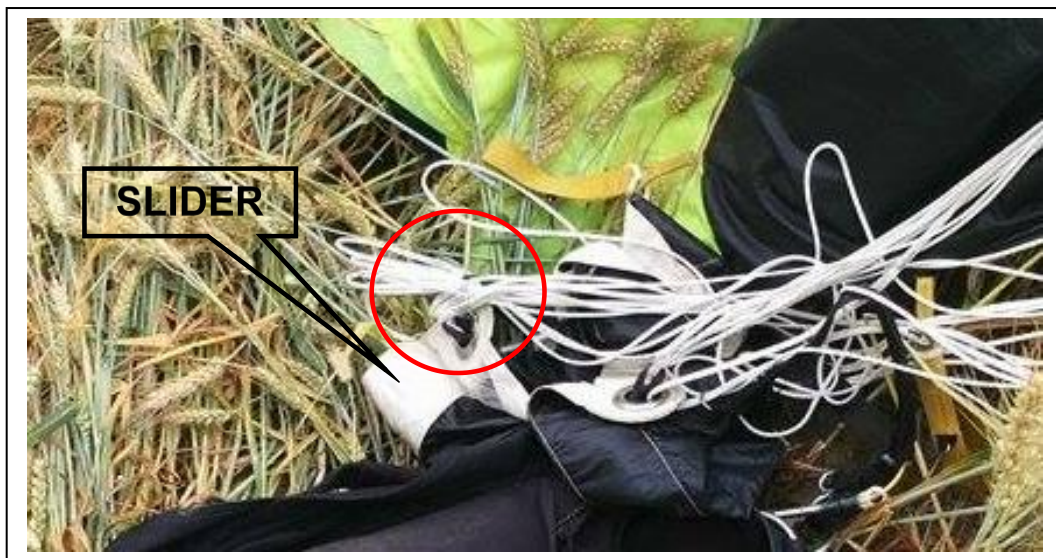
In the photograph made by the DZM during the time of providing the lay first aid there is a marked knot in the main parachute lines in the area of the back right slider eye (see Fig. 4). After consulting the expert, the commission has come to the conclusion that the main parachute rotation might have been caused by a self-induced spontaneous creation of the loop in the carrying lines that might have occurred during the loosening of the lines from the elastic bands. This knot was created by tightening a loop emerged on one side of the steering lines during contact with the slider eye. Thus caused asymmetry in the length of the lines resulted in an uncontrolled parachute rotation and its descent in a spiral.

Fig. 4 The knot in the main parachute lines
