CZ-14-181

FINAL REPORT

**Investigation into the serious incident
Separation minima infringement
at TMA Praha
on May 13, 2014**

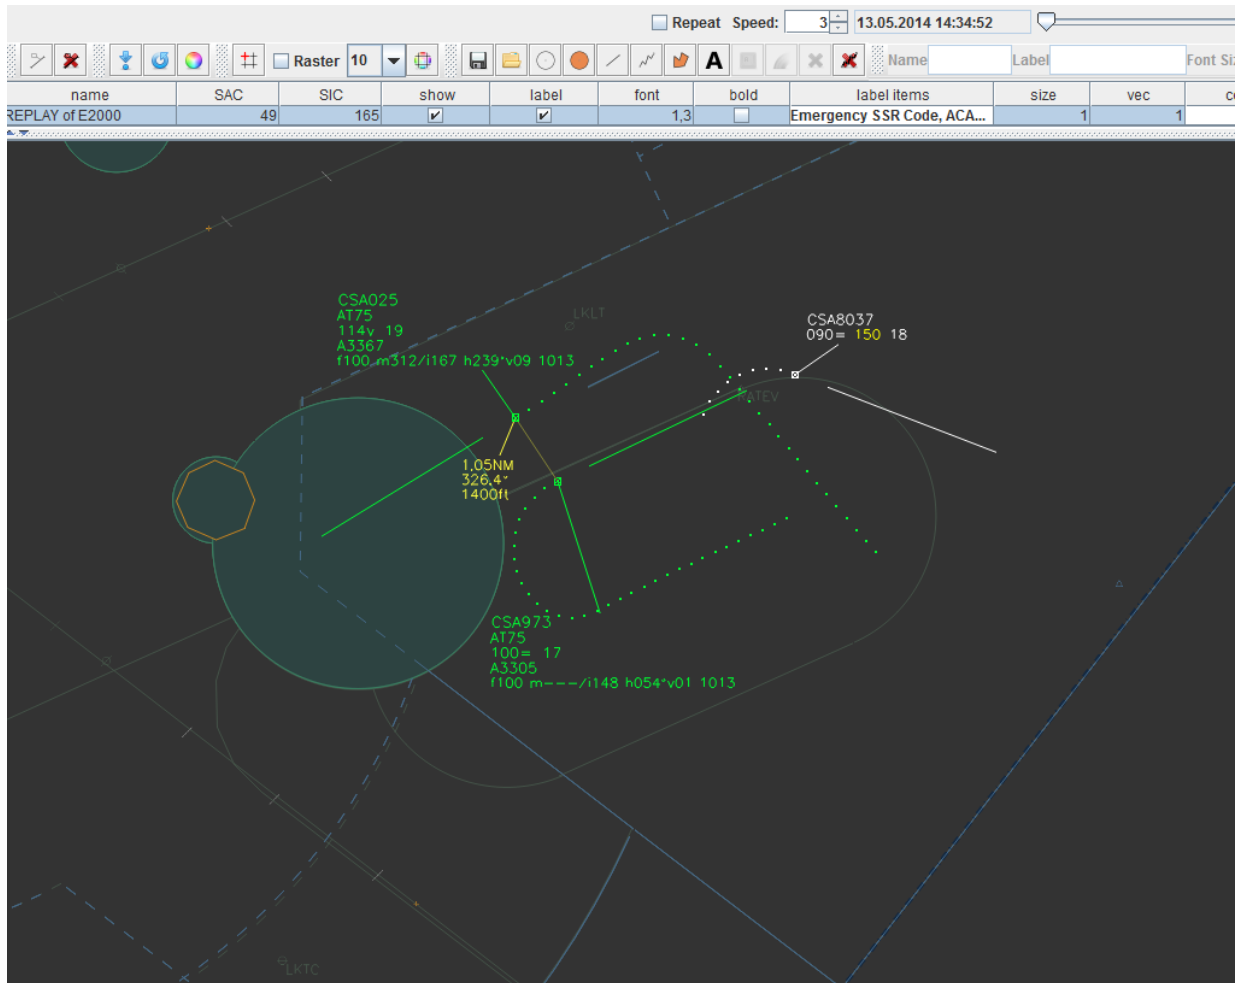
Fig. No. 3

During entering the holding pattern, CSA025 was descending to FL 100 occupied by CSA973, while bypassing this traffic with a vertical stack of 1,400 ft. The horizontal distance was 1.05 NM as illustrated in fig. No. 3.

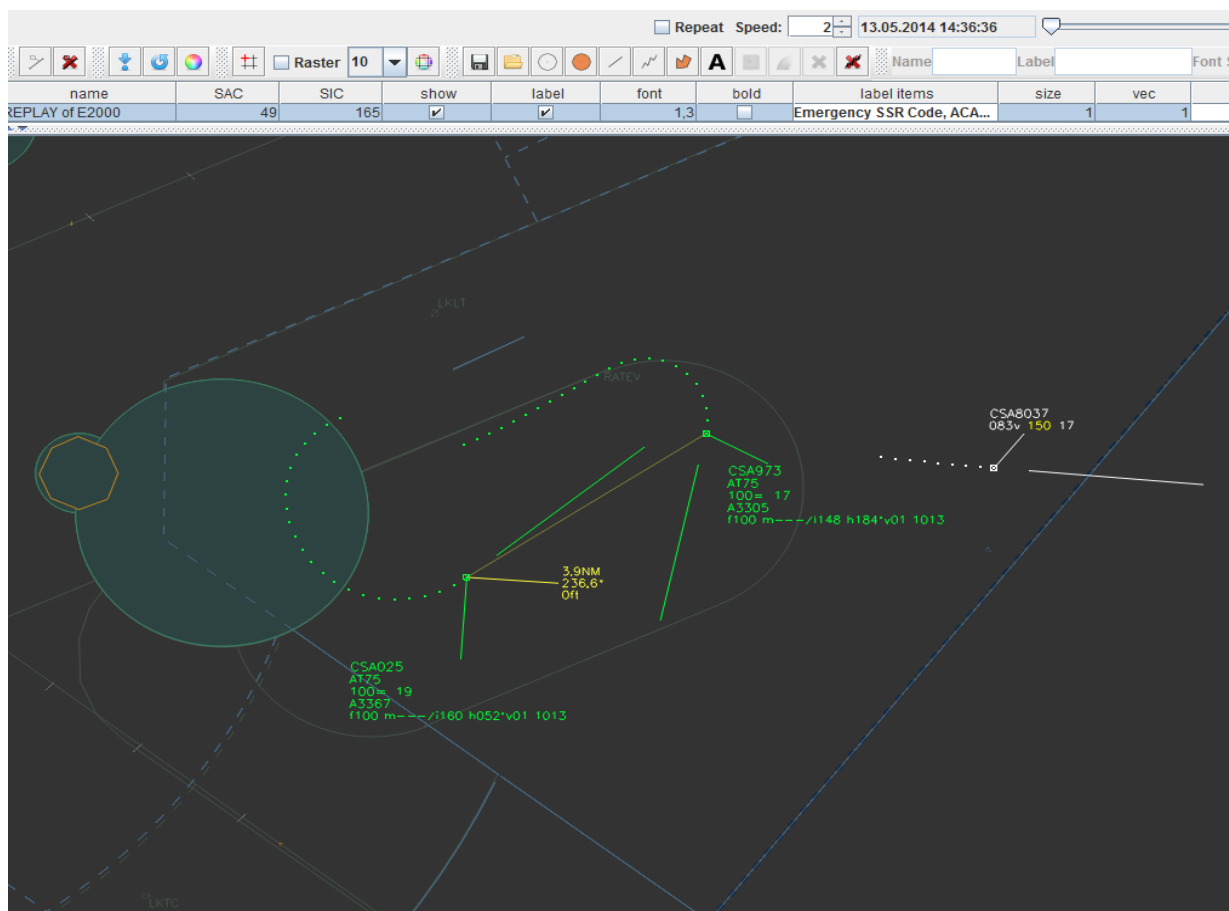
Fig. No. 4: STCA Activation

While further descending, CSA025 was completing parallel entry of the holding pattern. This manoeuvre resulted in the situation where both the aircraft were flying on routes in the opposite course at FL 100. The STCA alert function was activated at the moment when the horizontal distance between the aircraft was 3.9 NM. The situation is illustrated in fig. No. 4.

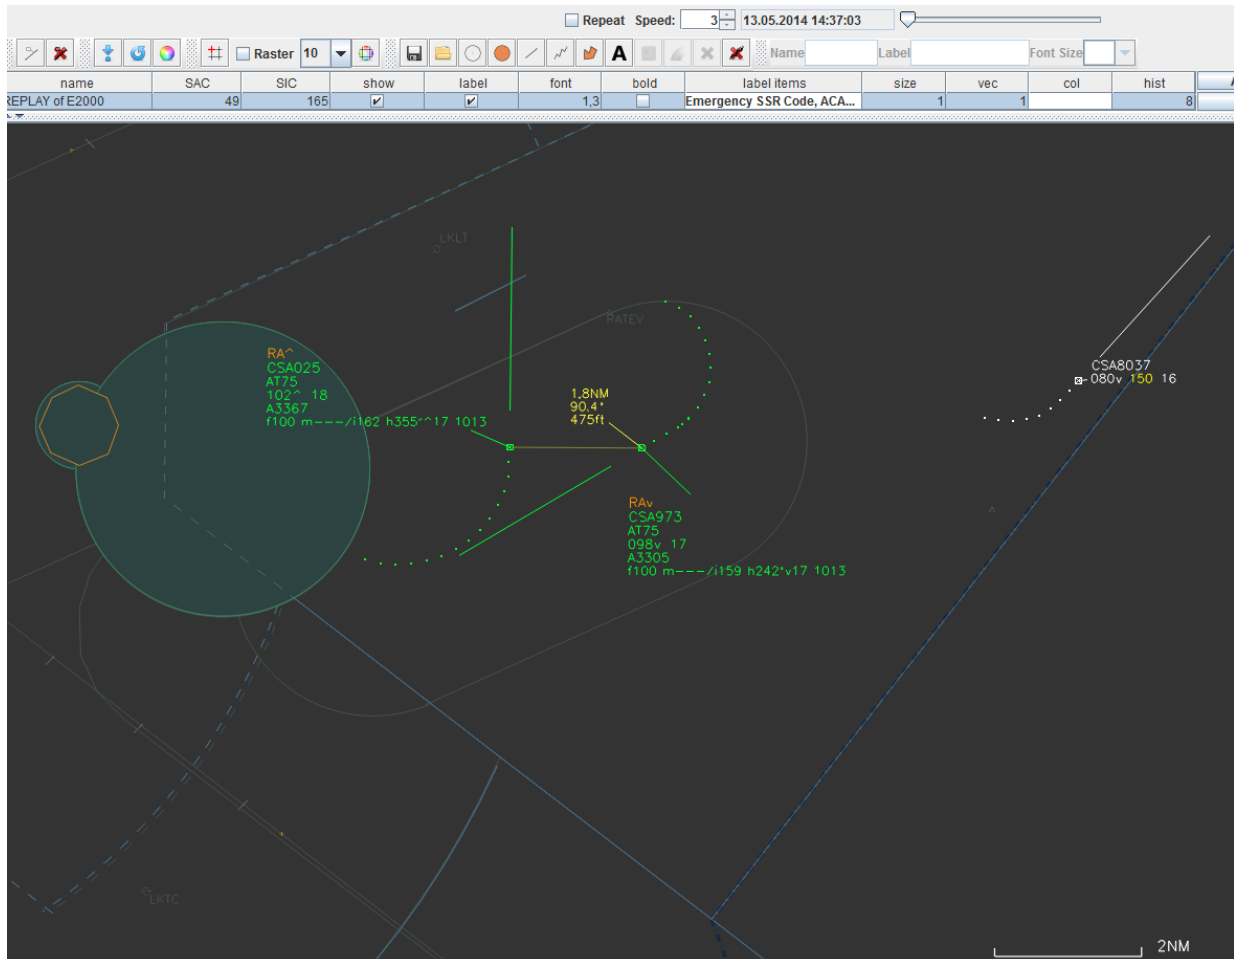
Fig. No 6.

In spite of a prompt response by both the AECs and both the crews, the radar separation minimum was reduced to 1.83 NM and 475 ft, which corresponds to 61 per cent of the required distance.

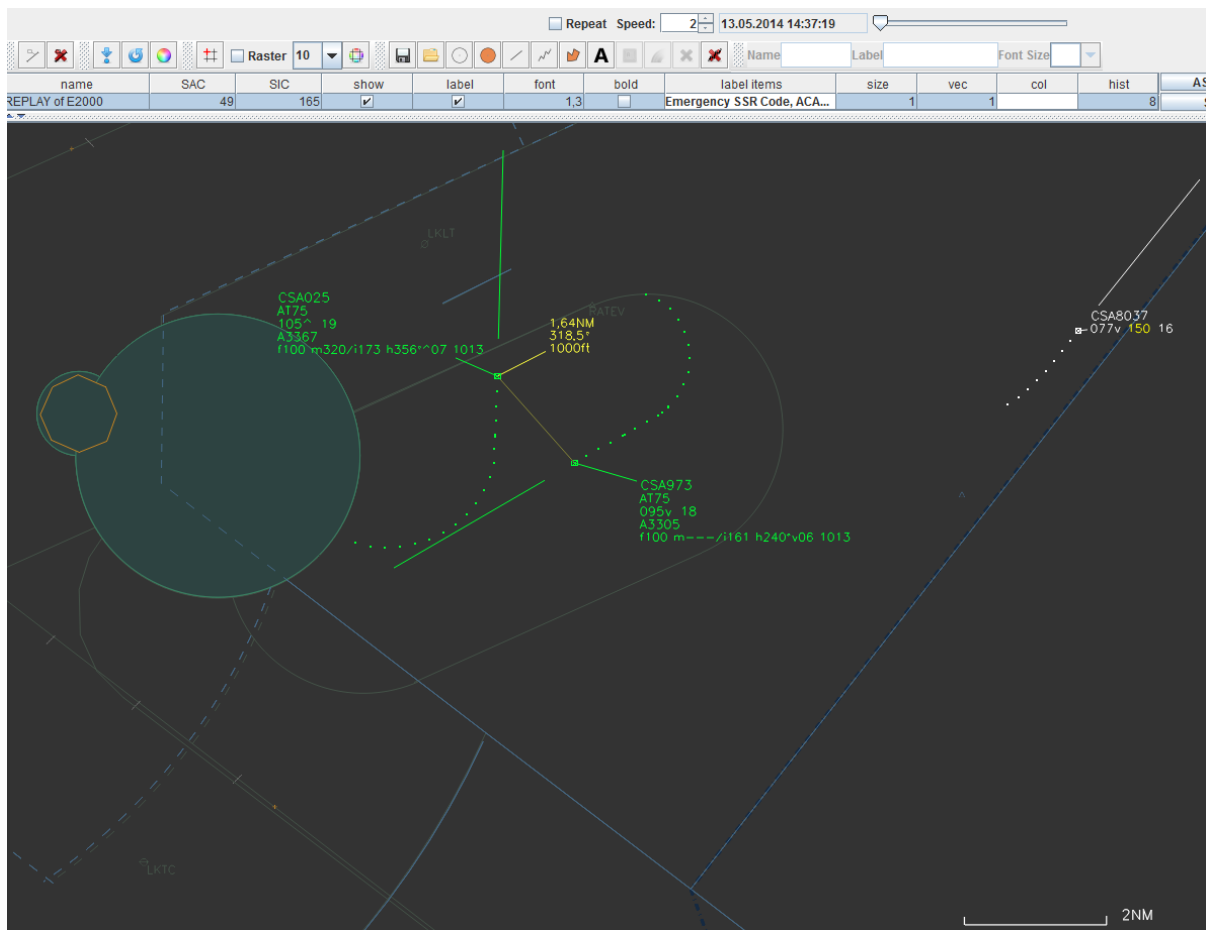
The AEC continued in controlling CSA973 by issuing an instruction to turn left up to the heading of 060 degrees. The crew of CSA025 responded to this instruction by reporting "clear of conflict".

Fig. No. 7: Clear of conflict
