AIR ACCIDENTS INVESTIGATION
INSTITUTE
Beranových 130
199 01 PRAHA 99

Ref. No. CZ - 12 - 131

FINAL REPORT

**Investigation of the air accident
involving the Safari helicopter, registration N 557XS,
at the village of Litvínovice - Šindlovy Dvory,
14 May 2012**

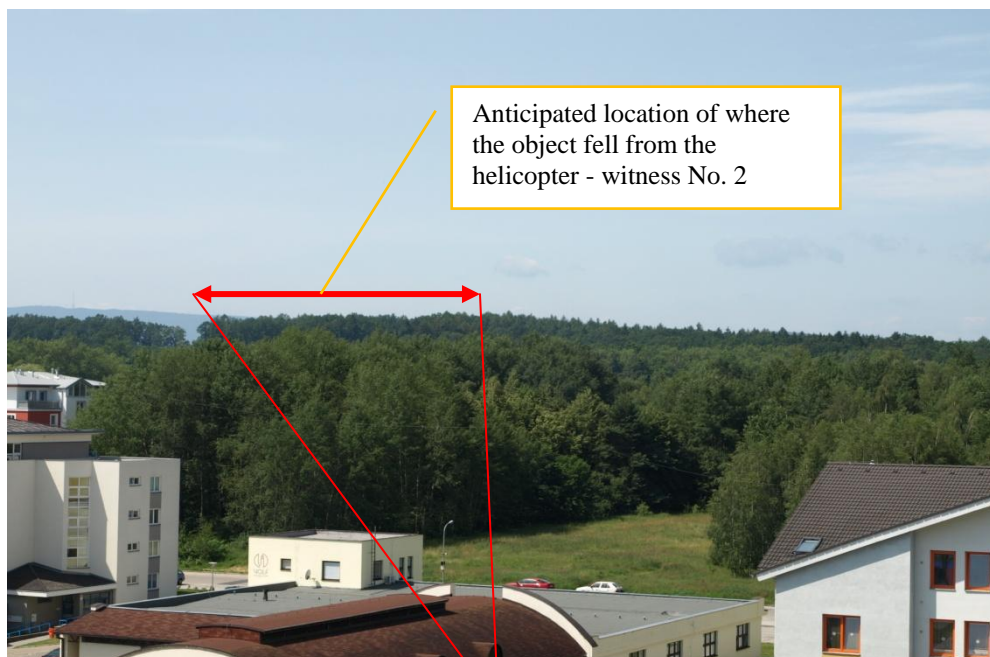
Fig. 1: View towards the location of the crash from the viewpoint of witness No. 2

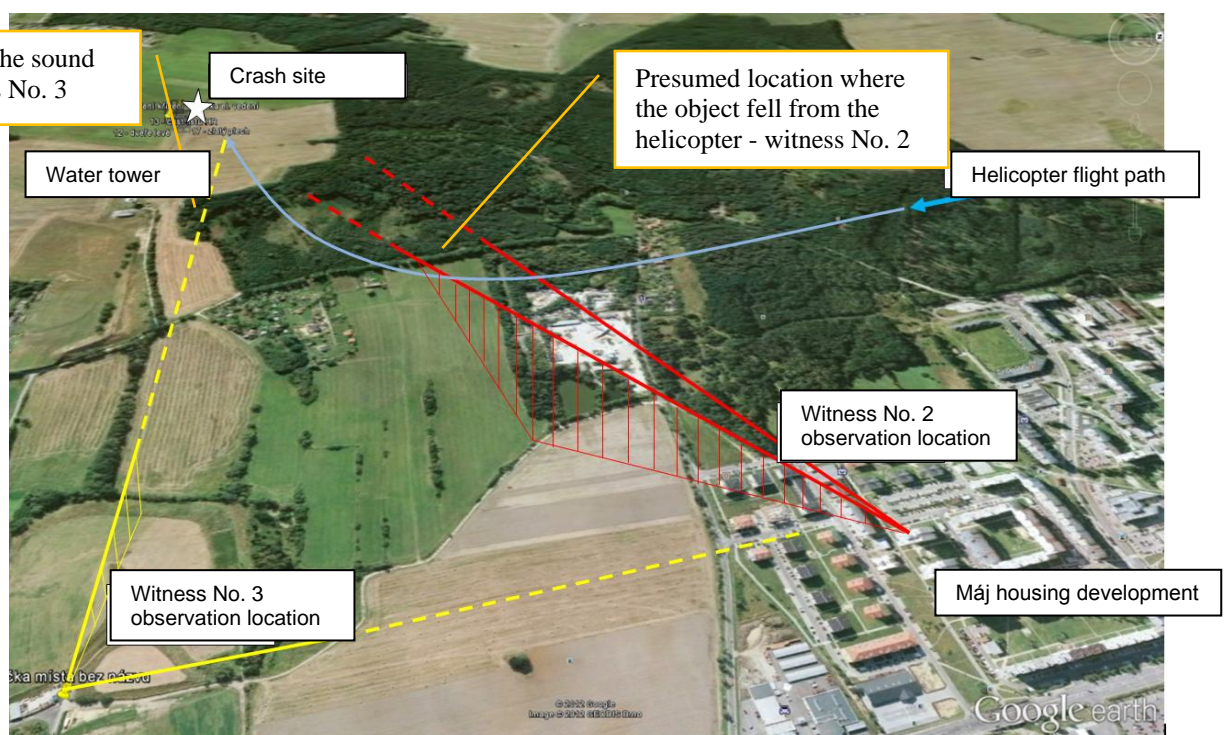
A series of flights took place along the trajectory that simulated the critical flight during which witness No. 2 attempted to confirm the approximate location where he saw an object fall from the helicopter. A Robinson R 44 was used for the attempt. Gradually the altitude of the flight was decreased from 150 m to 50 m AGL. The flights were coordinated by radio contact with the helicopter pilot and a member of AAll commission next to witness No. 2. The witness described with certainty the altitude of the flight, which was measured by the on-board altimeter and after conversion was determined to be 50 m AGL. The witness also described the approximate location where the object fell from the helicopter. Due to the distance, the witness could not determine the exact trajectory of the flight from the horizon of the forest.

Fig. 6: Graphic rendition of the observation of the flight trajectory according to the testimony of witnesses

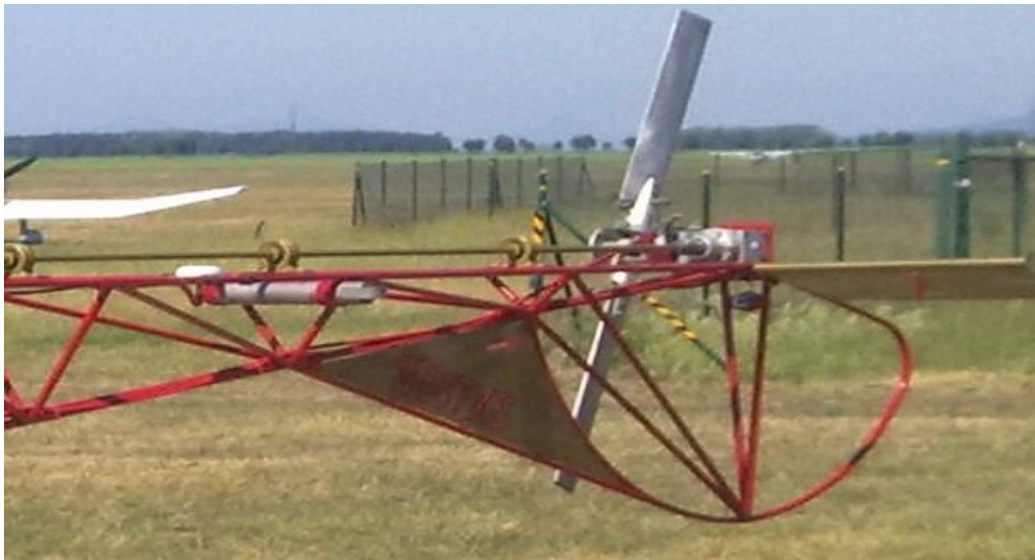
When assembling the main parts, it was found that the ballast weight with the locking pin and the left part of the rear holder of the weight were missing.

He said that the weight weighs 13.8 – 14.0 lbs. He also described the structural design and securing of the weight on the helicopter. The commission was not able to find evidence of how the weight was secured on the crashed helicopter. Presuming that it was the same as described by the manufacturer, the weight was secured by one locking pin into an opening on the left side of the holder. It can be presumed that the connection of the locking pin/hole could have been worn from operation of the helicopter, e.g. the ovality of the hole as a result of vibration of the tail beam during operation, or the ball mechanism of the locking pin could have been damaged thus losing its securing function.

Due to the fact that the pilot, after verifying the handling of the helicopter at LKHS, continued with his flight, it can be concluded that the weight was located at the specified location for a flight with two people. The findings resulting from the examination of the remains of the holder on the right side of the tail beam showed that the holder was not damaged or deformed. The paint, shape and welds remained intact and without damage. If the weight were in place at the moment the MR blade hit the tail beam, it is very probable that the inserted weight would have mechanically damaged the right holder. From the abovementioned, the commission came to the hypothesis that the weight was missing the moment the MR blades hit the tail beam. This fact is also supported by the observations of witness No. 2, who saw “some object” fall from the helicopter when the helicopter was steadily flying horizontally.

Fig. 6: Placement of ballast weight when occupied by two people
