**GOVERNMENT OF NEPAL
AIRCRAFT ACCIDENT INVESTIGATION COMMISSION**

FINAL REPORT

**9N-AKY LET 410 AIRCRAFT ACCIDENT
OPERATED BY GOMA AIR PVT LTD**

27 MAY, 2017

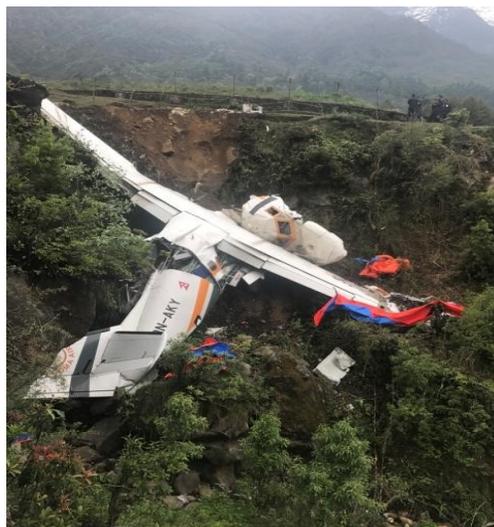
Figure 1 : Geographical reference of the crash site: 27416N, 864343 E
Elevation: 8800 feet AMSL
Point of Ultimate Impact

Abrupt change in aircraft attitude in an attempt to climb and reach threshold height at 8900ft. (on Kathmandu QNH) in a landing configuration, with landing gears down and on full flaps, created excessive drag resulting the aircraft to stall. Subsequently, its left wing first hit a small tree branch 180ft. short of the threshold. Then impacted the sloppy terrain 100ft. short of the runway. After the crash aircraft engine was reported to be running for about a minute. But there was no post-crash fire. Aircraft was totally damaged by the impact.
