**Accident to an ultralight aircraft VL-3 Evolution,  
national and registration markings LY-VLA,  
that occurred on 19 April 2014  
in Quarter No. 396 of Madžiūnai forest, Madžiūnai village,  
Paluknys neighbourhood, Trakai region, Vilnius district,  
the Republic of Lithuania**

**FINAL REPORT**

**Transport  
Accident and  
Incident  
Investigation Division**

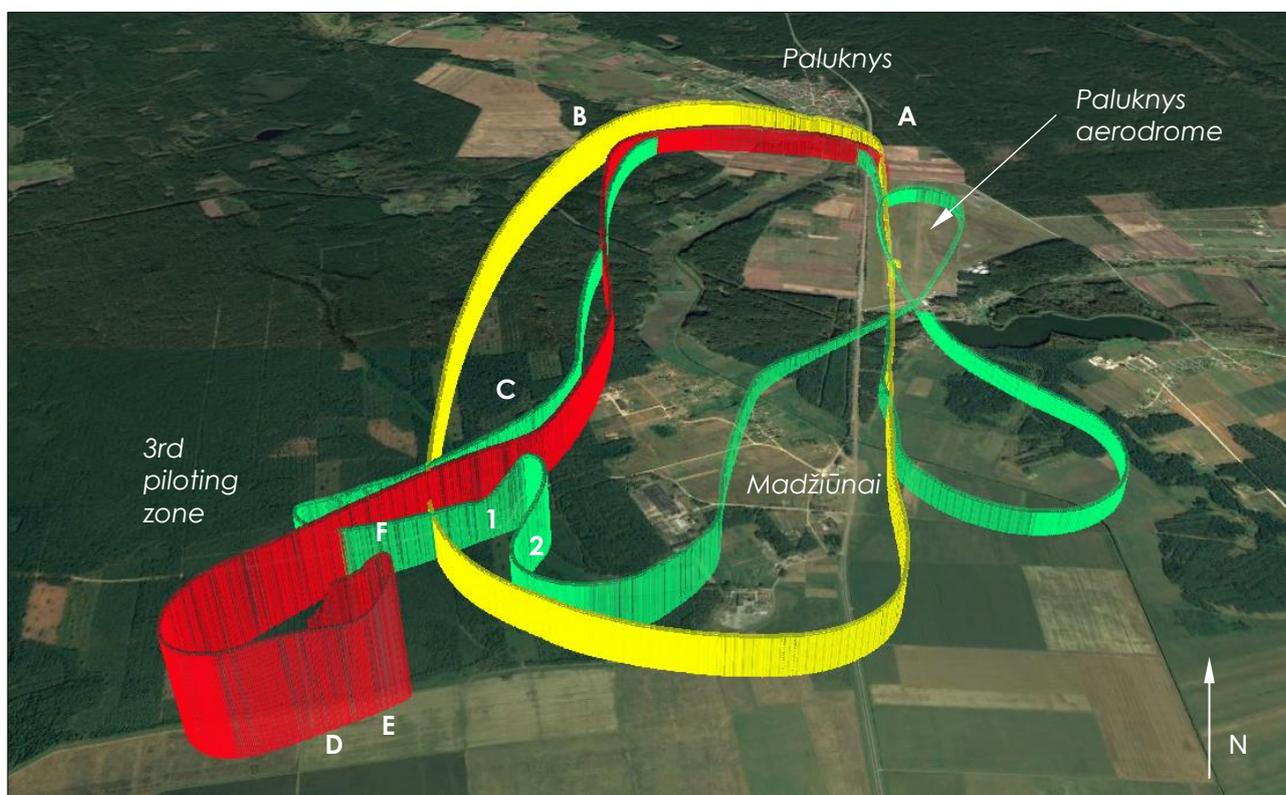
Fig. 3. First flight (yellow band), second flight (green band) and the third flight (red band) that ended in an accident of ultralight aircraft VL-3 Evolution

The flights trajectories recovered based on the data of the Dynon SkyView SV-D700 are shown in Fig. 3. According to the data, the ultralight aircraft took off for its first pleasure flight (yellow band, Fig. 3) at 19:34 at a 360° magnetic course from the aerodrome runway No. 36 and after a circle in the aerodrome area landed on 19:40. The ultralight aircraft took off for a second flight (green band, Fig. 3) at 19:45 for the same route and landed in the aerodrome on 19:55. It was established that Dynon SkyView SV-D700 started recording the data of third flight (red band, Fig. 3) at 20:01:10 and finished at 20:05:10. Data recording duration – 4 min. or 240 seconds.

The ultralight aircraft VL-3 Evolution took off for its third pleasure flight in the area of the Paluknys aerodrome at 360° magnetic course from the aerodrome runway No. 36 (Fig. 3). The ultralight aircraft reached the Northern end of the aerodrome, performed a standard left flight circle (points A-B-C, Fig. 3), which the aircraft left at the third turn (point C, Fig. 3). Afterward the ultralight aircraft performed a left turn between points C and E.

The second flight data shows (point 1, Fig. 3) that a similar manoeuvre was made when the ultralight aircraft reached the third zone of the aerodrome, but the ultralight aircraft did not enter to the spin.

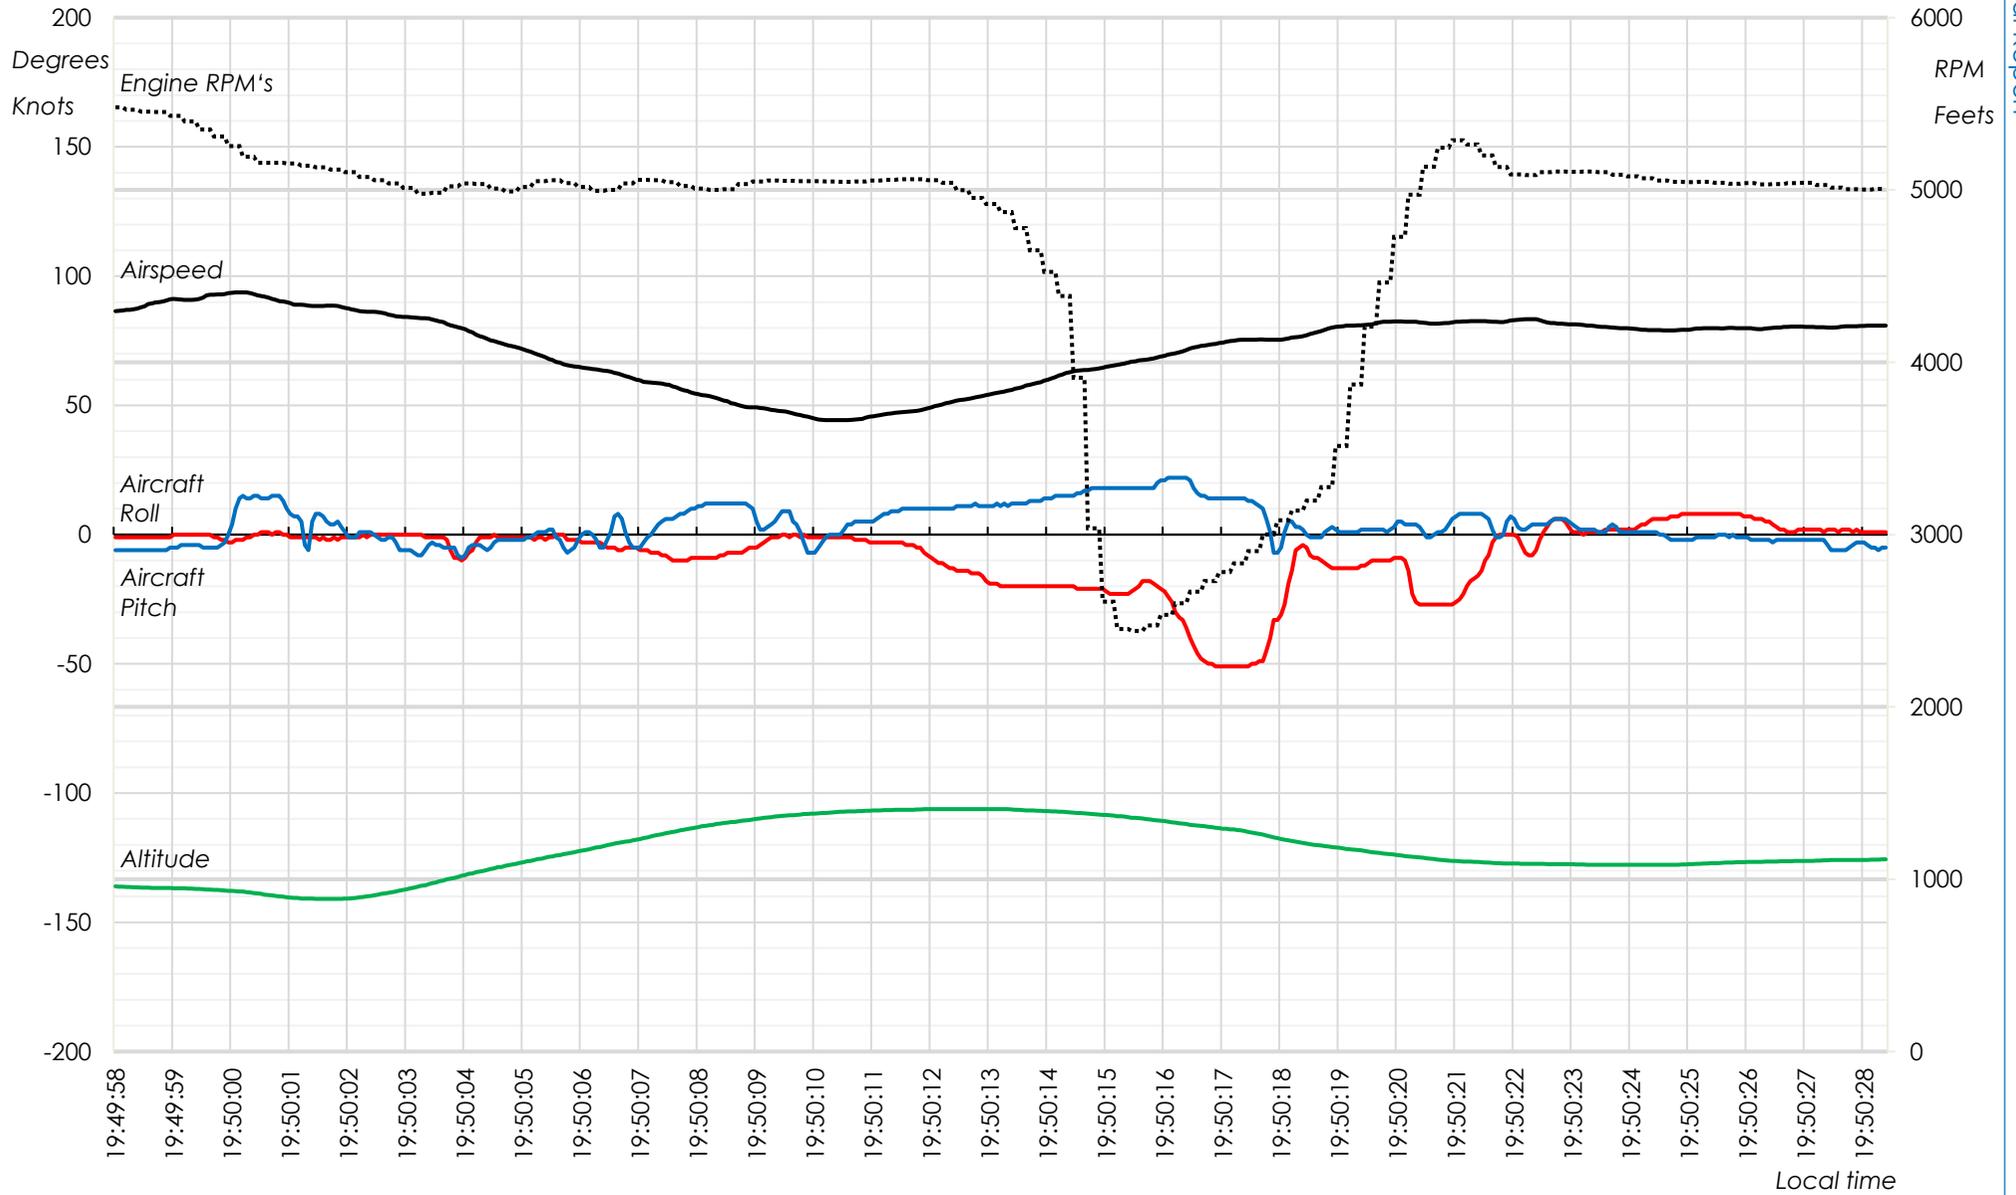
Fig. 4. Flight and engine operation parameter data of the second flight

During the second flight (Fig. 4), the engine RPM's were reduced evenly over 3 seconds from 5,056 rpm up to 2,441 rpm with the altitude decreased from 1,407 feet (429 m) to 1352 feet (412 m) and the speed of the aircraft increased from 50 knots (93 km/h) to 67 knots (124 km/h) (Fig. 5).
