CZ-18-0869

FINAL REPORT

**Investigation of causes of an air accident
of the Robinson R 44 RAVEN I helicopter
identification mark OK-PLP,
in the Pilsen industrial zone
on 5 September 2018**

Prague
August 2019

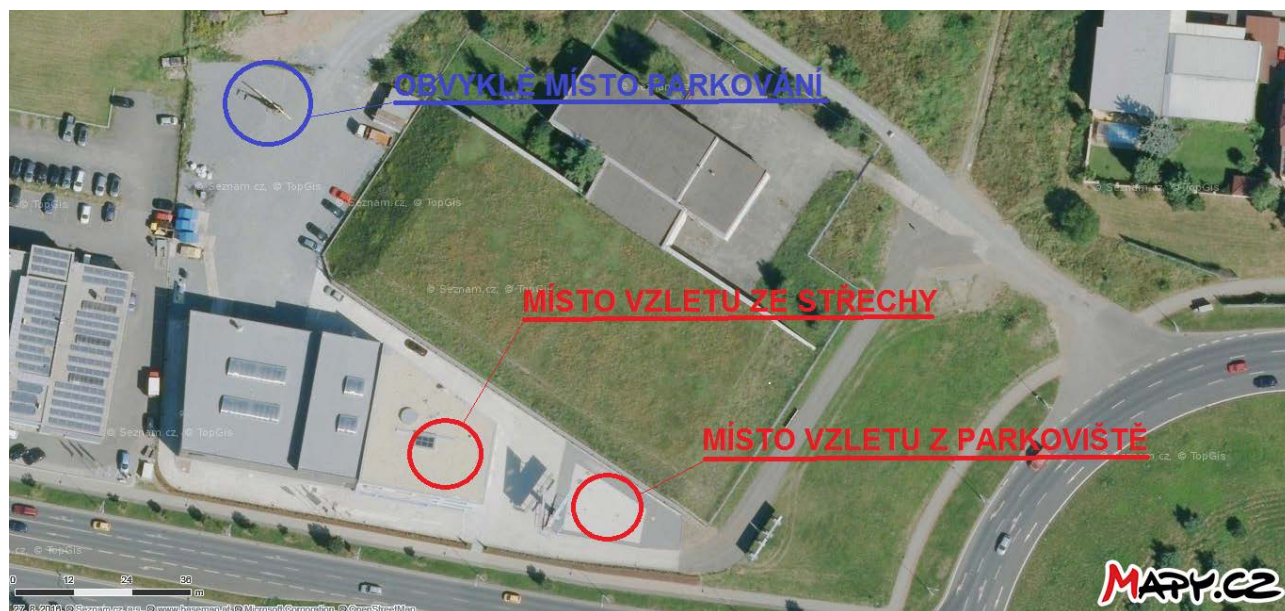
According to the owner's/operator's information, the helicopter was supposed to be parked in the fenced area behind the northern wall of the pilot's company building. (In Fig. 5, this place is marked as the usual parking place. It is highly probable that the pilot's helicopter RR 44, identification mark OK-BAJ, flown by the pilot from 13 May 2015 to 18 June 2018 according to the data recorded in the Pilot Logbook, was captured there by terrestrial photography. On the day of air accident, that helicopter was not there as it was in repair by repair service at LKMB.) On the day of the event flight, the helicopter was first parked at the corporate car park behind the eastern wall of the building and then the pilot flew it up onto the building roof. The corporate premises are located outside the municipal housing area. There is a multi-lane road, a pavement, and a cycle path along the southern edge of the building lot where the company building and the car park are located.

Fig. 5 – Places of take-off and landing on corporate premises
