AIR ACCIDENTS
INVESTIGATION INSTITUTE
Beranových 130
199 00 Prague 9 – Letňany

CZ-23-0869

FINAL REPORT

**on investigation of causes of an air accident of the PIK-20D glider,
registration mark OM-5133,
in a field south of Podhořany near Ronov
on 12 August 2023**

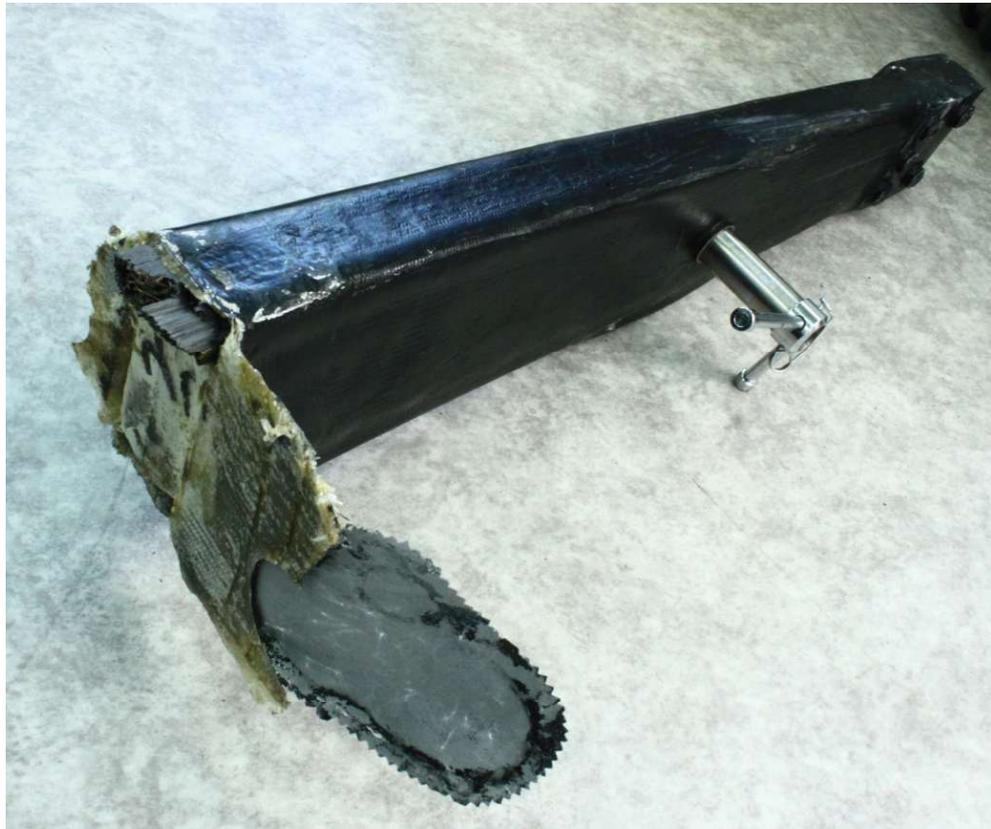
Fig. 2.1 – Provided wing spar part.

The following damaged left-wing spar part was delivered to the VZLU (Fig. 2.1).

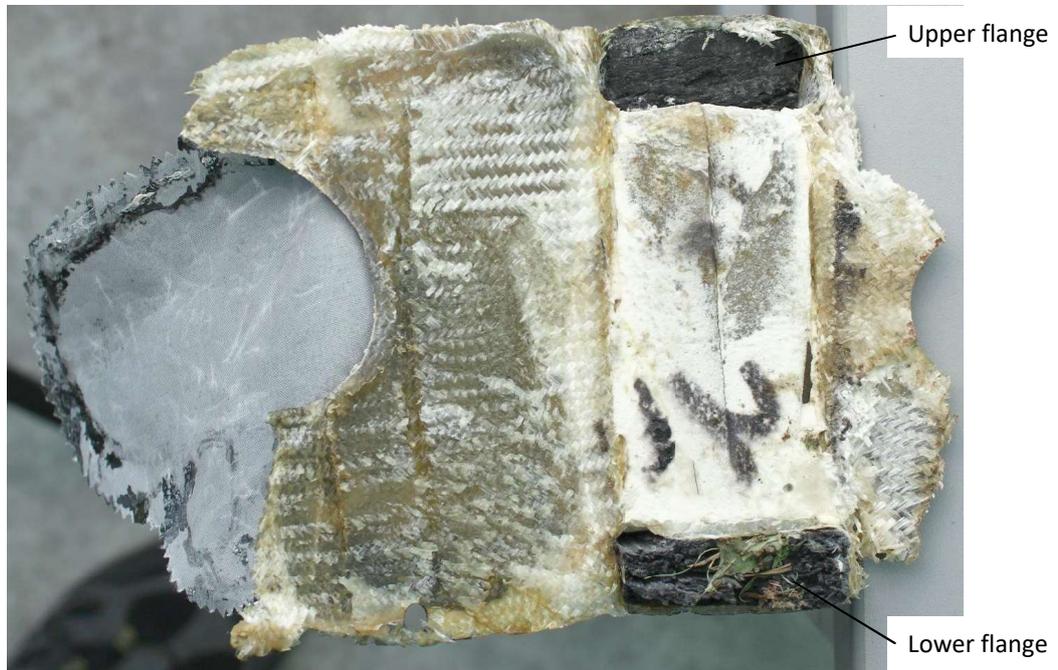
The overview images of the entire fracture surfaces are shown in Fig. 5.1 to Fig. 5.4. Fig. 5.3a shows the back side of the spar, where the tearing of the fabric occurred when the lower flange was fractured.

Fig. 5.1 – Overview image of the fracture surface from the fuselage view.

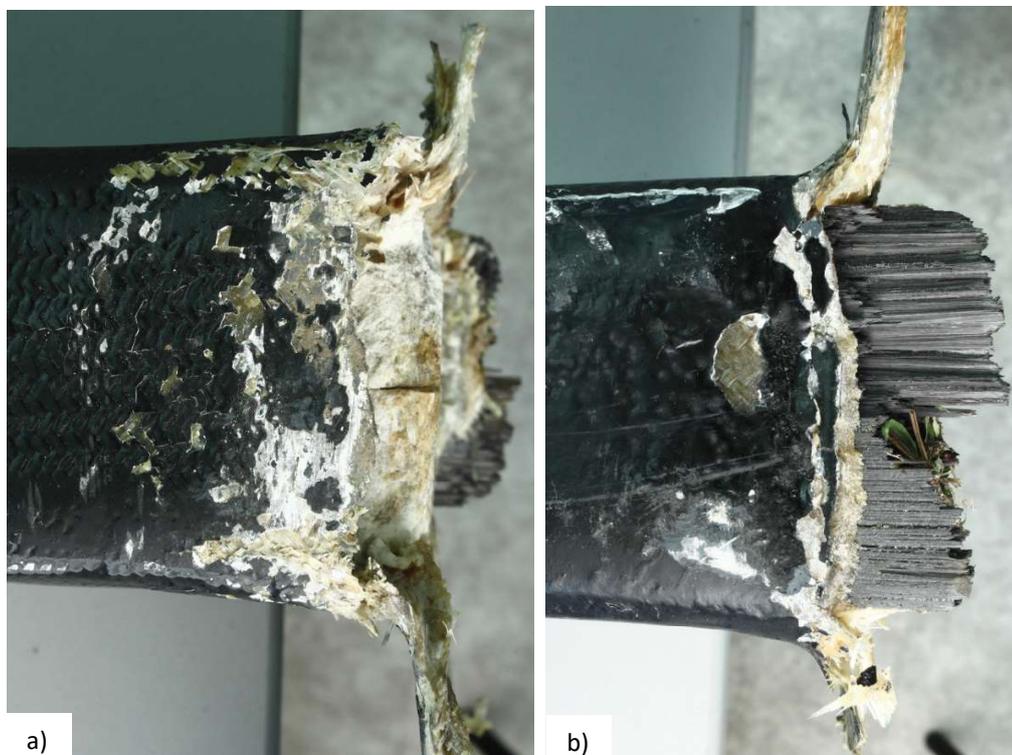
Fig. 5.2 – Overview image of a) upper flange from the top of the spar, b) lower flange from the bottom of the spar.

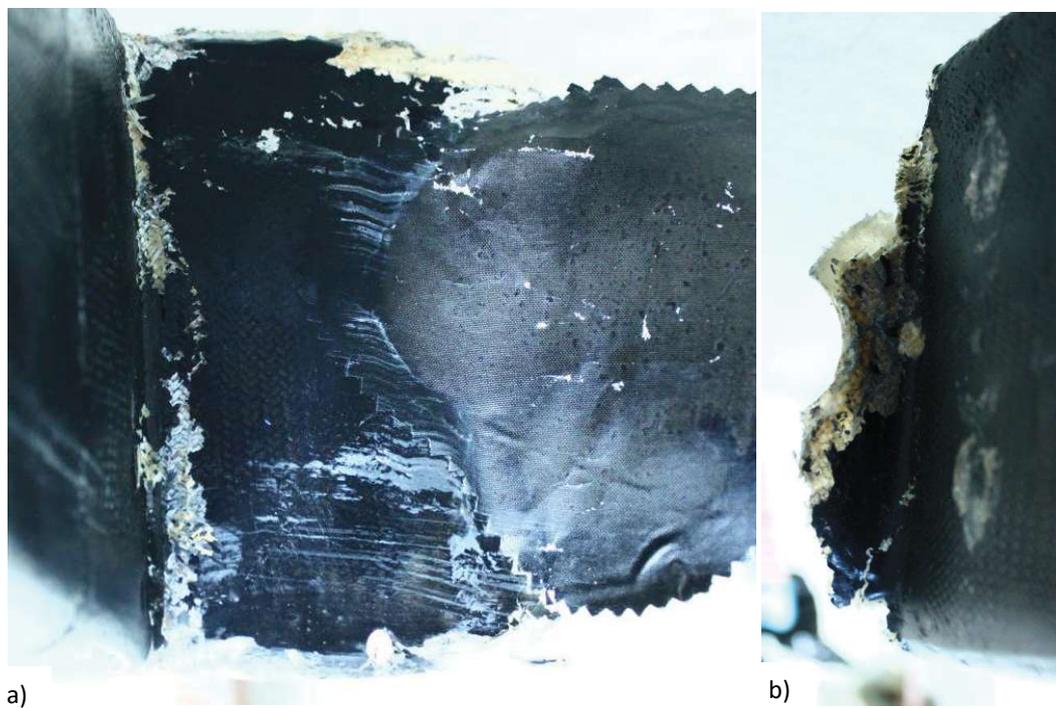
Fig. 5.4 – Overview images of the delaminated fabric on the side of a) the front part and b) the back part. The upper flange is always pictured on top.

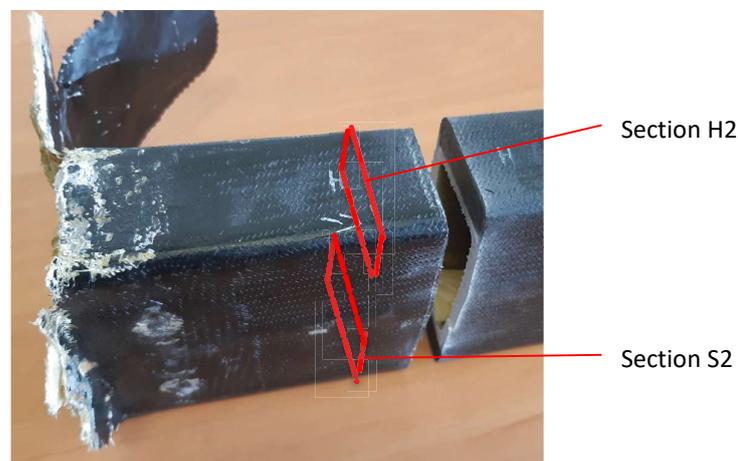
Fig. 5.10 – Schematic representation of sections for metallographic analysis of flange porosity.

Based on the observed porosity in the flange, metallographic analysis of both flanges was carried out at a section approximately 10 cm behind the fracture (Fig. 5.10). In Figs. 5.11 and 5.12, significant porosity is visible on both flanges, particularly at the interface of randomly placed fibre tows. The pore size was 100 to 500 μm . Large pores were also observed at the interface of the inner carbon fibres and the surface fabric, which supported the observed delamination of the fabric at the fracture.
