AIR ACCIDENTS INVESTIGATION
INSTITUTE
Beranových 130
199 00 Praha 9 - Letňany

CZ-24-1093

FINAL REPORT

**on the investigation of the causes of
the accident to Cessna P210N registration OM-DKA,
at Bartošovice, 4,7 km SW THR RWY 04 LKMT
on 9. 8. 2024**

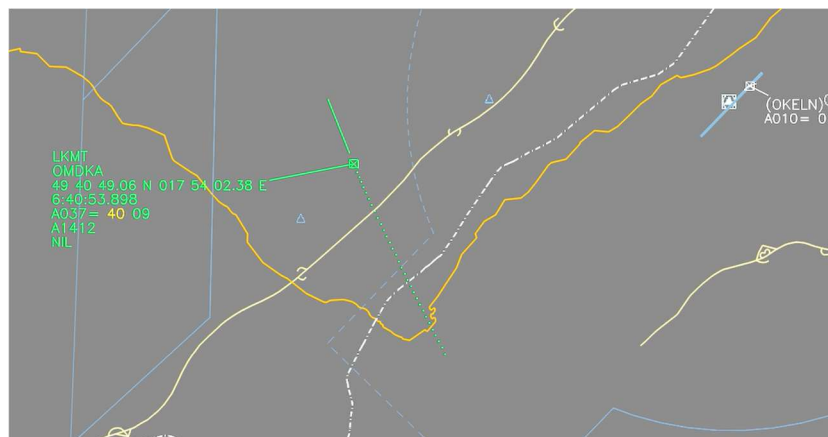
At 06:40:53, at a position approximately 14 km W THR RWY 04 LKMT at 3,700 ft AMSL (2,620 ft AGL), the pilot sent a distress signal MAYDAY on the frequency and a message that he had had an engine failure and was turning towards Mošnov Airport. The position of the aircraft is shown in Fig. 1.

Fig. 1 – Position of the OM-DKA aircraft at the time of the MAYDAY distress signal.

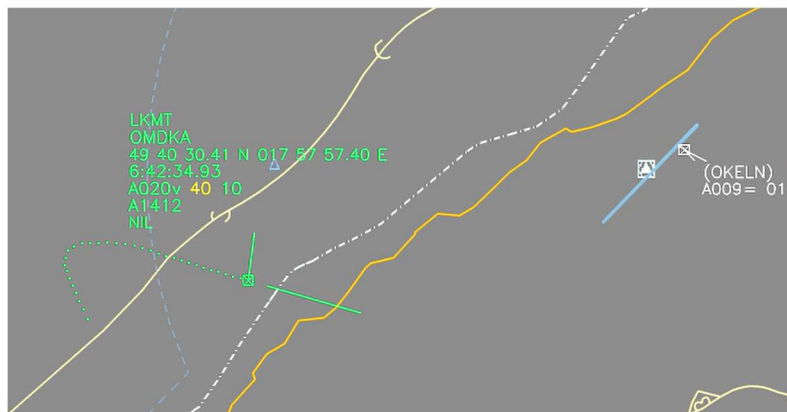
At 06:42:35 (8.6 km W THR RWY 04 LKMT), the pilot announced on TWR Mošnov frequency that he was in a position approximately 3–4 min west of LKMT, at 1,800 ft AMSL (relative to terrain 1,000 ft AGL) and would attempt an emergency landing at Mošnov airport. ATCo acknowledged the distress message and issued a clearance for landing on RWY 04. The position of the aircraft is shown in Fig. 2. The pilot explained that when the engine lost power, he tried to restart it, but the engine no longer responded.

Fig. 2 – Position of the OM-DKA aircraft at the time of establishing communication with TWR Mošnov

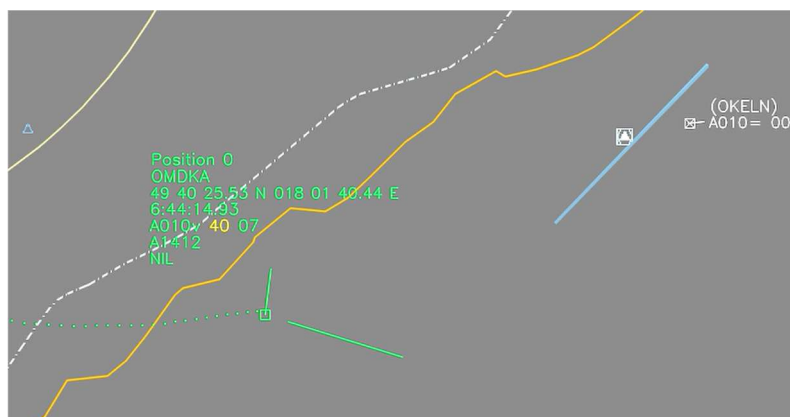
At 06:44:14, at a position approximately 4.8 km from THR RWY 04 LKMT, the pilot announced that he would be landing to terrain as he would not reach the airport. The aircraft was in descent at about 200 ft AGL and descending at GS of 70 kt. The position of the aircraft is shown in Fig. 3.

Fig. 3 – Position of the OM-DKA aircraft at the time of sending the message about landing to terrain

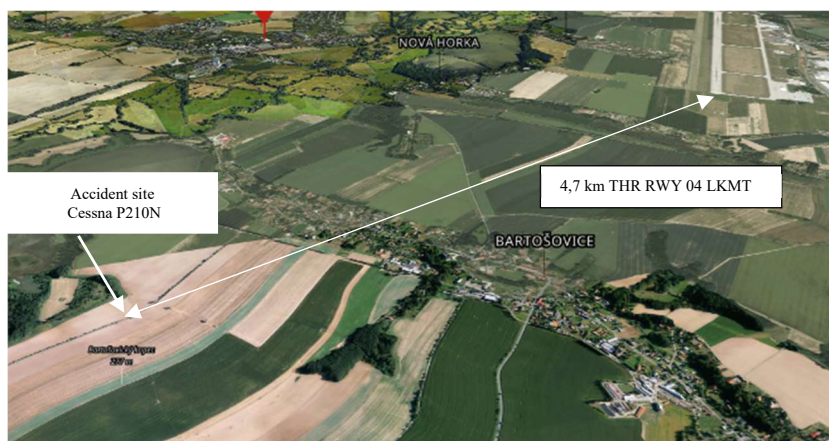
At 06:45, the pilot landed with the landing gear and flaps retracted on a shallow-ploughed field near the village of Bartošovice. Upon touchdown in the field, the propeller and exhaust hit the ground, and the aircraft rolled over the nose after about 40 m. The position of the accident site relative to LKMT is shown in Fig. 4.

Fig. 4 – Location of the accident site of OM-DKA aircraft in relation to LKMT

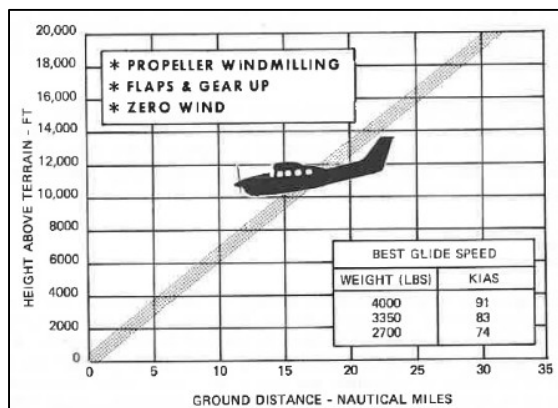
The “Amplified Procedures” section provides a chart of the maximum range of the aircraft in descent with an inoperative engine, see Fig. 13.

Fig. 13 – Chart of maximum flight range of Cessna P210N in descent with an inoperative engine
