CZ-14-181

FINAL REPORT

**Investigation into the serious incident
Separation minima infringement
at TMA Praha
on May 13, 2014**

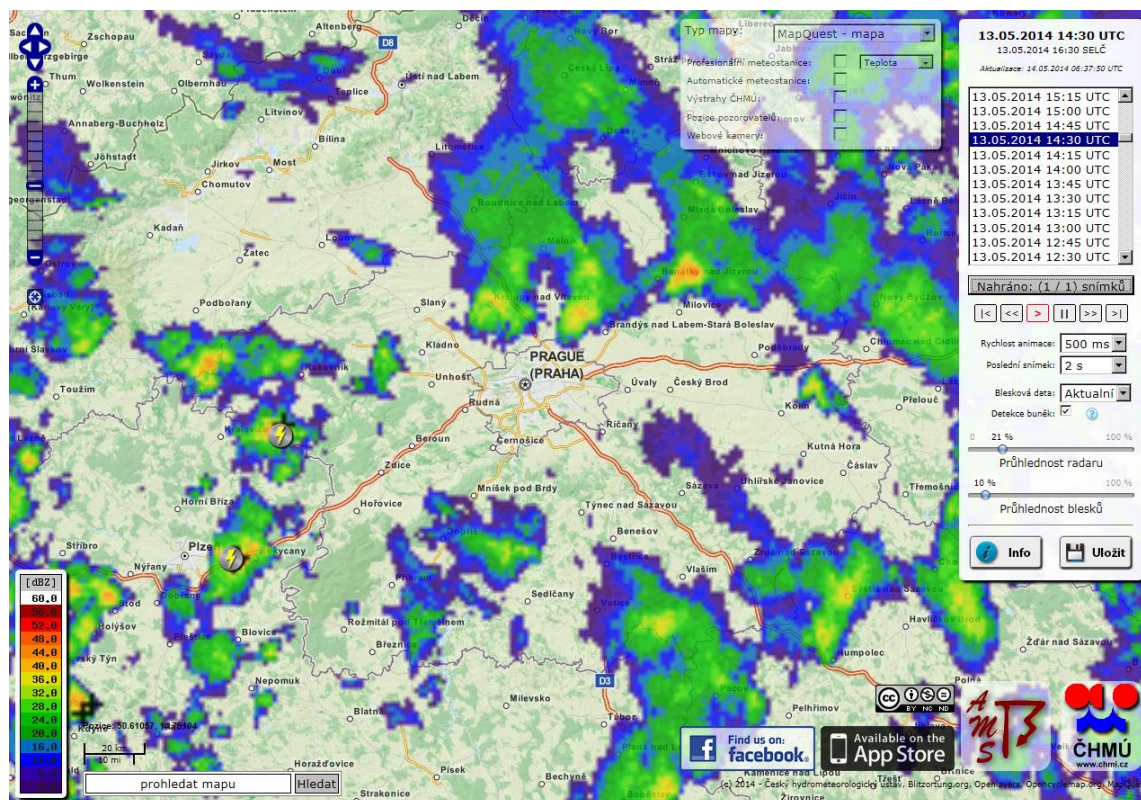
Fig. No. 1: Meteo radar Record

131300Z 21007KT	9999	FEW020	10/07	Q1013	NOSIG	RMK	REG	QNH	1010=
131330Z 22008KT	9999	FEW020	11/07	Q1013	NOSIG	RMK	REG	QNH	1010=
131400Z 22006KT 150V280	9999	FEW023CB	12/07	Q1013	NOSIG	RMK	REG	QNH	1010=
131430Z 22007KT	9999	FEW023CB	13/07	Q1013	NOSIG	RMK	REG	QNH	1010=
131438Z 30012KT 260V320	9999	FEW023CB	12/06	Q1013					RMK REG QNH 1010=
131500Z 36011KT	9999	VCSH FEW023CB SCT040	11/05	Q1014	TEMPO	SHRA	RMK		
REG QNH 1010=

The incident occurred at the Prague APP control site between two arrivals at LKPR. Because of intensive storm activity at Prague TMA, the APP WS decided to join the DEP and ARR control sites. With regards to medium traffic density and meteorological conditions the joining was applied as more suitable in terms of operation.

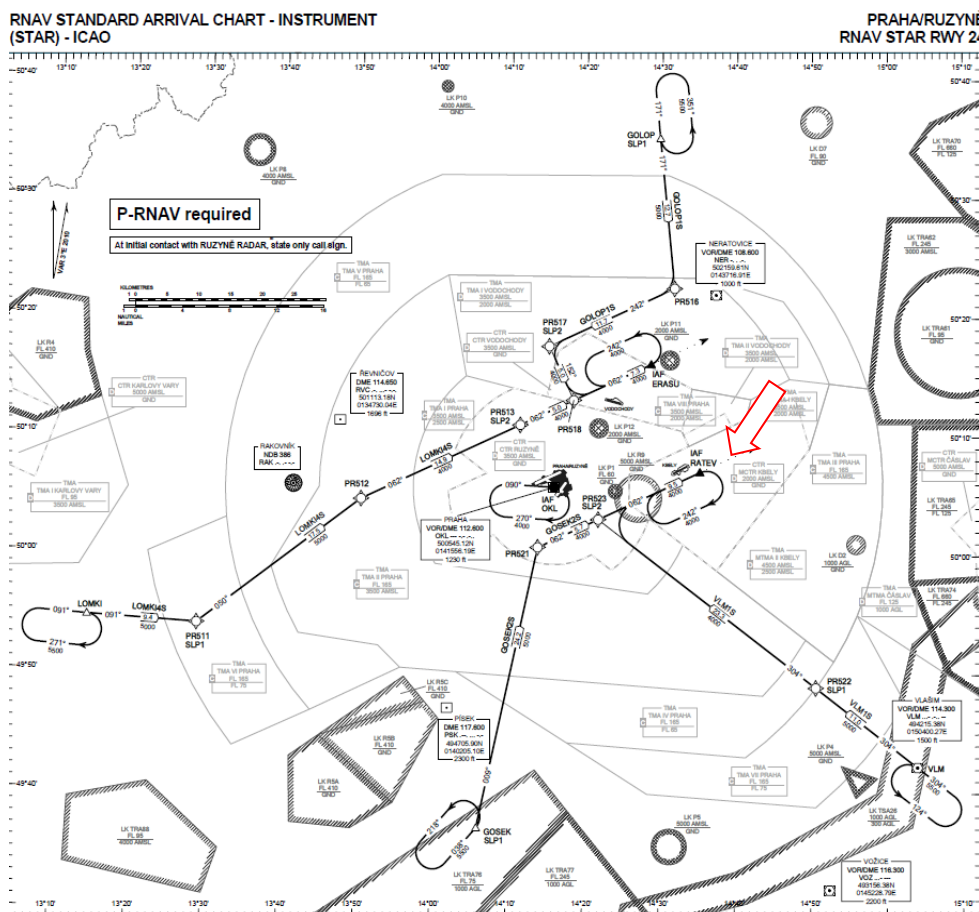
Fig. No. 2: Map - RNAV STAR RWY 24

The incident took place at TMA III PRAGUE, over the RATEV point, (IAF for RWY 24), at FL 100.

- The specified minimum separation reduction was caused by an incorrectly issued clearance by the respective AEC due to which flights CSA973 and CSA025 descended and kept the same flight level in the identical holding pattern over the RATEV point.
